COMPLIANCE REPORT
CONSTRUCTION OF THE CHEDA CREEK FISH PASSAGE STRUCTURE
FILE NUMBER 25315N

Submitted by the National Park Service
Point Reyes National Seashore
Point Reyes Station, California, 94956

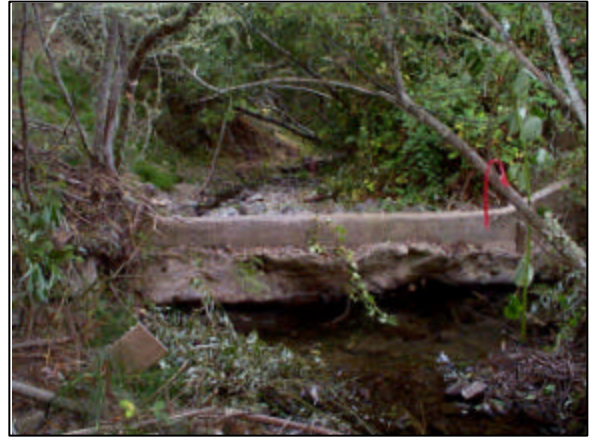
Upstream Migrating Head Cut (1999)

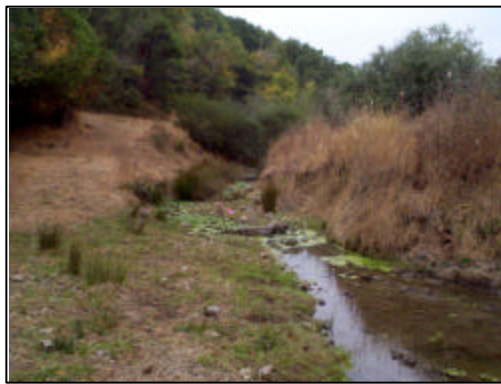
Dammed Pool

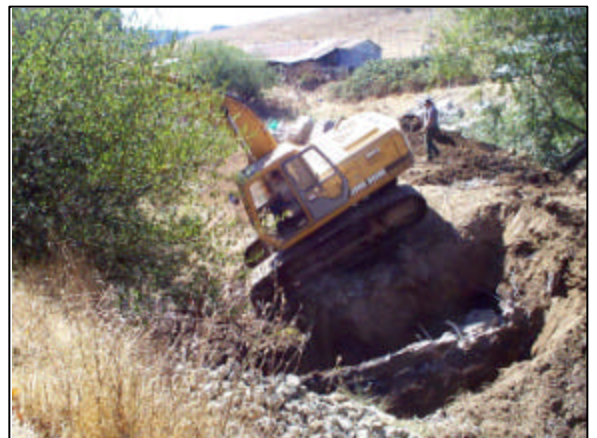
Removal of Cement
Barrier

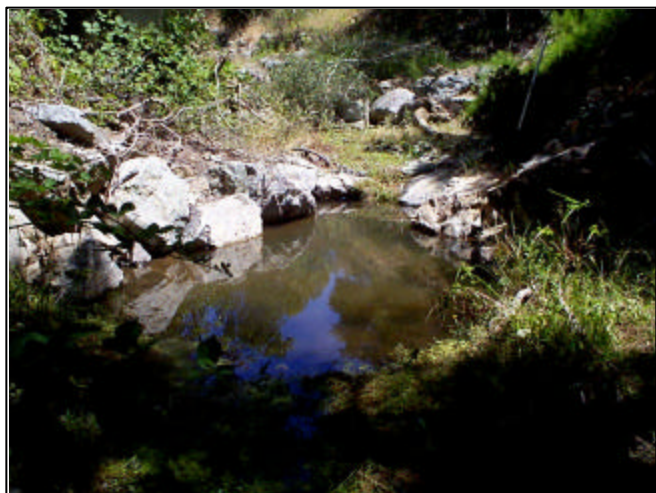
Weir 5 – Summer Habitat

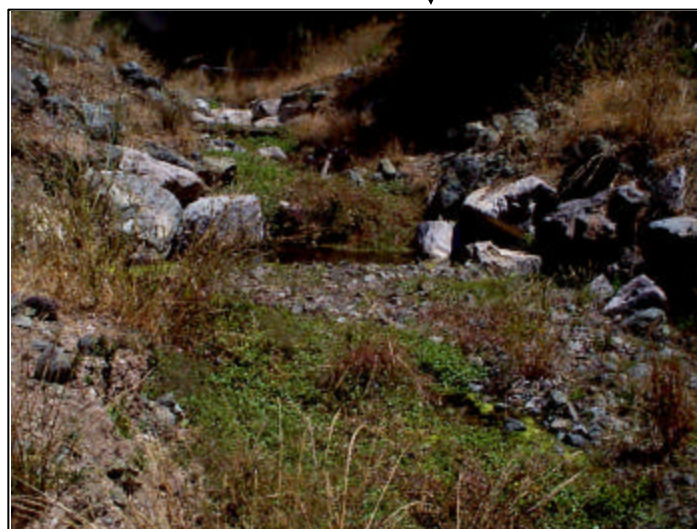
Weir 4 – Summer Habitat
