**California Department of Fish and Game
Inland Fisheries Division**

**Evaluation of Salmonid Habitat Restoration Structures in Northwestern California
Streams Conducted during 1993 and 1995.**

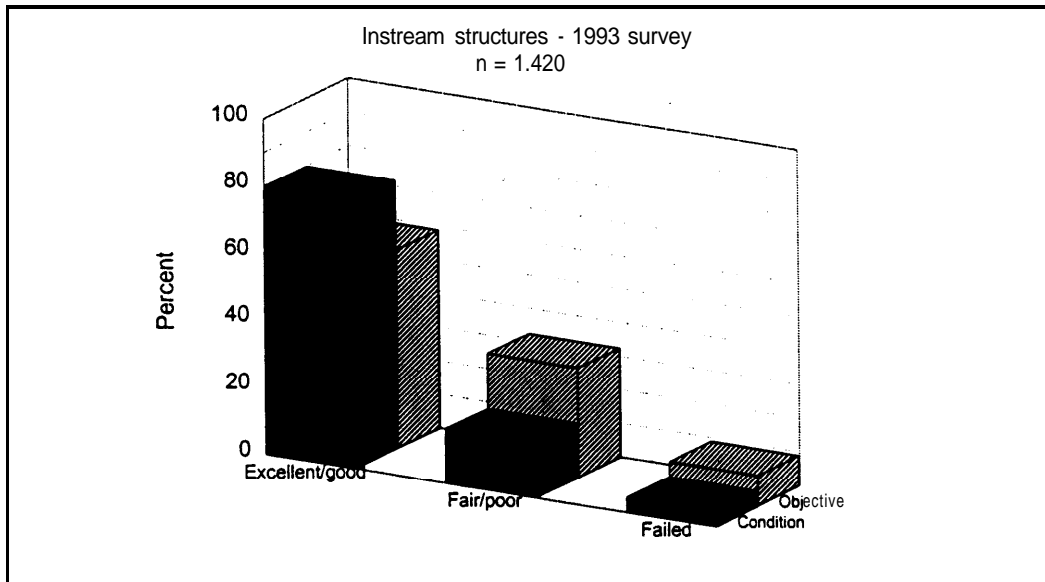
During 1993, physical condition was rated excellent or good in 79.6 percent of all instream structures built prior to 1993. Only 4.4 percent of structures built prior to the 1993 survey physically failed. In contrast, 1993 ratings for how well structures were meeting intended objectives were 58.9 percent for excellent or good categories and 8.8 percent had failed to meet intended objectives (Figure 1).

Figure 1. Evaluation ratings of 1,420 fish habitat improvement structures observed in northwestern California streams during 1993. Condition pertains to structural integrity and objective pertains to how well structure meets intended purpose of improving habitat.

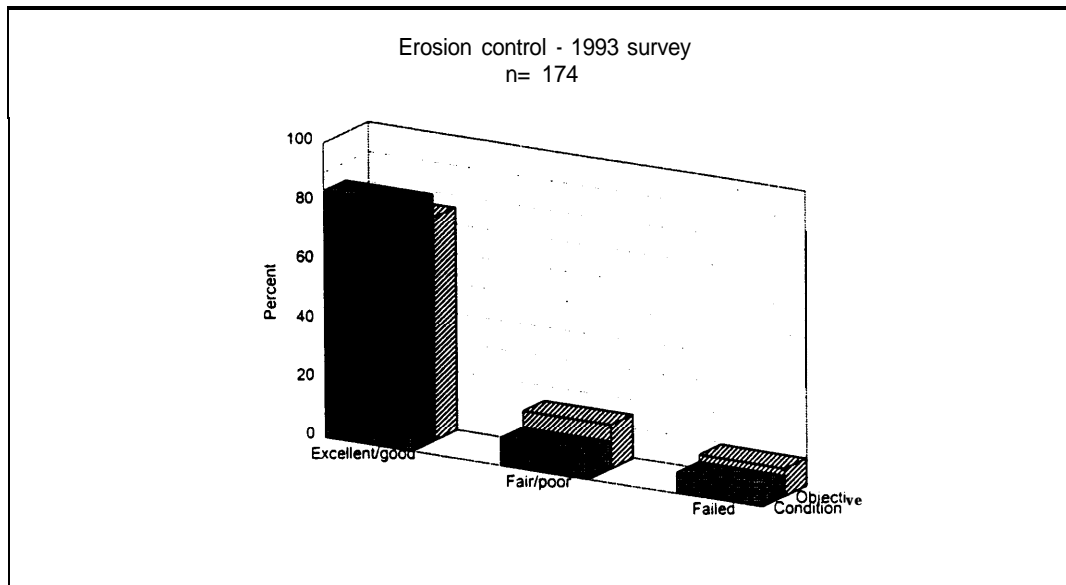
Physical condition of erosion control structures was rated excellent or good in 85 percent of all streams surveyed in 1993 (Figure 2). A total of 6.9 percent had completely failed structurally. Erosion control devices were meeting objectives in the excellent or good categories in 75.9 percent of the cases surveyed. A total of 9.2 percent had failed completely to meet any intended objective.

Figure 2. Evaluation ratings of 174 erosion control or bank stability structures observed in northwestern California streams during 1993. Condition pertains to structural integrity and objective pertains to how well structure meets intended purpose of preventing slope or bank erosion.

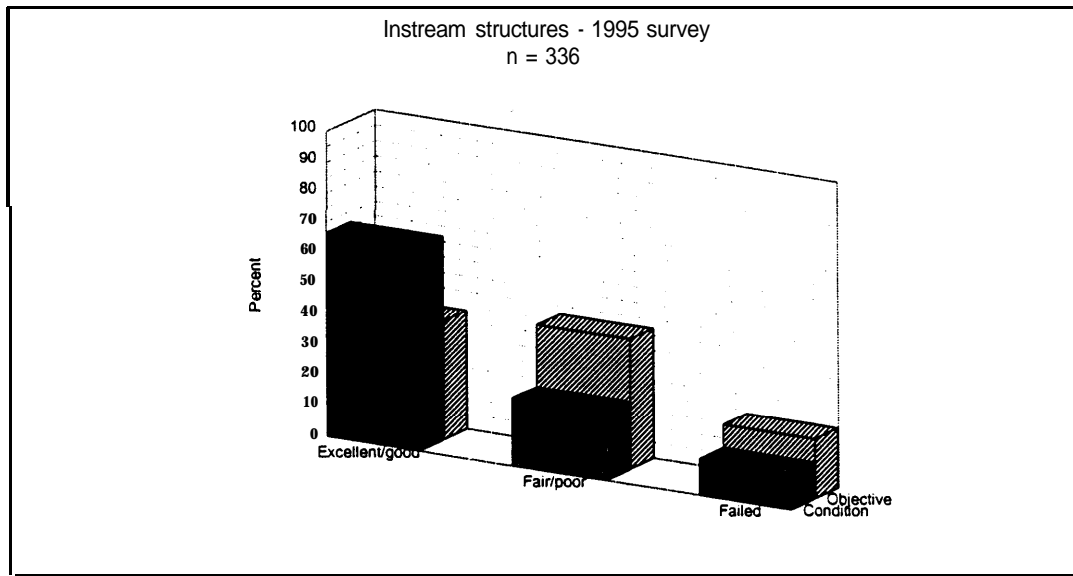
During 1995, physical condition in combined rating categories of excellent or good was 67.3 percent of all instream structures built prior to 1993. Only 11.0 percent of structures built prior to the 1993 survey had physically failed entirely. Ratings for how well structures were meeting intended objectives in 1995 were 39.3 percent for combined excellent or good categories and 18.8 percent had failed to meet any degree of intended objectives (Figure 3).

Figure 3. Evaluation ratings of 336 fish habitat improvement structures observed in northwestern California streams during 1995. Condition pertains to structural integrity and objective pertains to how well structure meets intended purpose of improving habitat.

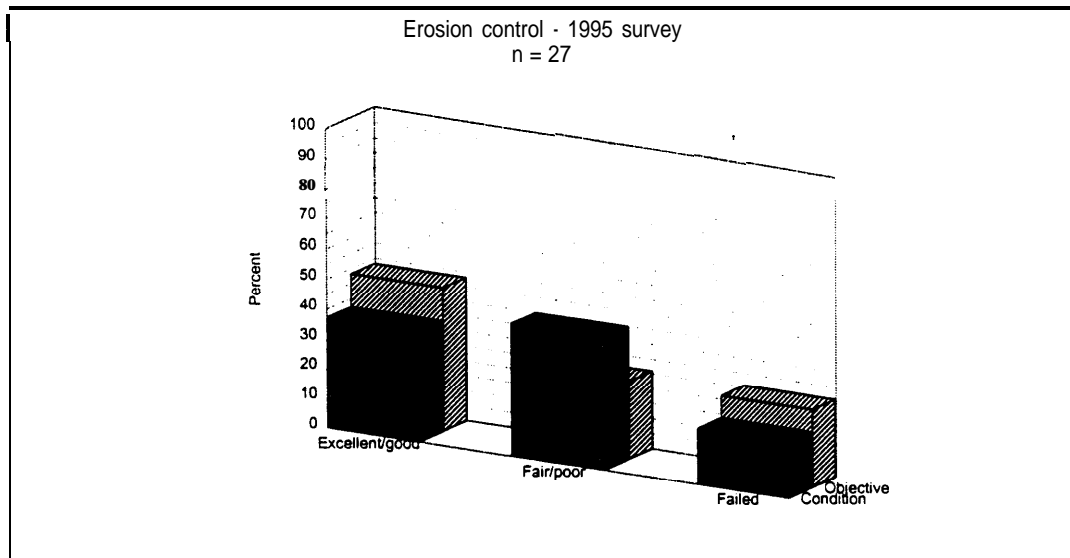
Physical condition of erosion control structures was rated excellent or good in 37 percent of all streams surveyed in 1995 (Figure 4). A total of 18.5 percent had completely failed structurally. All erosion control devices were meeting objectives in the excellent or good categories in 48.1 percent of the cases surveyed. A total of 25.9 percent had failed completely to meet any intended objective.

Figure 4. Evaluation ratings of 27 erosion control or bank stability structures observed in northwestern California streams during 1995. Condition pertains to structural integrity and objective pertains to how well structure meets intended purpose of preventing slope or bank erosion.

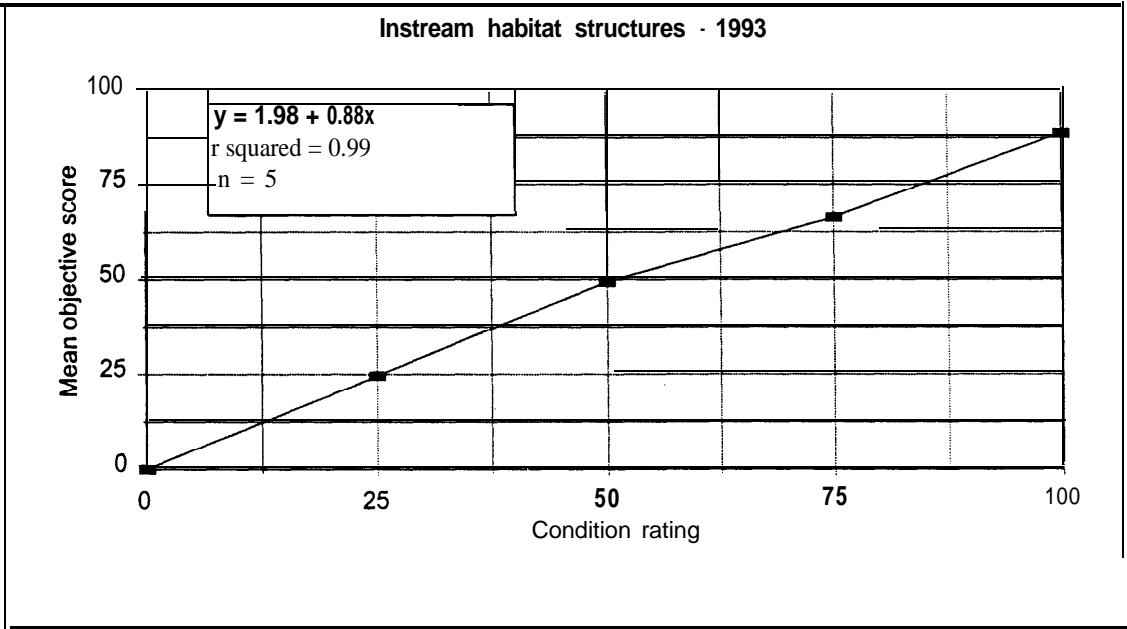
For instream habitat structures observed in 1993, the percent of paired excellent or good scores for condition and objective categories was 55.7 percent. Objectives were being met, regardless of structure condition, in the excellent or good categories in 58.9 percent of the structures. In contrast, physical condition was judged to be excellent or good in 79.6 percent of the structures, regardless of how well objectives were being met (Figure 5). These data illustrate that structures are generally in better condition than their ability to meet intended objectives. However, how well a structure meets intended objectives correlates strongly with the physical condition of the structure (Figure 5).
