NAME..... VALENTINE CREEK..... COUNTY..... MENDOCINO.....  
 Length 3 miles  
 TRIBUTARY TO..... BIG RIVER..... Twp..... 17N..... R..... 14W..... Sec..... 33.....  
 OTHER NAMES..... RIVER SYSTEM.....  
 SOURCES OF DATA..... Personal Observations.....

Extent of Observation: On July. 29, 1959, James Morehouse walked upstream from the mouth to the extreme headwaters of this creek.

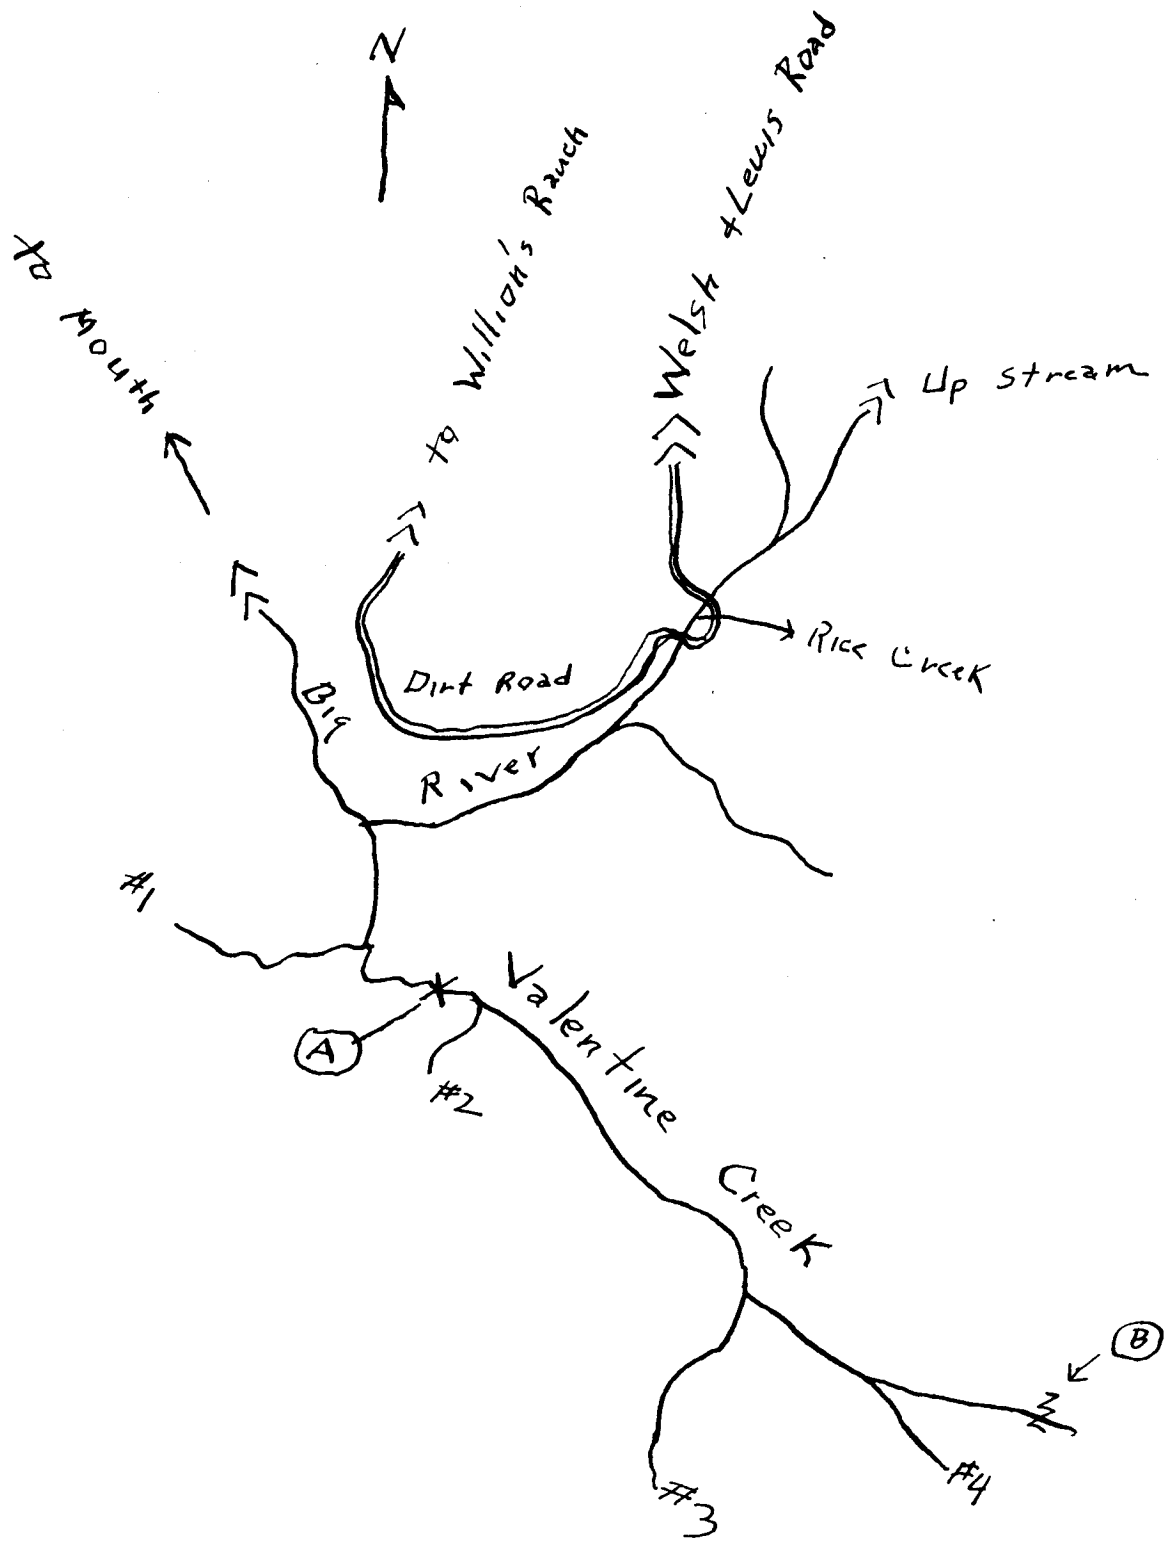
1. This tributary is dry, immediately steep and is not considered to be of any value to fish life. Extensive log jams near the mouth.
2. This tributary is not flowing. Small intermittent pools. Series of 3 ft to 4 ft falls. Falls are the result of large boulders and logs. It is felt that this tributary is of little value to fish life. Extensive logging damage.
3. This is a very small steep headwaters tributary with no flow and no value to fish life.
4. Headwaters tributary small, steep, boulder steps. No value to fish.

- a. Log jam caught on large boulder.  
25 ft long 10 ft wide 10 ft high void 60%. As the stream above is clean, it is felt that this jam will not become a problem. It is recommended that this jam should not be removed.
- b. Log jam - it is felt that this is a logging flush dam that has fallen in:  
100 ft long 150 ft wide 90 ft high. Void 80%. There are trout in the pool immediately below this dam, but only extreme headwaters are above it. This writer believes that these, logs will cone downstream. It is recommended not to remove this jam.

It is felt that this flush dam is responsible for the scouring of the upper stream bed.
