Analysis of the 1998 Garcia River Cross Sections

by
Dennis Jackson

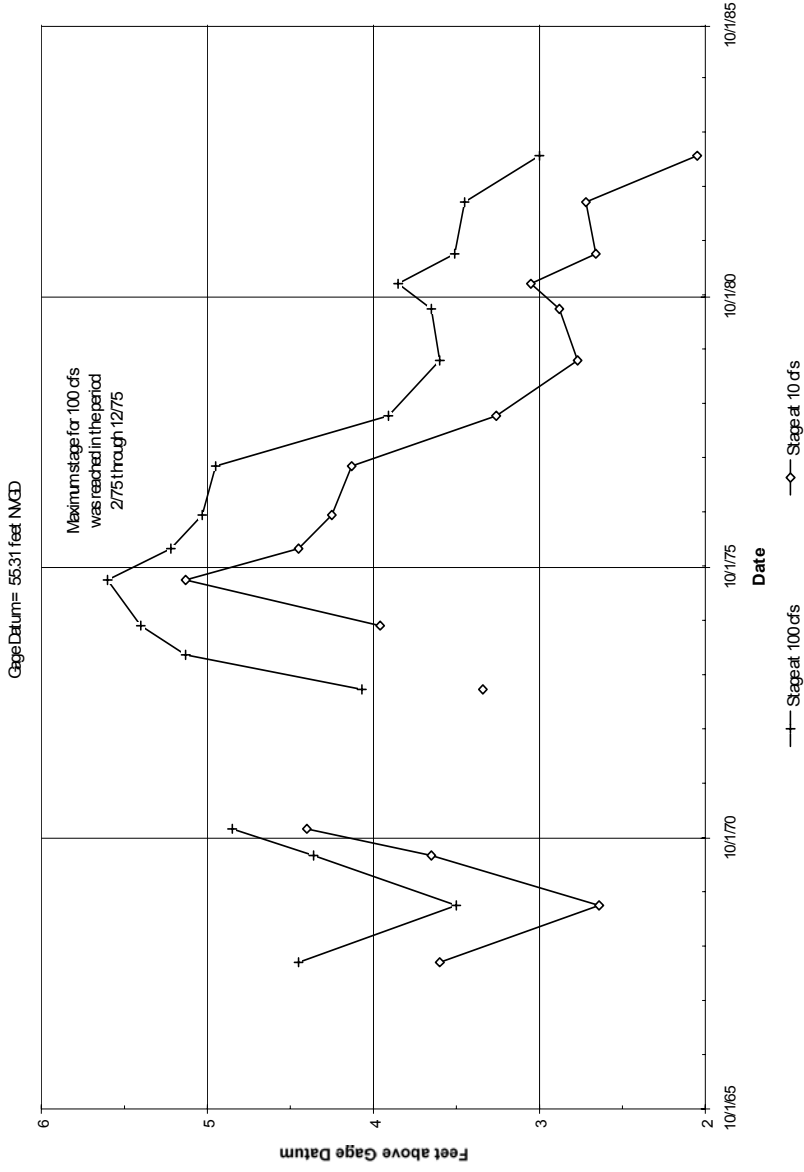
In April of 1991, Jackson prepared a graph of the stage for 100 cfs at the Conner Hole gaging station (see Figure 1). The data for the graph were obtained by looking at all of the available rating curves and reading the stage which was required for 100 cfs of flow and for 10 cfs of flow. The graph shows that the case for 10 cfs mirrors the 100 cfs case. Figure 1 shows that during the period, January 1969 to December 1969, the stage required for 100 cfs of flow was 3.5 feet. By February 1975 the required stage to produce 100 cfs flow had risen to 5.6 feet, a 2.1 foot increase in six years, for an average rate of 0.35 foot per year. The increase in stage required to produce 100 cfs of flow indicates that the downstream control (riffle crest) for the gaging pool must have risen. This implies that the low water channel of the reach below the gaging station aggraded relative to its 1969 condition. By December 1982 the stage required for 100 cfs of flow had dropped to 3.0 feet, a drop of 2.6 feet in seven years, for an average rate of 0.37 feet per year. The decrease in stage required for 100 cfs of flow implies that the riffle crest below the gage eroded, relative to its 1975 condition. Figure 1 indicates that a wave of bed material passed the USGS gaging station during the period January 1969 to September 1983, when the record ended because the station was closed.

Figure 1. Water surface elevation (stage) required to maintain a flow of 100 cfs. The stage is graphed at the mid-point of each rating period. For example, the maximum stage is plotted at the mid-point of the period February 1975 - December 1975.

It is strongly recommended that a low flow rating curve be developed for Conner Hole. This was attempted in 1992-1993 but soil creep disturbed the lowest staff gage at the station. A new staff was installed in the fall of 1995. The new staff is in a protected location and should not be subject to further soil creep. The development of a new low flow rating curve would relate the present conditions in the river to the graph of stage for 100 cfs of against time. This would indicate whether the river has incised relative to its 1983 condition.

Besides developing a new low flow rating curve it is recommended that the elevation of the present gage datum be confirmed by surveying the staff gages and USGS benchmark. USGS records give the gage datum as 55.31 feet NGVD and that the bronze marker on the right bank is 18.82 feet above the gage datum or 74.13 feet NGVD. The 1992 survey of the river, associated with the bentonite clean up, indicated that the elevation of the benchmark at the gaging station reported by the USGS was 0.59 feet lower than reported by the 1992 survey. However, all the cross section surveys have used the 74.13 feet elevation for the bronze marker, as reported by the USGS.

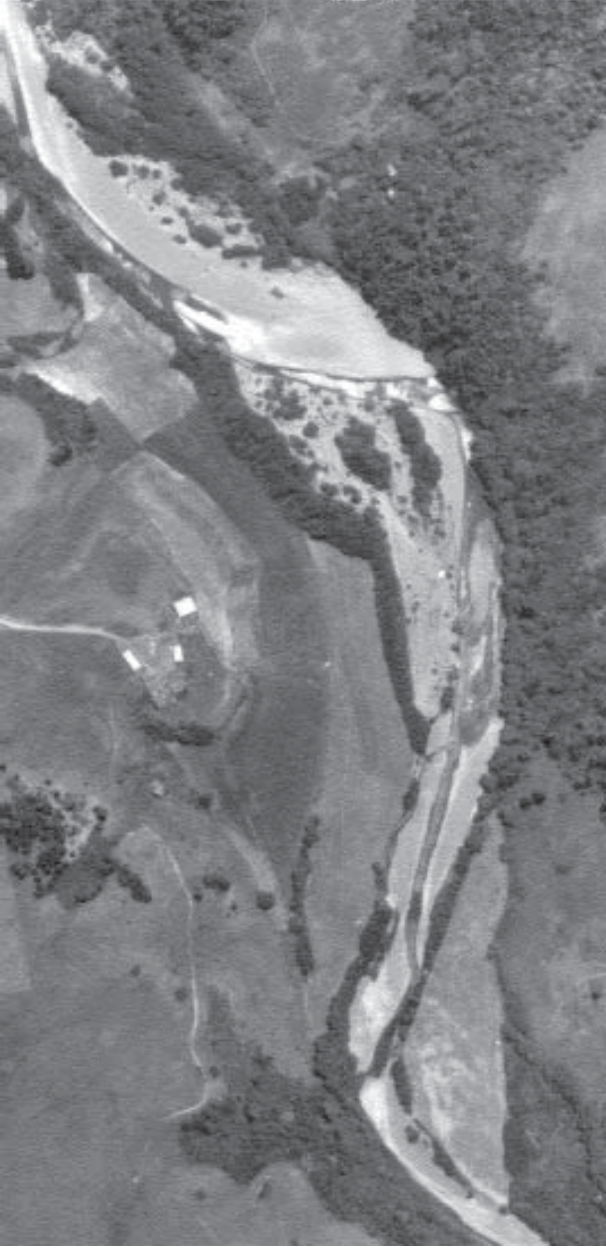
In 1996 several hundred feet of bank collapsed on the right bank on the Kendall property downstream of Bar 26. The 1997 flood event resulted in several hundred additional feet of bank collapse. Review of aerial photographs taken in 1972, 1988, 1990, 1993, 1995 and 1996, see Figure 6, show that by 1988 the low water channel was positioned to deliver the full thrust of the river to the bank that would fail. The only thing that was lacking from 1988 to 1993 was a sufficiently large flood event to cause the bank to col-

Figure 6(a). Kendall bend in 1972. Flow is from right to left. North is towards top of photo. See Figure 8 for location of Kendall cross sections.

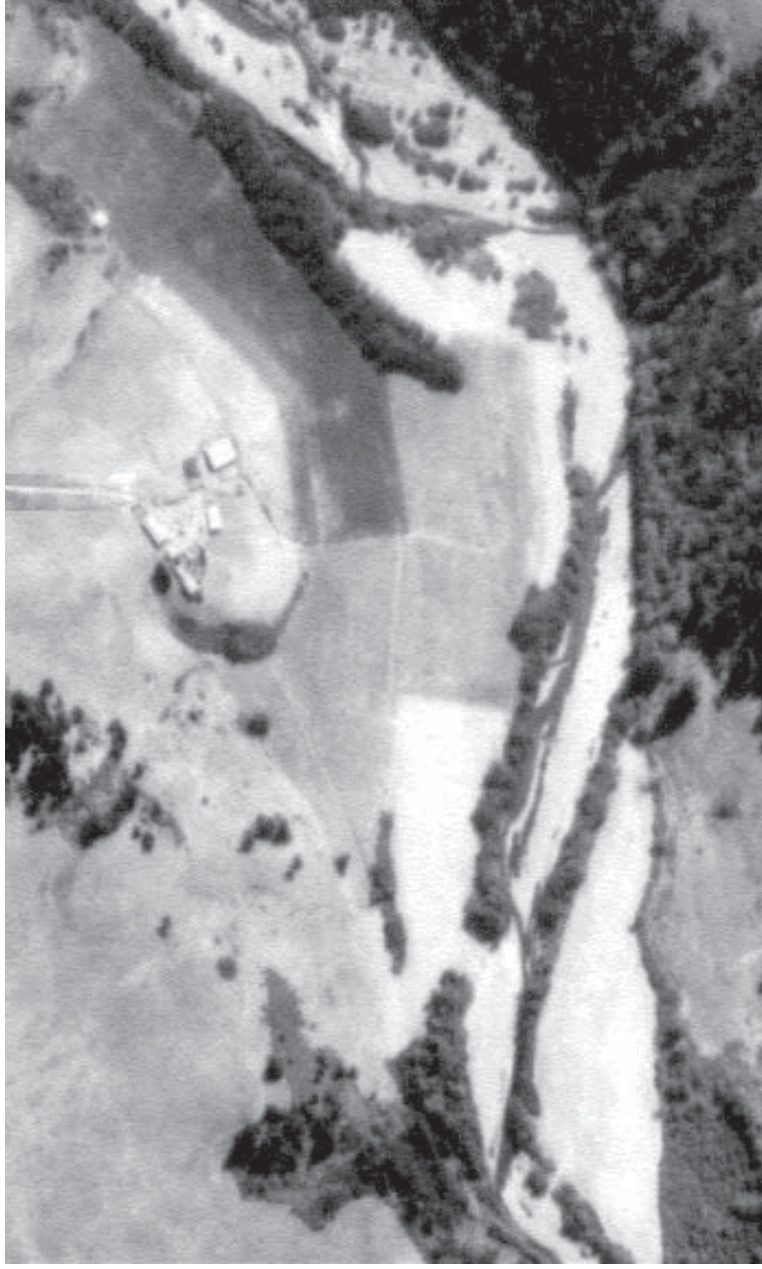
Figure 6(b). Kendall bend in 1988. Flow is from right to left. North is towards top of photo. See Figure 8 for location of Kendall cross sections.

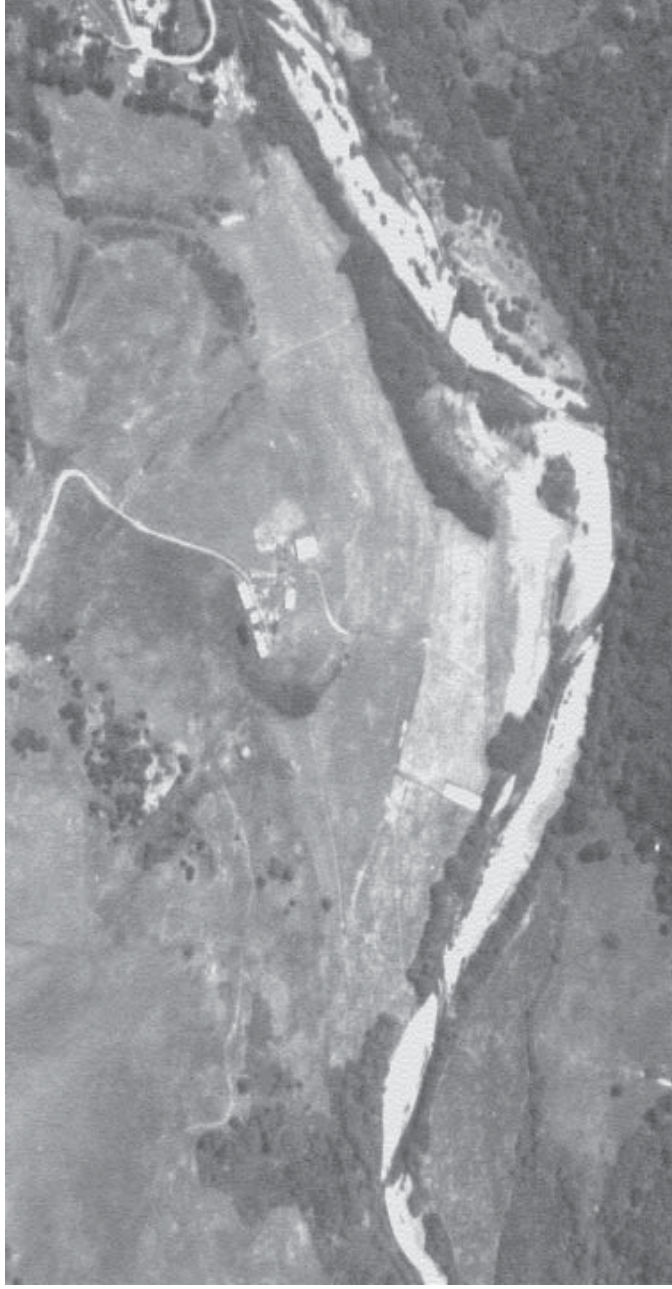
Figure 6(c). Kendall bend in 1990. Flow is from right to left. North is towards top of photo. See Figure 8 for location of Kendall cross sections.

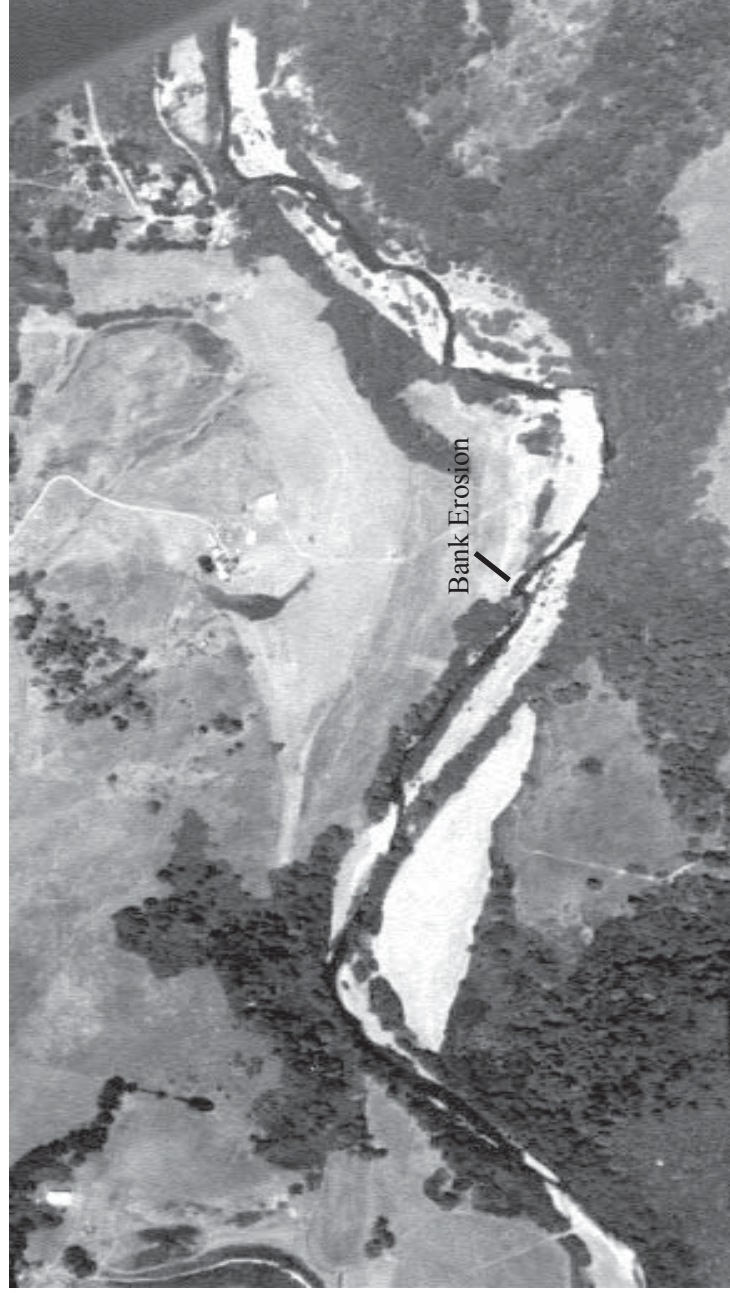
Figure 6(d). Kendall bend in 1993. Flow is from right to left. North is towards top of photo. See Figure 8 for location of Kendall cross sections.

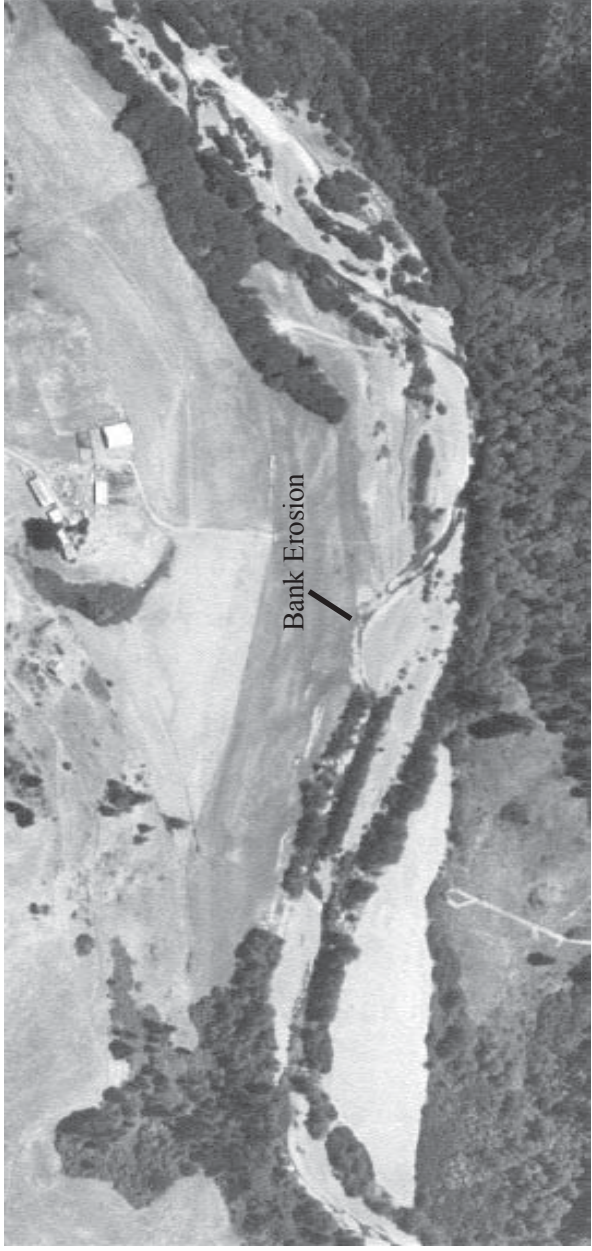
Figure 6(e). Kendall bend in 1995. Flow is from right to left. North is towards top of photo. See Figure 8 for location of Kendall cross sections.

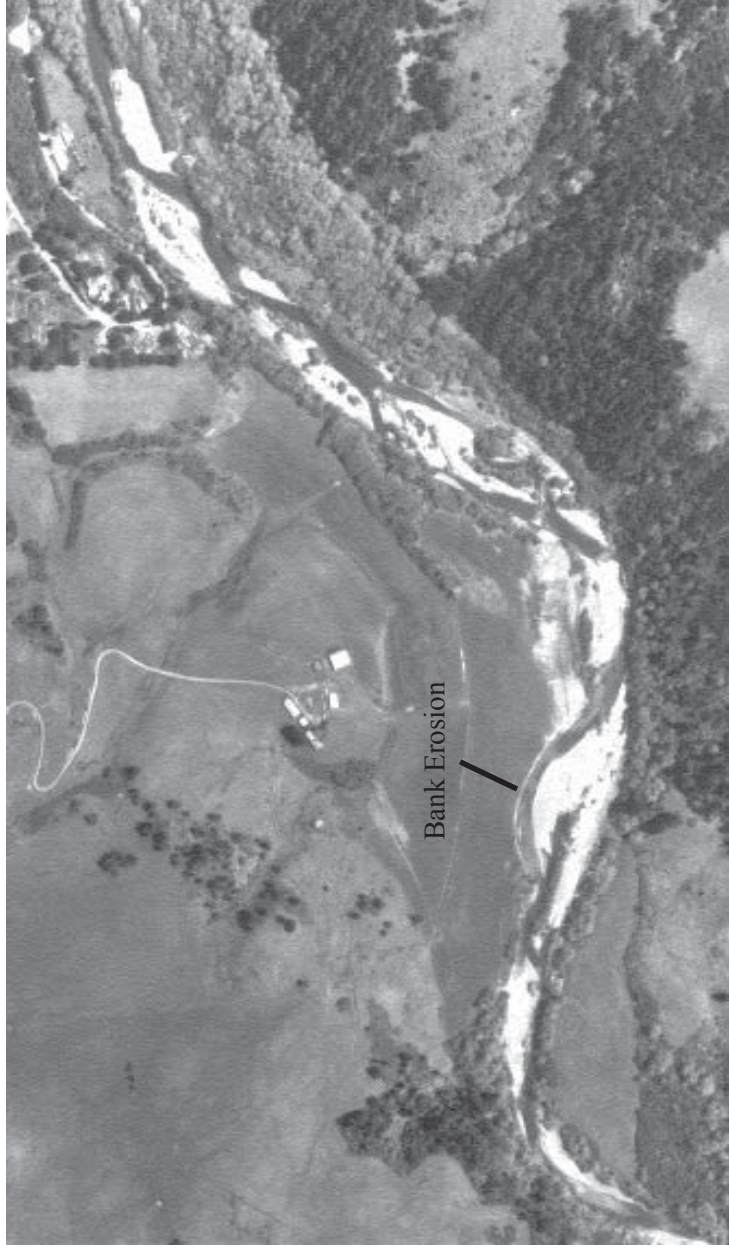
Figure 6(f). Kendall bend in 1996. Flow is from right to left. North is towards top of photo. See Figure 8 for location of Kendall cross sections.

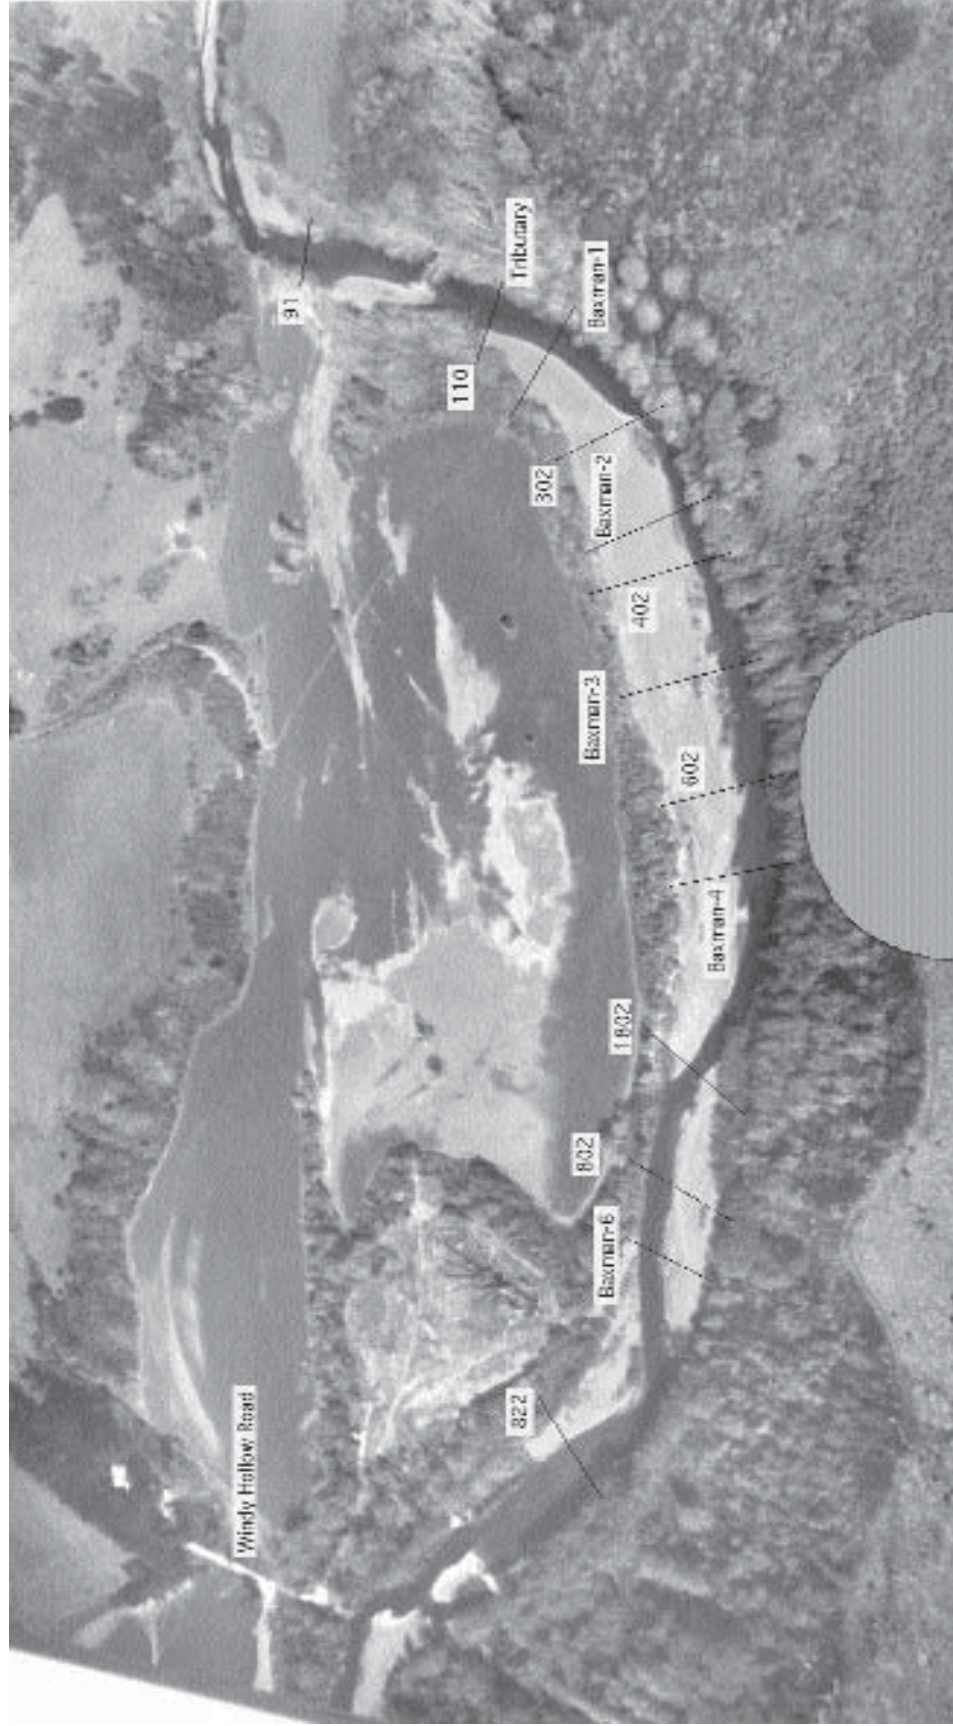
Figure 7. Map of Bentonite monitoring cross sections. Photo from 1997. Photo shows flood deposits on the floodplain.

on Bar 30. However, the low flow channel adjacent to Bar 30 appears to be, on average, slightly lower relative to 1993 and relative to 1997. Thus, relatively little deposition occurred in the low flow channel adjacent to Bar 30 in 1998 supporting the notion that a high bar helps prevent deposition in the low flow channel.

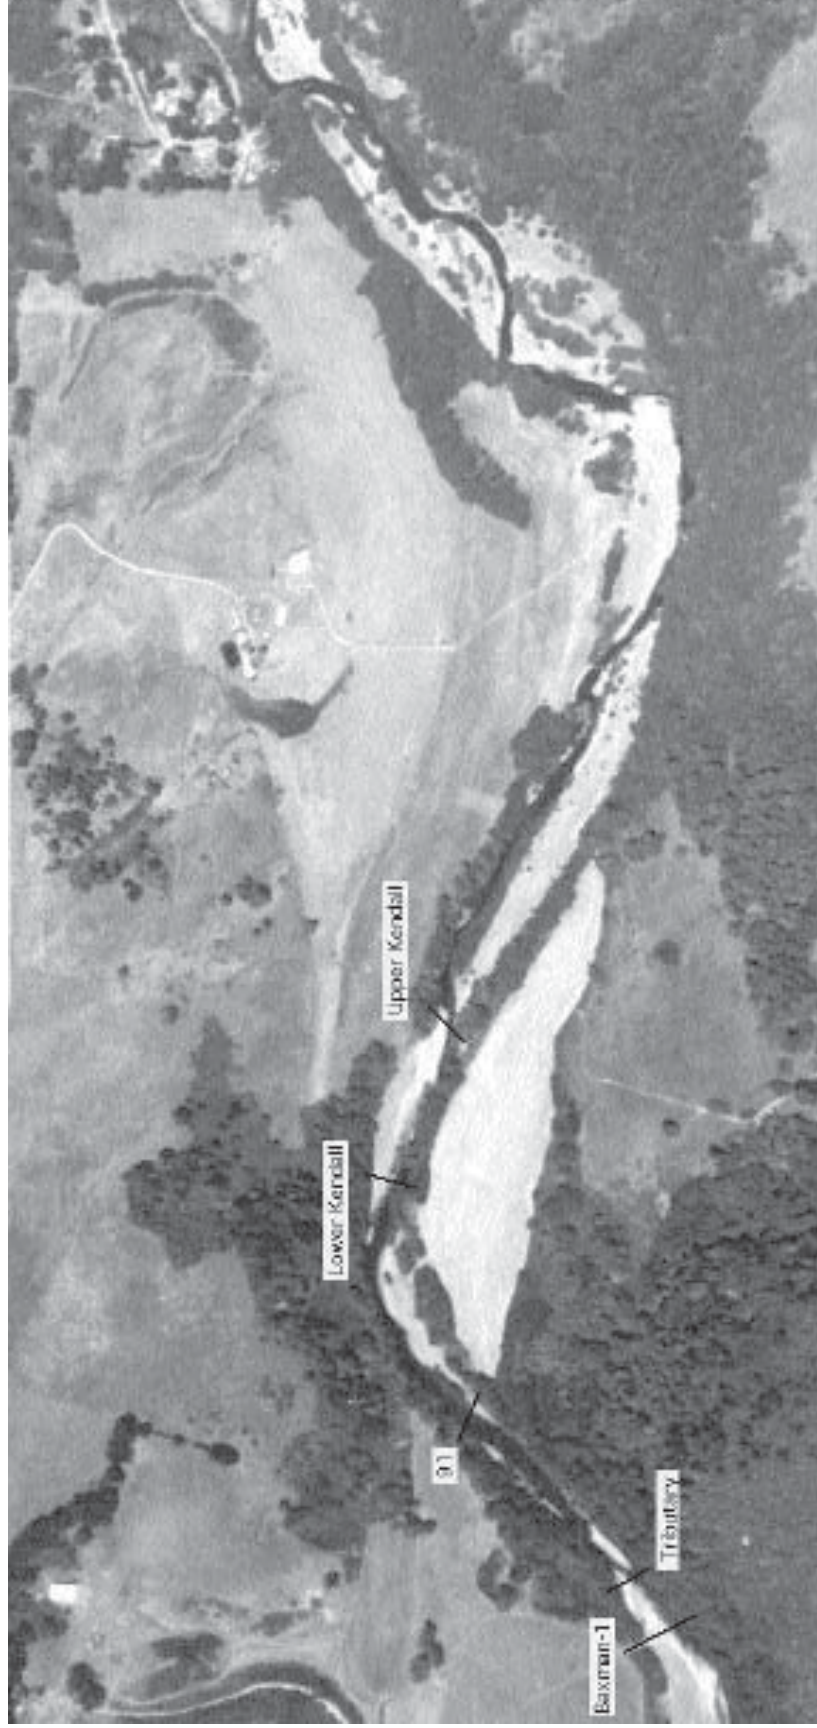
Figure 8. Map of Kendall cross sections and upstream bentonite cross sections. Photo from 1993. Flow is from right to left.

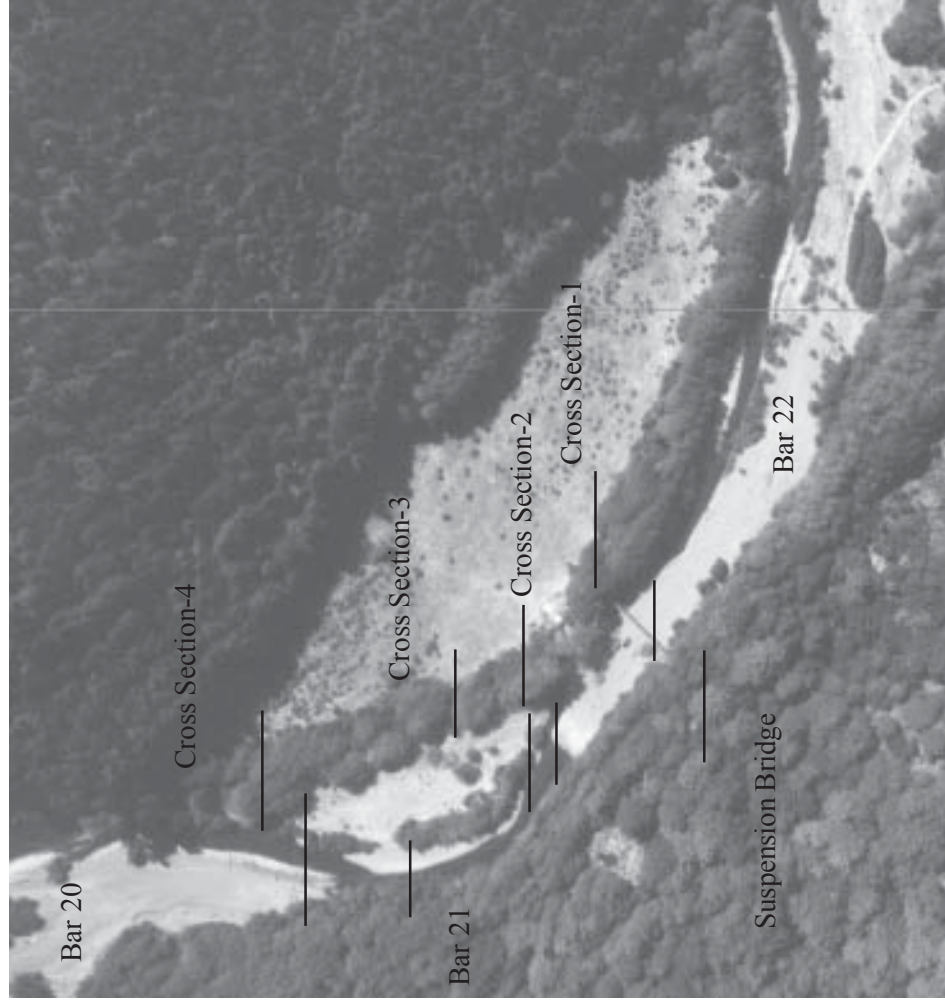
Figure 9. Map of the Hooper cross sections.

Cross section 1 is located approximately 135 feet downstream of the site of the suspension bridge (see Figure 9). The suspension bridge was destroyed by the 1993 flood. Between 1991 and 1993 the water surface dropped 0.3 feet and the thalweg rose 0.3 feet (see Table 7(c)). From 1991 to 1993 the low water channel narrowed by 10 feet with the deposition of up to 3 vertical feet of material along the right edge of the low water channel. The rise in the thalweg plus the deposition along the right margin resulted in a 61% decrease in the area below water and a -36% decrease in the area of the channel occupied by the low water channel (see Table 8). The surface of the bar lowered about 2 feet between 1991 and 1993. The loss of material from the bar and the deposition of material along the edge of the low flow channel resulted in a 40% increase in the area of the dry portion of the channel. The total cross sectional area changed by only 4% from 1991 to 1993.

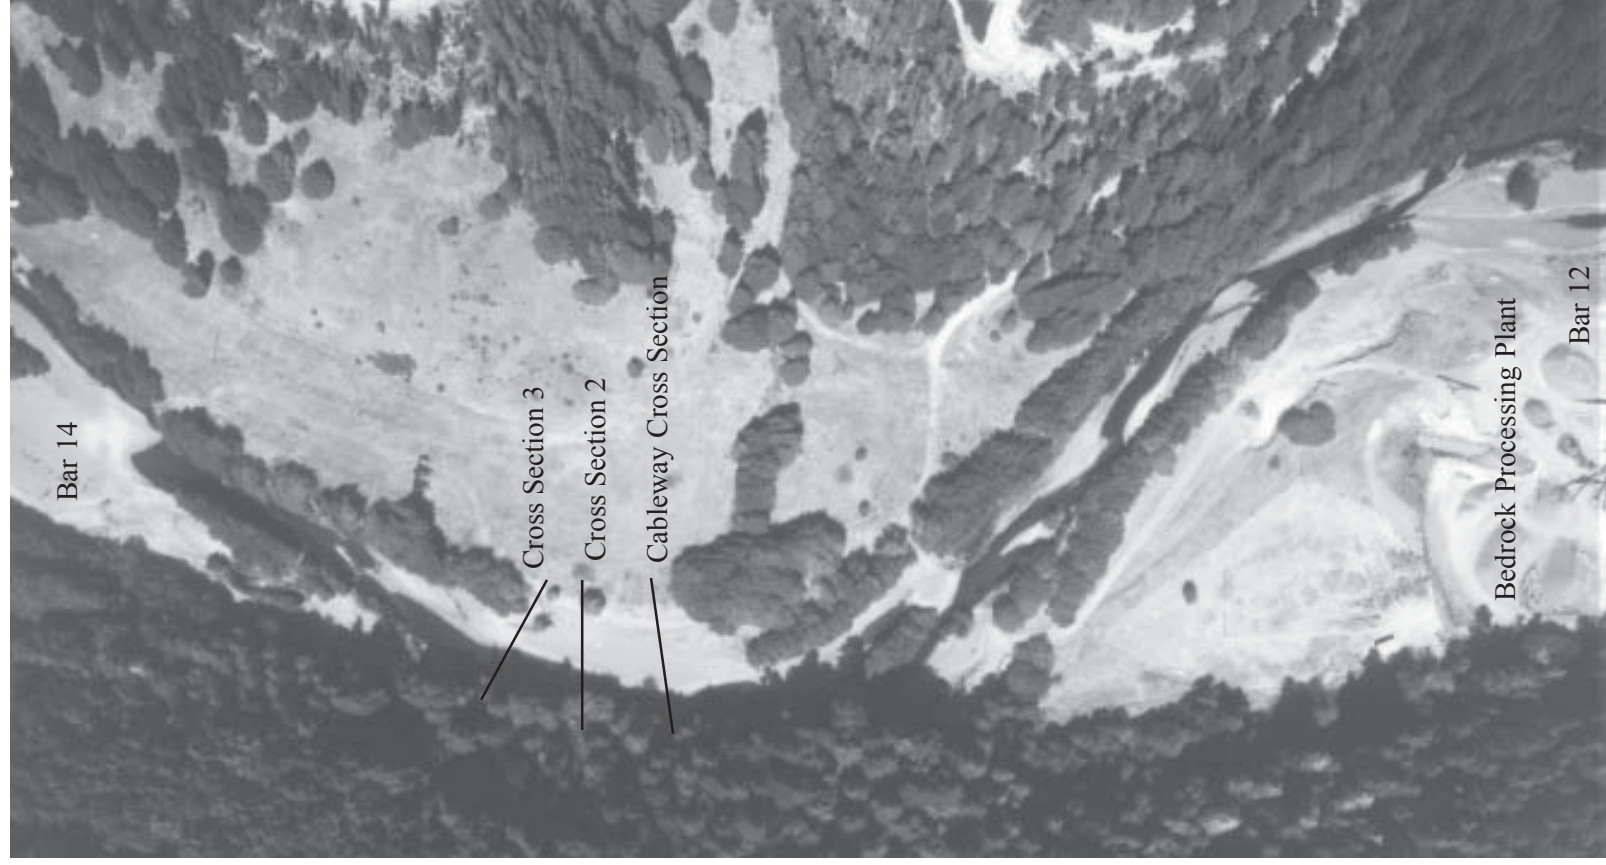
Figure 12. Conner Hole gaging station cross sections. River flows towards top of photo. Photo from September 1992.

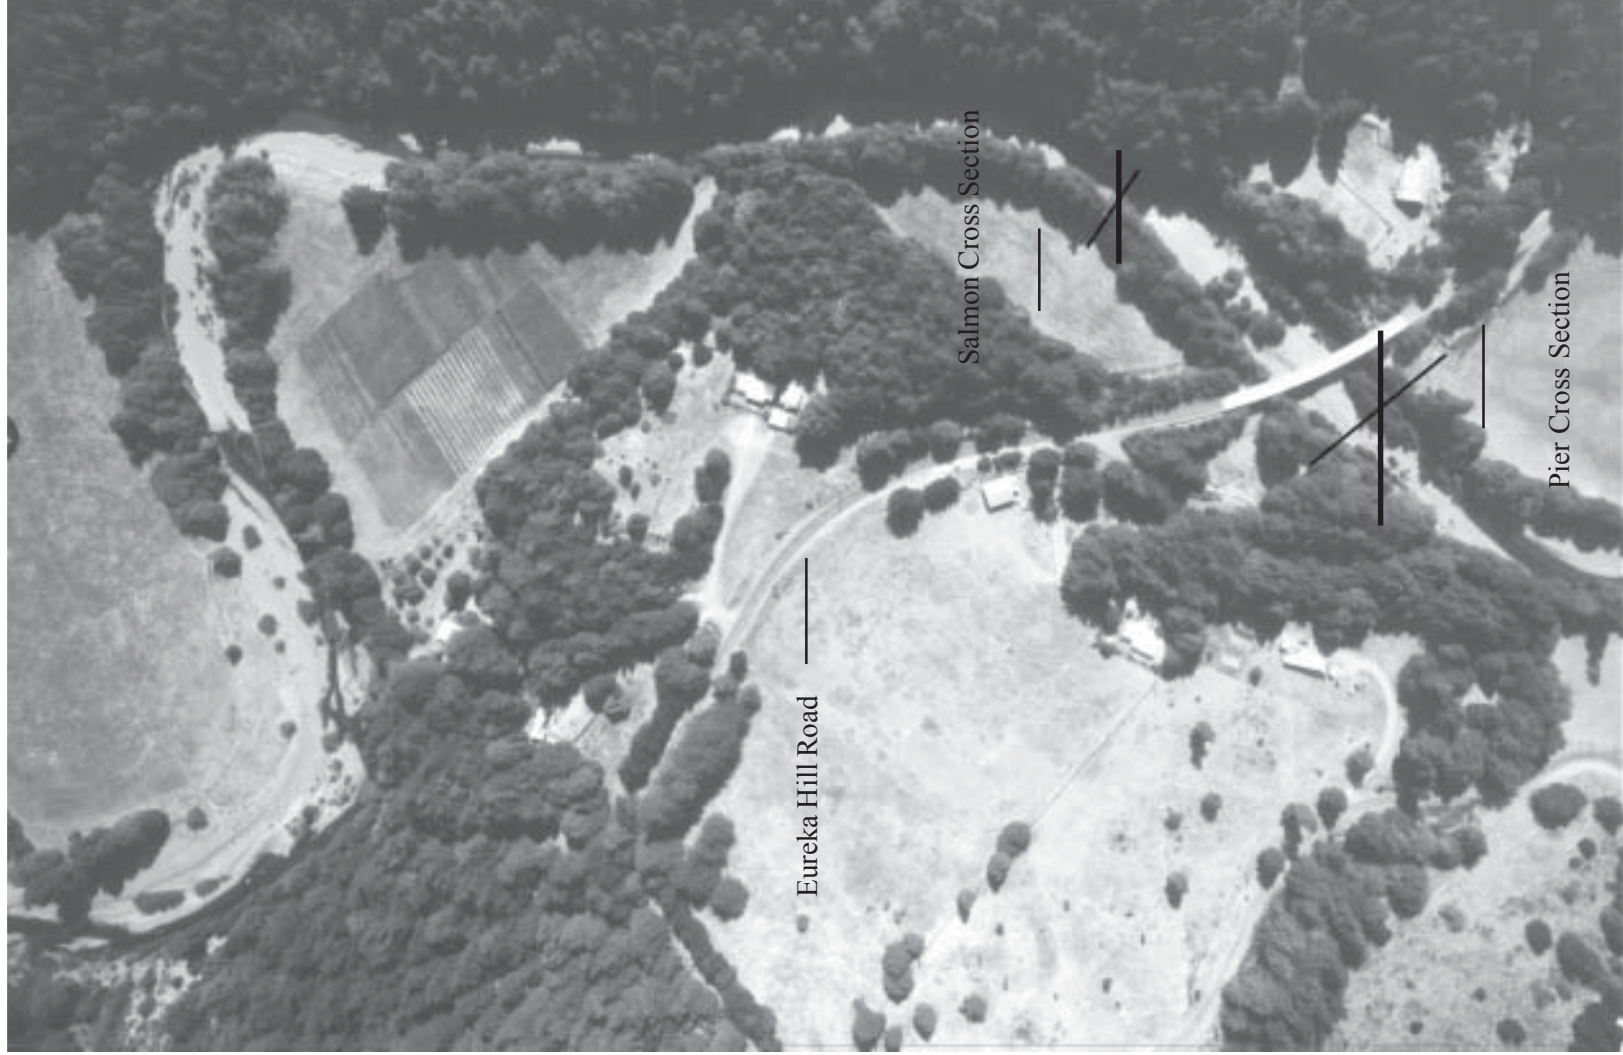
Figure 18. Map of Eureka Hill Bridge cross sections,. Photo from September 1992. Flow is from the top of the picture towards the bottom.
