STREAM INVENTORY REPORT
NORTH FORK GUALALA RIVER

Prepared for:
GUALALA REDWOODS
P.O. Box 197
Gualala, CA 95445

Prepared by:
Dan Gale
ENTRIX, Inc.
590 Ygnacio Valley Road, Suite 200
Walnut Creek, CA 94596

March 25,1995

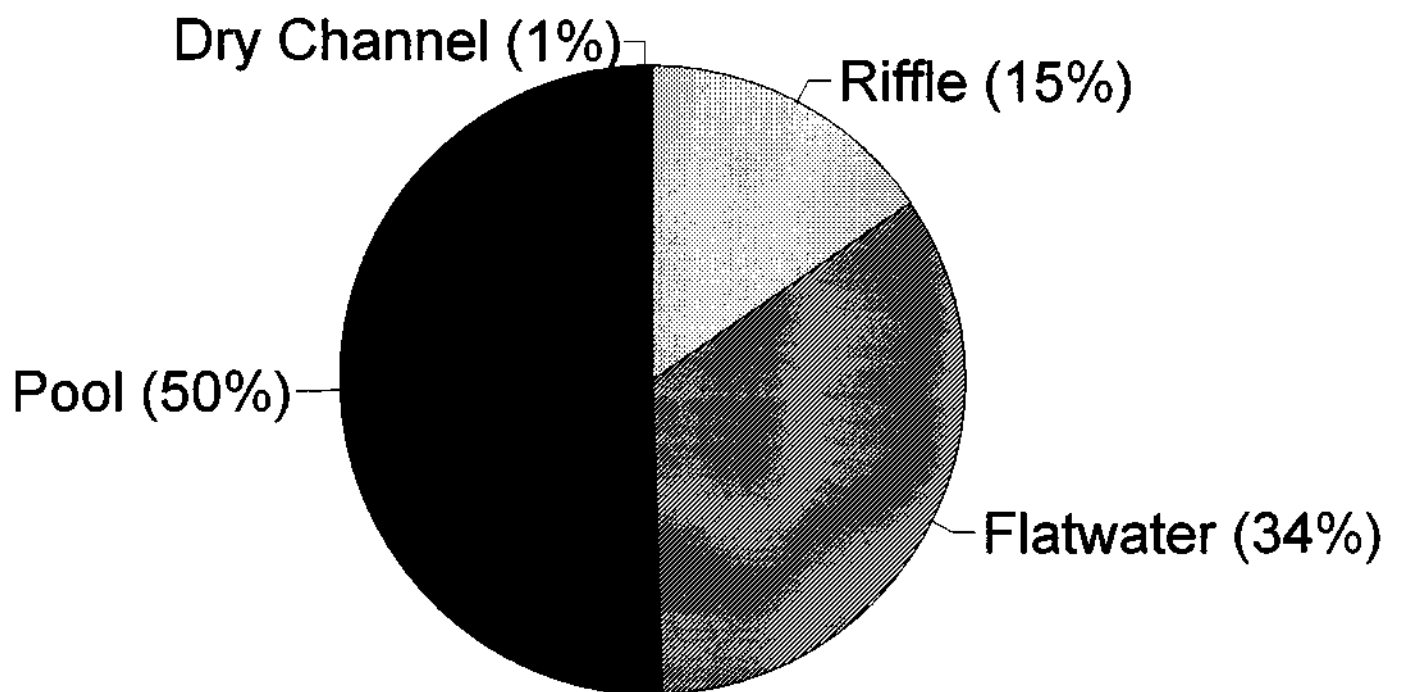
**Figure 1. North Fork Gualala River
Habitat Types by Percent Occurrence**

The Level II riffle, flatwater, and pool habitat types are summarized in Table 1. By percent occurrence, pools made up 50%, flatwater types 34%, riffles 15%, and dry channel 1% (Figure 1). Pools made up 64% of the total survey length, flatwater habitat types 32%, riffles 4% and dry channel <0.5% (Figure 2).

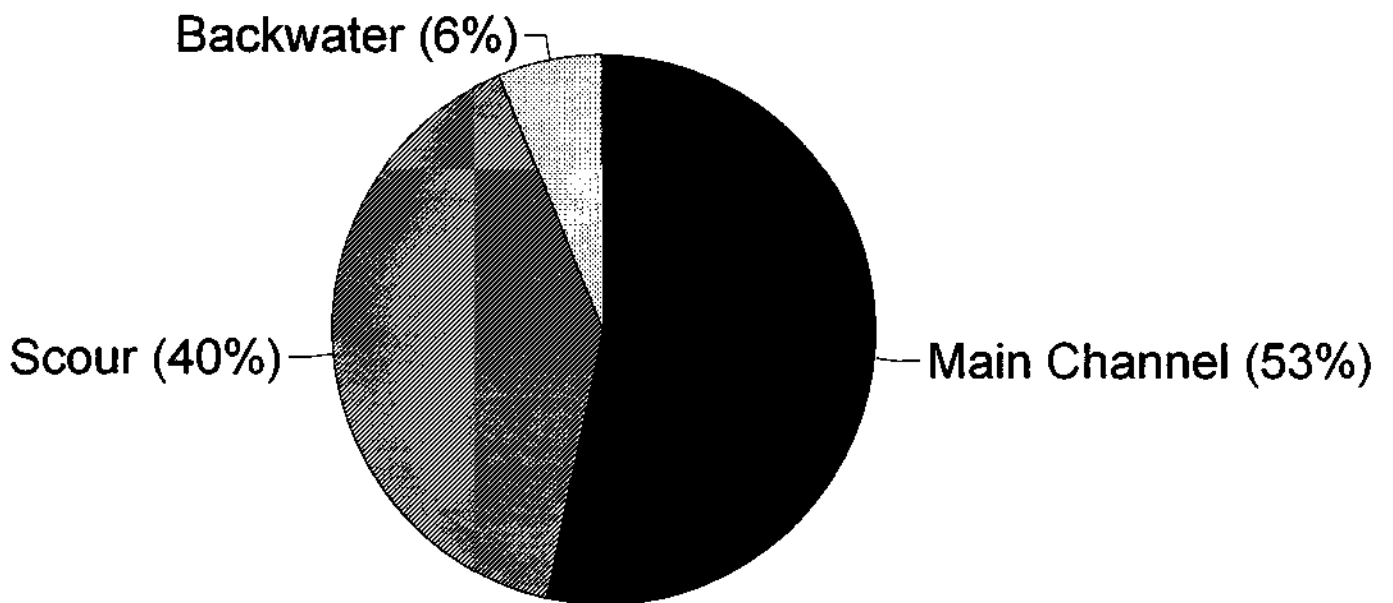
**Figure 4. North Fork Gualala River
Pool Types by Percent Occurrence**

A total of 304 pools were identified (Table 3). Main channel pools were most often encountered at 53%, and comprised 62% of the total length of pools (Figure 4). Scour pools accounted for 40% of the pools encountered and comprised 36% of the total length of pools.

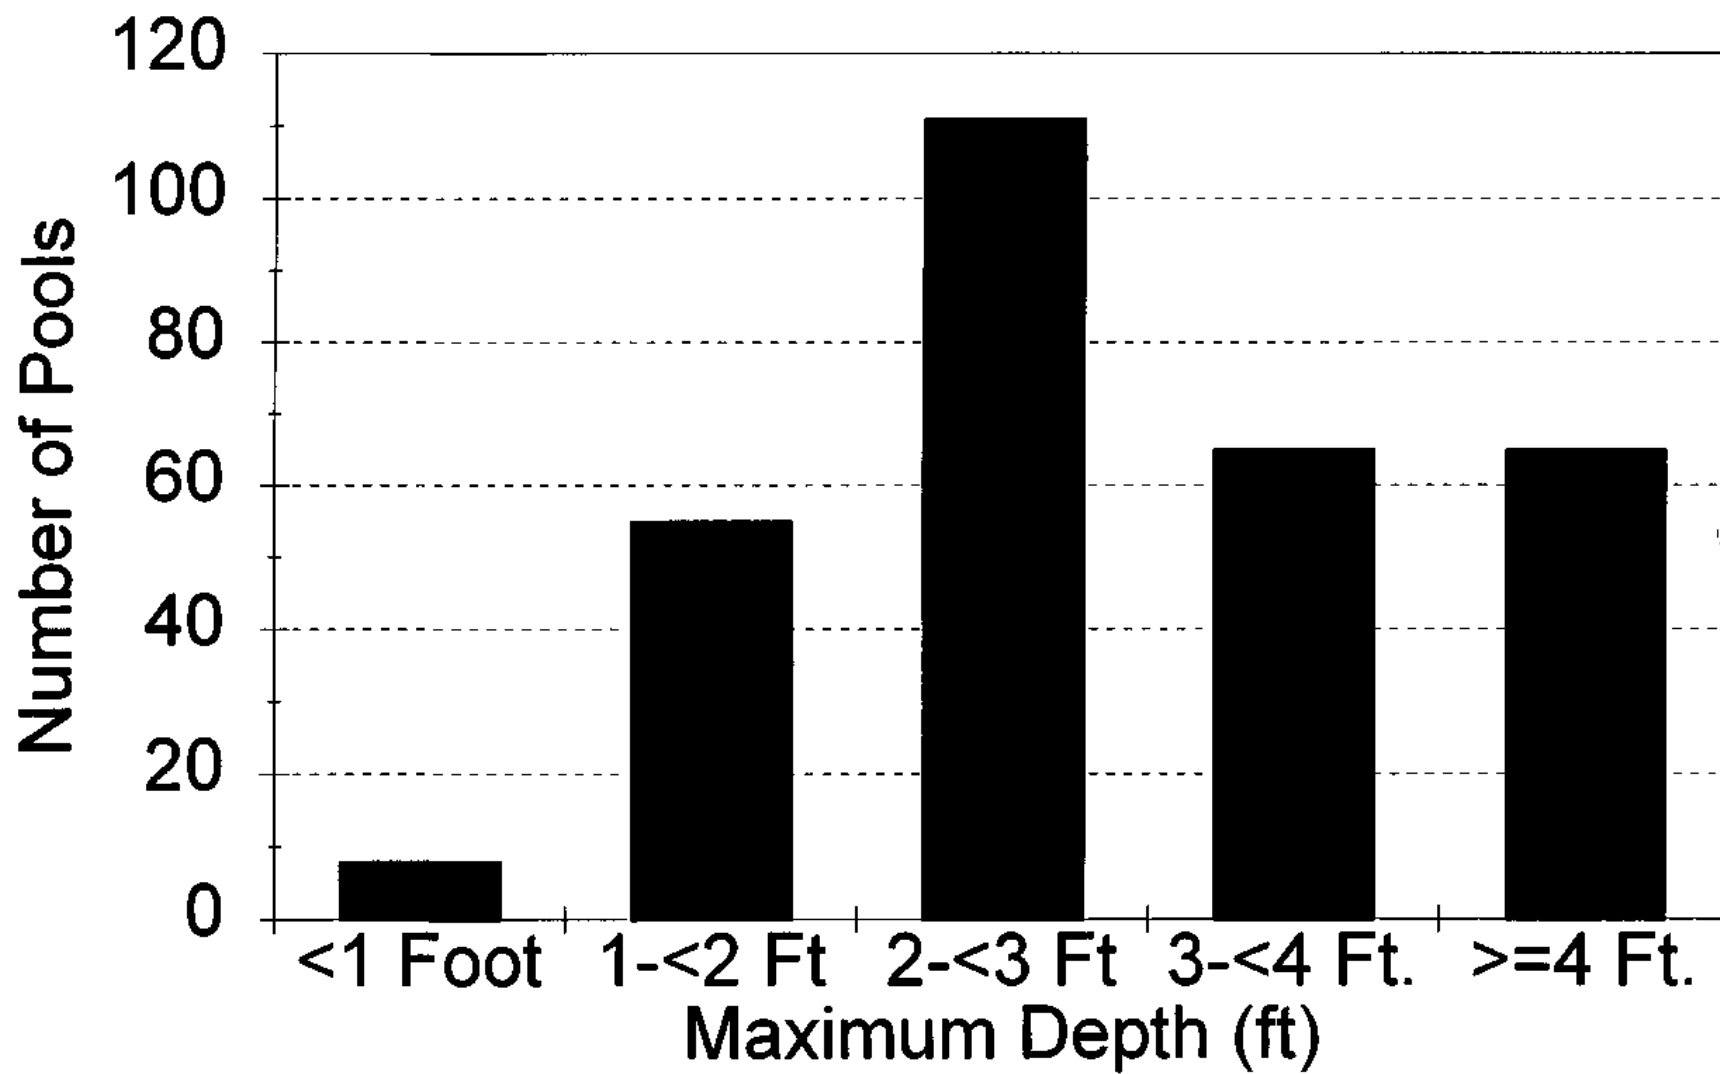
**Figure 5. North Fork Gualala River
Total Pools by Maximum Depth**

Table 4 is a summary of maximum pool depths by pool habitat types. Depth is an indicator of pool quality. Out of the 304 pools encountered, 130 (43%) had a depth of three feet or greater (Figure 5).

Flatwater habitat types comprised 32% of the total length of this survey, riffles 4%, and pools 64%. The pools are relatively deep with 43% of the pools having a maximum depth greater than 3 feet. In coastal coho and steelhead streams, it is generally desirable to have primary pools comprise approximately 50% of total habitat. In third and fourth order streams a primary pool is defined to have a maximum depth of at least three feet, occupy at least half the width of the low flow channel, and be as long as the low flow channel width. Therefore, installing structures that will increase pool habitat is recommended for locations where their installation will not jeopardize the unstable C3 stream banks, or subject the structures to high stream energy.

- 3) Where feasible, design and engineer pool enhancement structures to increase the number of pools. This must be done where the banks are stable or in conjunction with stream bank armor to prevent erosion.

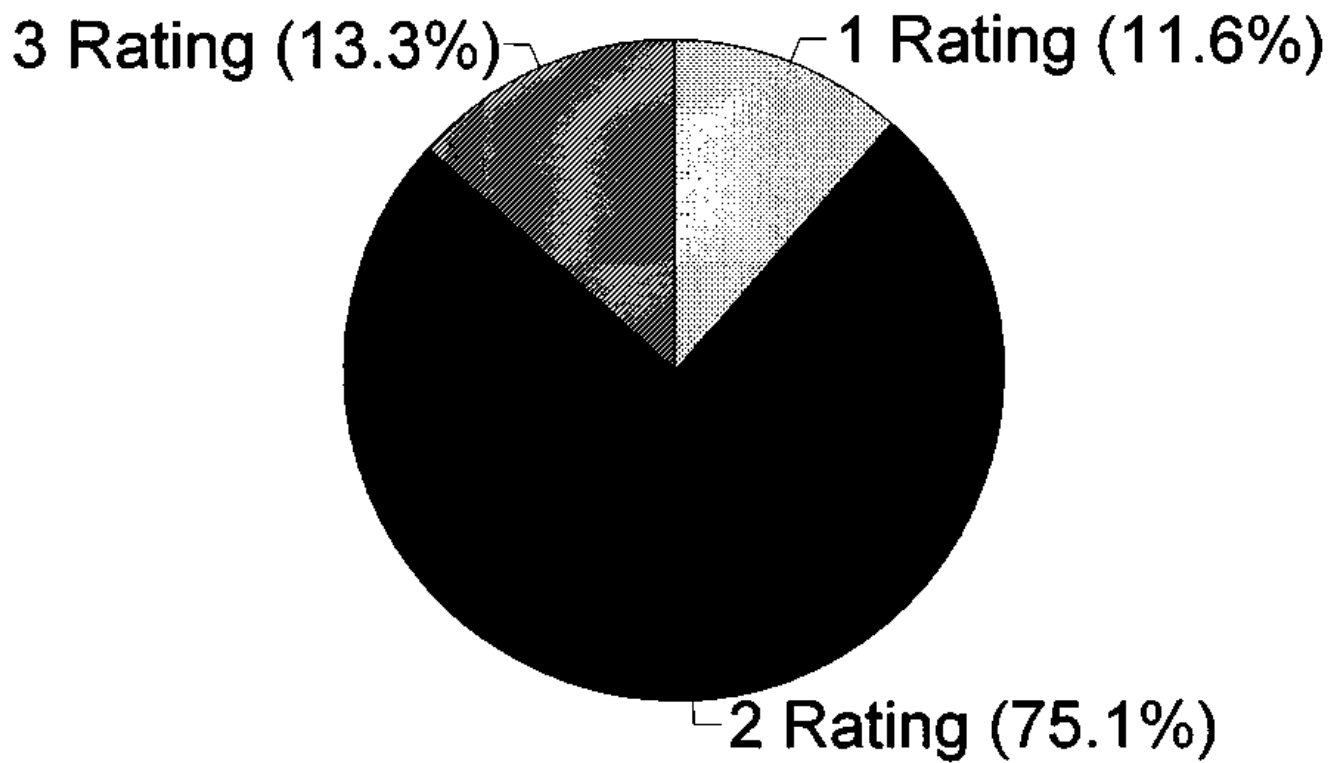
**Figure 6. North Fork Gualala River
Pool Tail-out Embeddedness**

The substrate embeddedness was estimated at main and scour pool tail-outs. Of the 285 pool tail-outs measured, 33 had a value of 1 (11.6%); 214 had a value of 2 (75.1%); 38 had a value of 3 (13.3%); and none of the tailouts had an embeddedness value of 4 (Figure 6). On this scale, a value of one is best for fisheries.

Out of the 285 pool tail-outs measured, only 38 (13.3%) had a rating of 3 and none had a rating of four. Cobble embeddedness measured to be 25% or less, a rating of 1, is considered best for the needs of salmon and steelhead. The majority of pool tailouts (75.1%) contained a rating of 2, while only 11.6% contained a rating of 1. Drought conditions in Northern California over the last 6-7 years in California have likely resulted in a decreased number of larger "flushing flows" in the North Fork Gualala River. Flushing flows are important in reducing substrate sedimentation and embeddedness problems in salmonid streams, and an increase in these flow events under normal rainfall conditions may result in decreased embeddedness in the North Fork Gualala River. Pool tailout embeddedness should be re-analyzed following the occurrence of flushing flows within the basin such as those that have occurred during the high flows in the winter of 1994/1995.

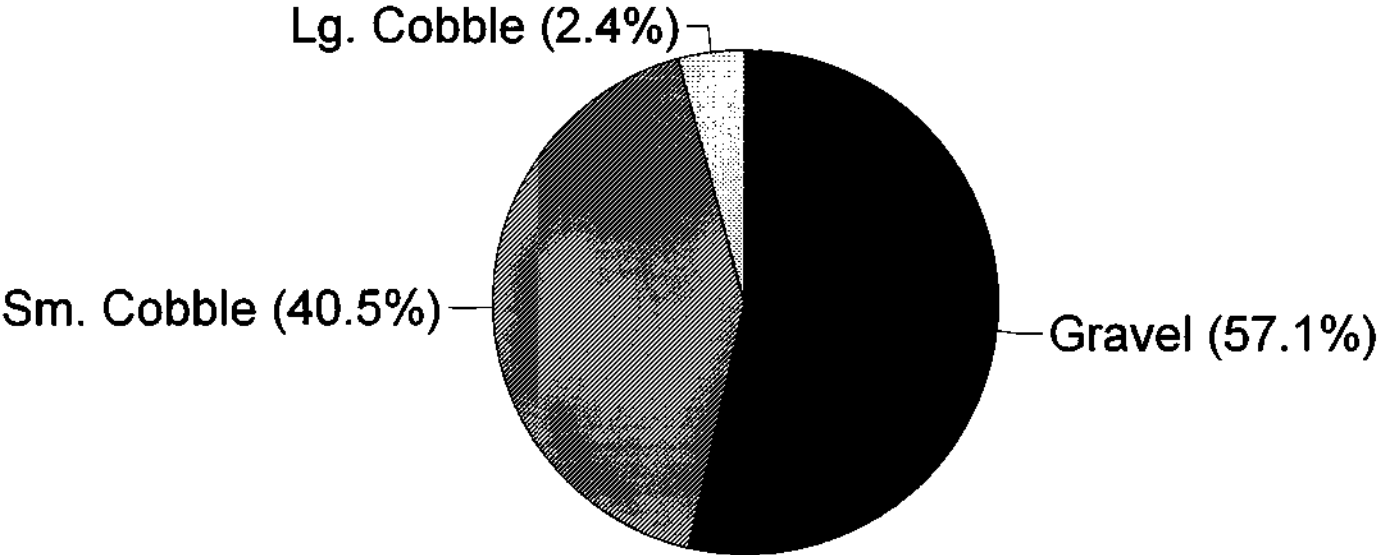
**Figure 8. North Fork Gualala River
Dominant Substrate Type in Low Gradient Riffles**

Table 6 summarizes the dominant substrate by habitat type. Gravel was the dominant substrate observed in 38 of the 71 low gradient riffles (53.5%). Small cobble was the next most frequently observed dominant substrate type, and occurred in 42.3% of the low gradient riffles (Figure 8).

Sixty-eight of the 71 low gradient riffles (95.8%) had either gravel or small cobble as the dominant substrate. This is generally considered excellent for spawning salmonids.

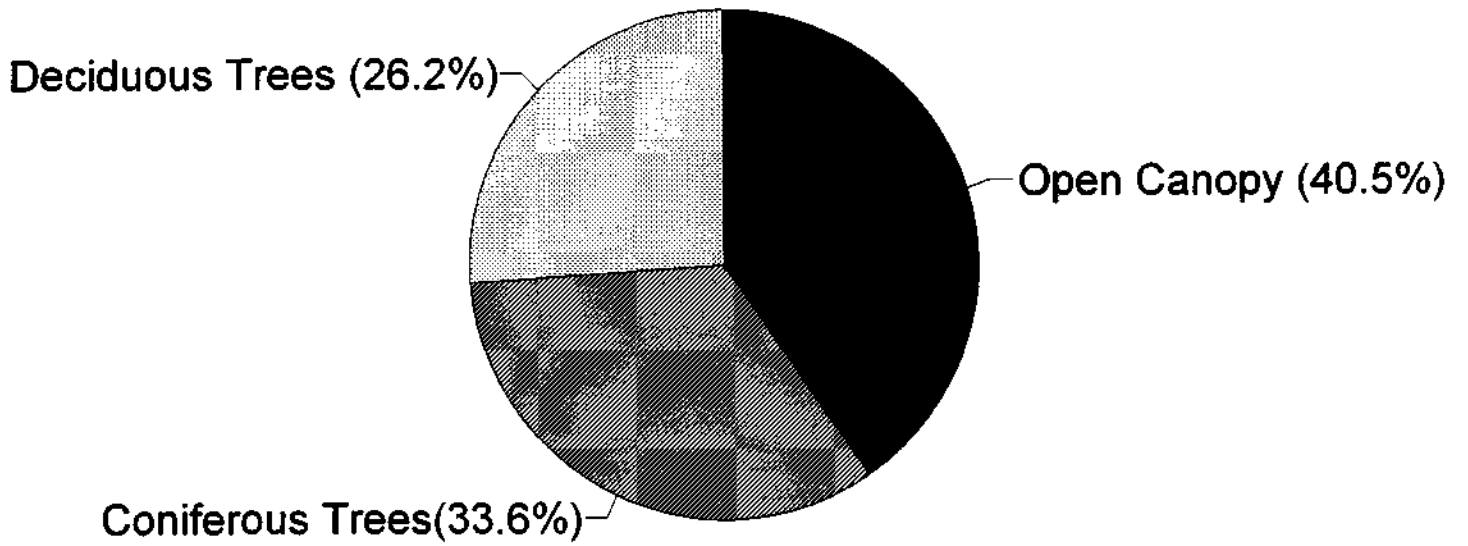
**Figure 9. North Fork Gualala River
Canopy Composition**

The mean percent of open canopy for the entire portion of the North Fork Gualala River surveyed was 40.5%. Of the 59.5% of the stream that was covered with canopy, 44% was composed of deciduous trees and 56% was composed of coniferous trees. Figure 9 describes the canopy composition in the North Fork Gualala River.

The mean percent canopy for the survey reach was 59,5%. This percentage of canopy closure is somewhat low, since 80 percent is generally considered desirable. Elevated water temperatures in portions of the North Fork Gualala River could be reduced by increasing stream canopy. The large trees required to contribute shade to the wide channel typical of this reach would also eventually provide a long term source of large woody debris needed for instream structure.

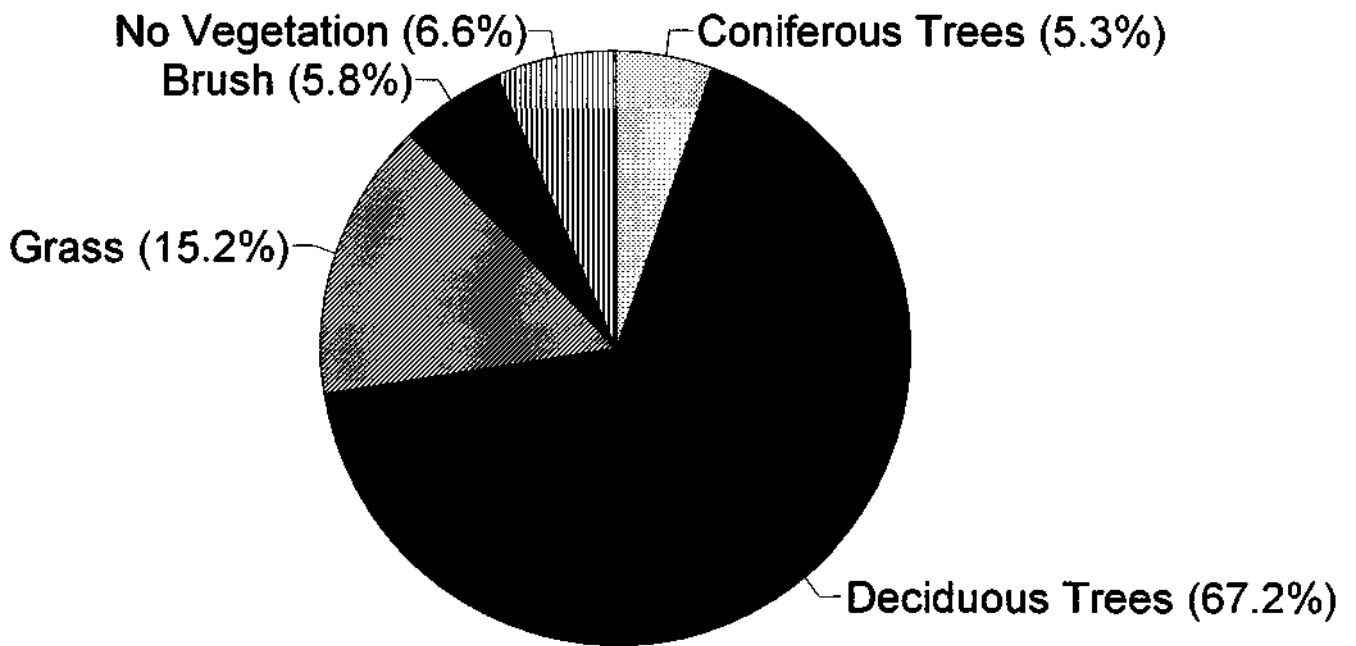
**Figure 10. North Fork Gualala River
Bank Composition by Dominant Vegetation Type**

Table 2 summarizes the mean percentage of the right and left stream banks covered with vegetation by habitat type. For the stream reach surveyed, the mean percent right bank vegetated was 45.2%. The mean percent left bank vegetated was 46.4%. The dominant substrate elements composing the structure of the stream banks consisted of 7.8% bedrock, 14.0% boulder, 50.5% cobble/gravel, and 27.6% silt/clay/sand. Additionally, 67.2% of the banks were covered with deciduous trees and 5.3% with coniferous trees, including downed trees, logs, and root wads (Figure 10).
