Dynamics of Recovery

A Plan to Enhance the Mattole Estuary

Mattole Restoration Council

February 1995

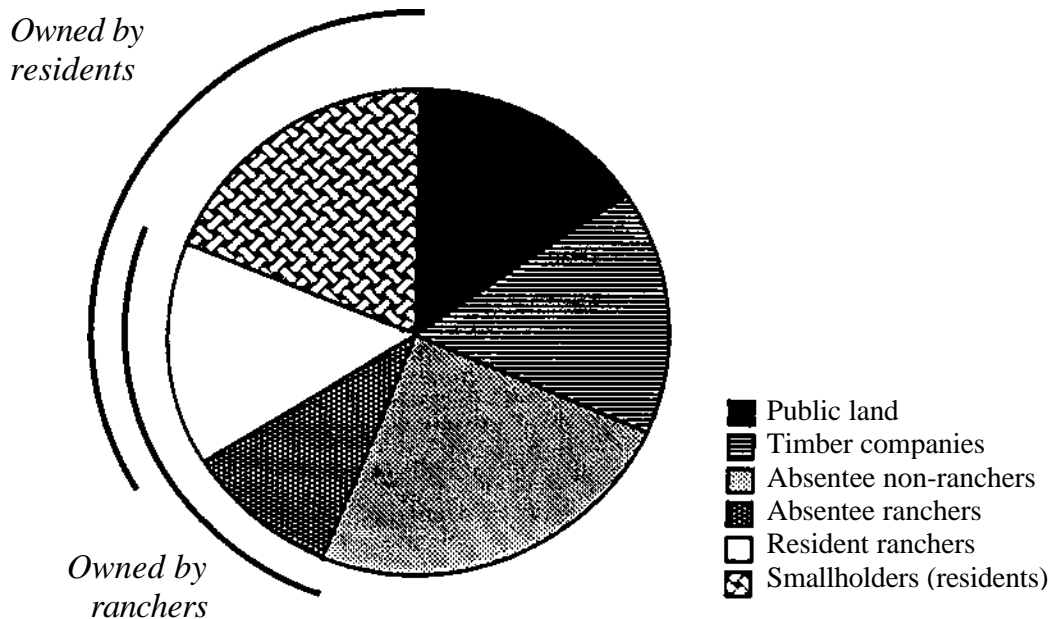
Mattole landowners fall into several categories
(Fig. 2.1)

Most of the landmass in the watershed is privately owned, with the exception of one-seventh or so managed by the federal Bureau of Land Management. As of 1988, the last date for which figures have been compiled, roughly a sixth was held by four timber companies, with the remainder owned by ranchers (one-quarter), resident smallholders (one-fifth) and absentees (one-quarter). (See Fig. 2.1, *Mattole landowners fall into several categories.*)

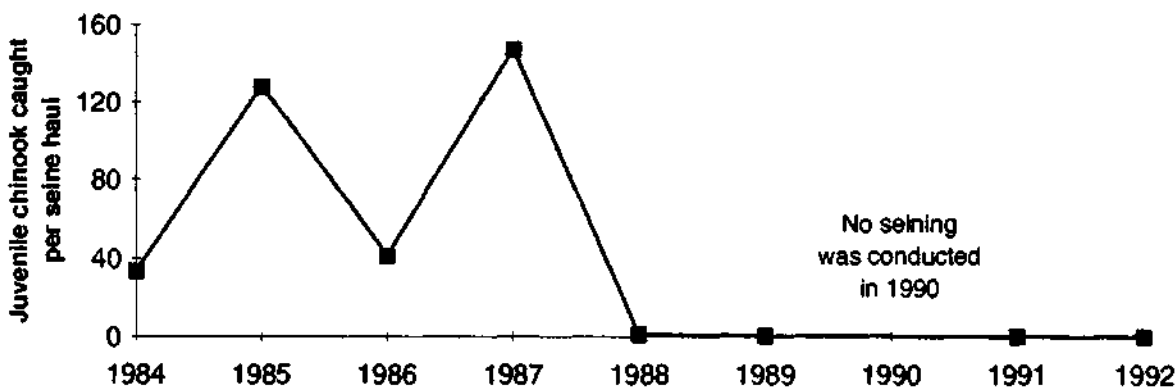
Juvenile chinook are no longer found in the Mattole summer lagoon (Fig. 2.5)

Humboldt State University students, assisted by Mattole volunteers, seined the Mattole lagoon monthly for eight out of nine consecutive summers, in order to estimate juvenile fish populations. After finding some young chinook in the first four years, researchers encountered very few thereafter. (Data from Busby et al. 1988 and research notes of M. Roche.)

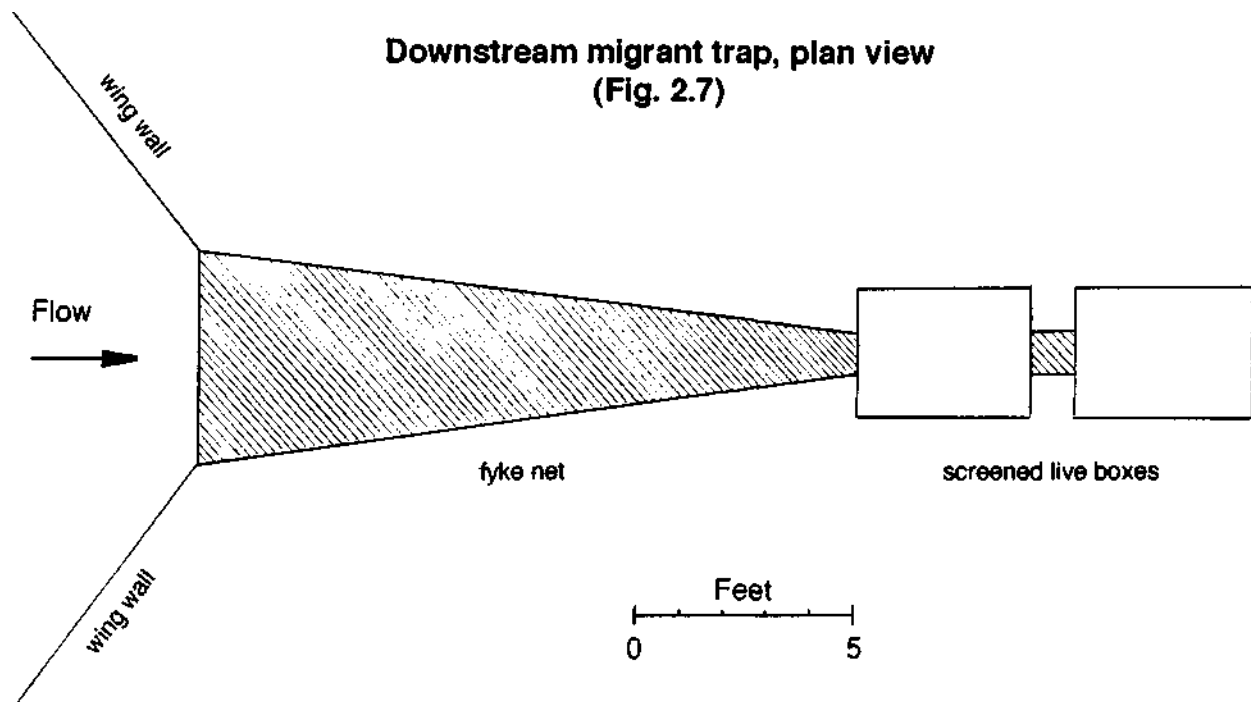
Downstream migrants were trapped near the mouth of Mill Creek, at river mile 2.63. The trap consists of a quarter-inch mesh fyke net, with a four-by-five foot opening tapering to a one-foot outlet into three-by-four-foot wooden boxes. (See Fig. 2.7, *Downstream migrant trap, plan view*.) Wings of net-covered panels were arranged on both sides of the trap mouth to funnel more of the fish into the trap. The device was set in the thalweg (deepest part of the channel) and moved during the trapping season to adapt to different discharge levels. At highest trapping flows of nearly 1900 cfs, about 10 percent of the flow ran through the trap; at the lowest trapping flow (61 cfs), 90 percent of the flow passed through the trap. The trap was set in the evening and the catch counted the following morning, after a mean set time of 12.5 hours. Threespine sticklebacks (*Gasterosteus aculeatus*) were so numerous that they were not counted. All other fish species were anesthetized with Alka-Seltzer, measured to the nearest millimeter (fork length for salmonids), and counted. In 1993, the fish were then released; in 1994, most of the chinook were diverted into the Mattole Watershed Salmon Support Group's Rescue Rearing Program. Figure 2.8, *Juvenile chinook down-migrants are observed mainly in May and June*, provides an idea of when the fish head for the lower river; companion Figure 2.9, *Juvenile chinook reach the estuary below optimal size for entering the ocean*, shows how large they are at that time.

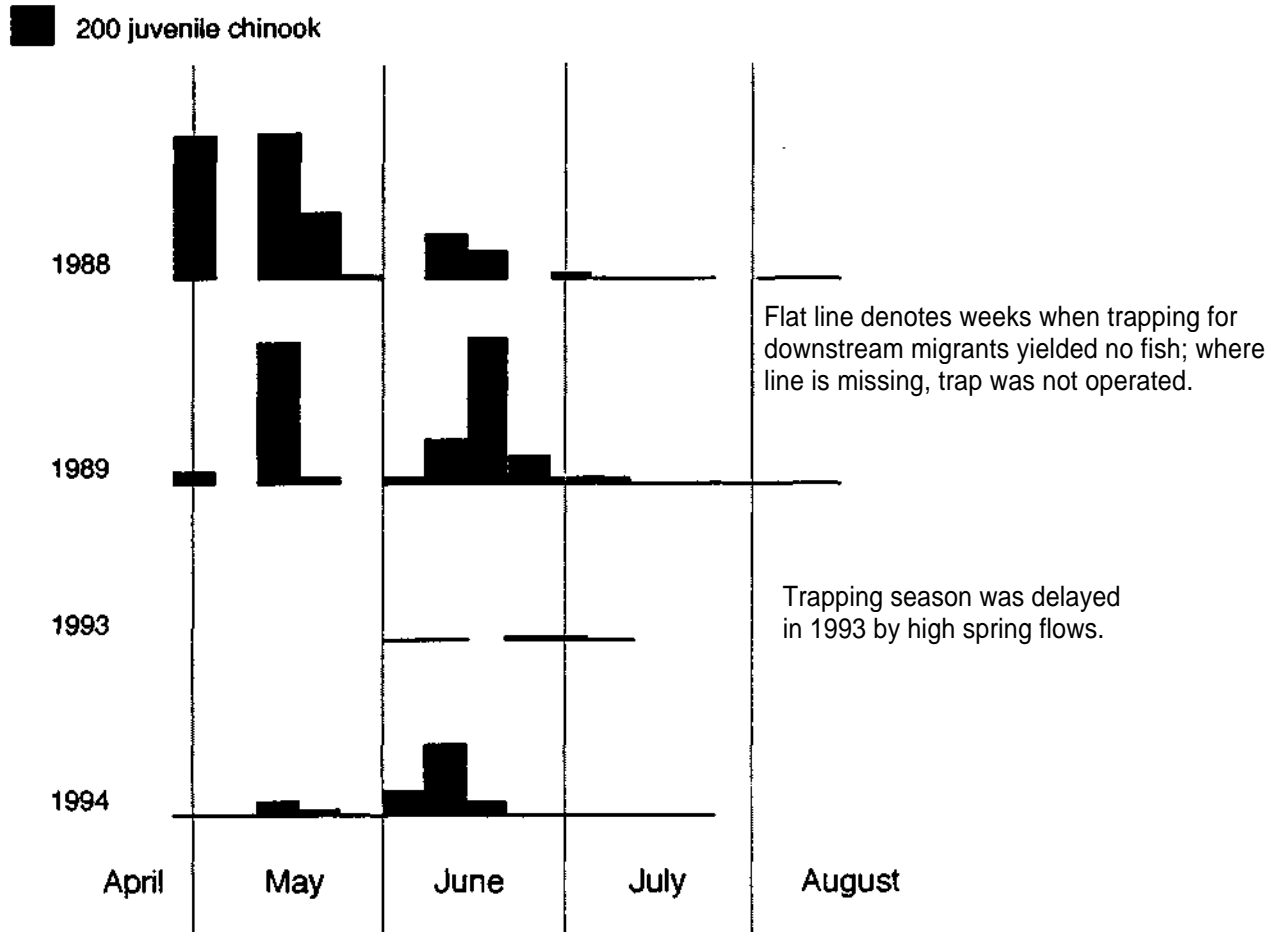
Juvenile chinook down-migrants are observed mainly in May and June
(Fig. 2.8)

This graph shows weekly catches of juvenile chinook in the downstream migrant trap during four trapping seasons. Bars indicate the number of fish trapped; a line at the base of the graph denotes weeks when the trap was operating but no fish were caught.

These data do not indicate the abundance of emigrating chinook, but only the times when juvenile fish were moving past the mainstem trapping site near the confluence of Mill Creek. In 1990, chinook down-migrants began appearing as soon as trapping began at the end of April, continuing through mid-May when high spring flows prevented trapping from continuing. In 1991, despite regular trapping from early April to early July, only 5 chinook fingerlings were captured. And in 1992, the main chinook down-migration was observed in the first three weeks of June, out of a trapping season that lasted throughout May and June.

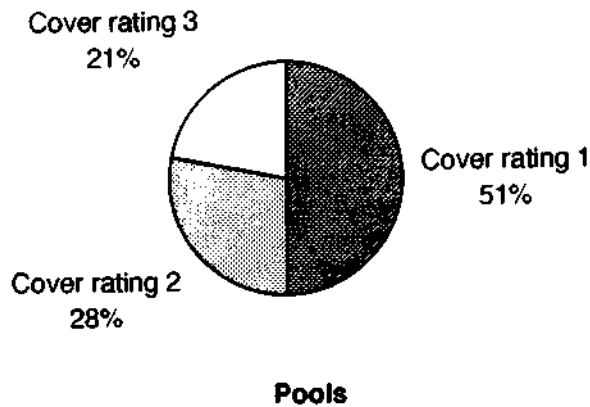
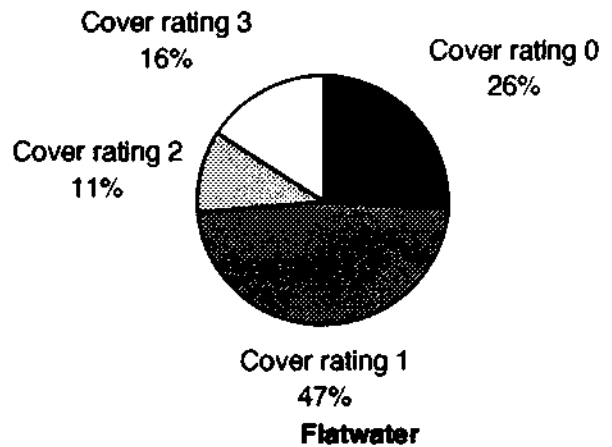
Pools and flatwater are low in cover (Fig. 2.12)

A notable finding in the 1991 habitat typing surveys was the lack of cover over pools and flatwater, rated on a scale from 0 (barren) to 3 (well-covered). Juvenile fish need cover to avoid predators. It also adds complexity to streams, which allows a given reach to accommodate more fish. Percentages calculated by area.

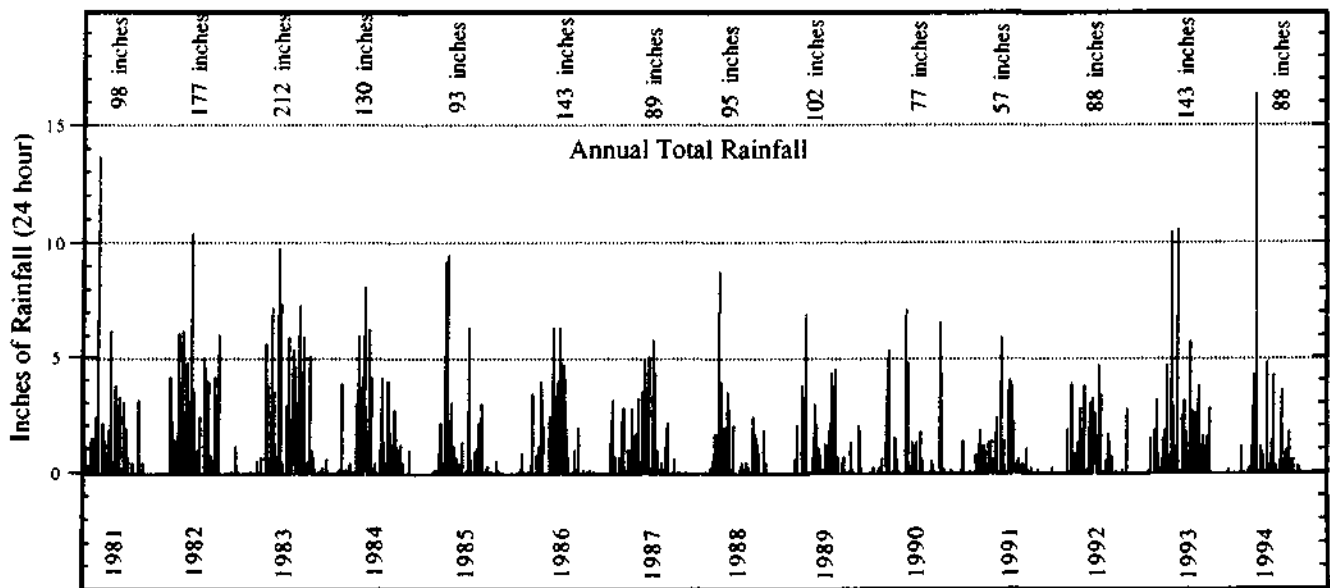
**Daily rainfall of ten inches is not uncommon on Wilder Ridge
(Fig. 3.3)**

This figure is a summary of daily rainfall amounts on Wilder Ridge from 1981 through 1994. The data show the nature of peak events, such as fourteen and sixteen-inch *daily* totals. Daily precipitation of ten inches are not unusual. These are the events that bring about dramatic changes in the hillslopes and stream channels. Annual rainfall totals at the top of the figure display a range from 212 inches in 1983, to 57 inches in 1991.

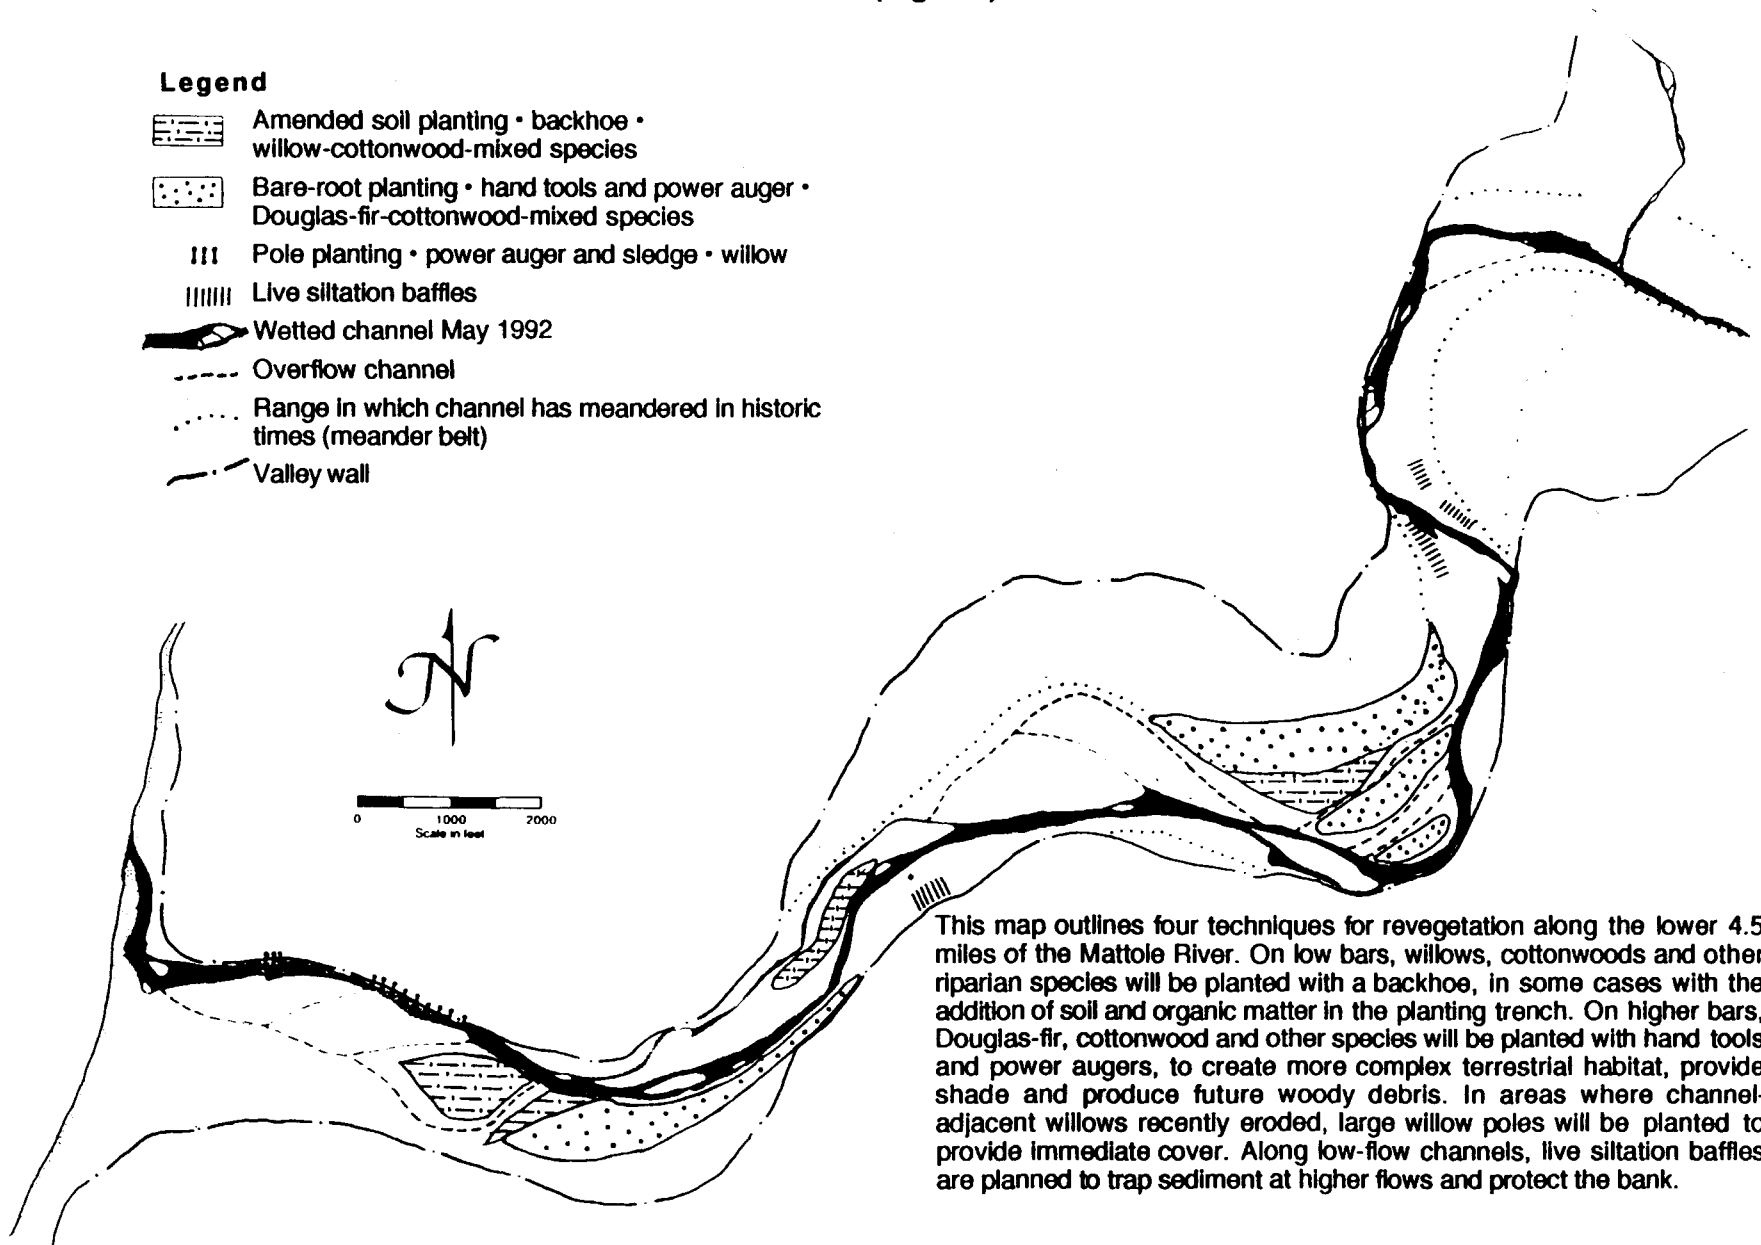
This map outlines four techniques for revegetation along the lower 4.5 miles of the Mattole River. On low bars, willows, cottonwoods and other riparian species will be planted with a backhoe, in some cases with the addition of soil and organic matter in the planting trench. On higher bars, Douglas-fir, cottonwood and other species will be planted with hand tools and power augers, to create more complex terrestrial habitat, provide shade and produce future woody debris. In areas where channel-adjacent willows recently eroded, large willow poles will be planted to provide immediate cover. Along low-flow channels, live siltation baffles are planned to trap sediment at higher flows and protect the bank.
