FISHERIES ASSESSMENT FOR BOLINAS
LAGOON TRIBUTARIES WITHIN THE
GOLDEN GATE NATIONAL RECREATION
AREA, 1995-2000

Darren Fong
Aquatic Ecologist
Golden Gate National Recreation Area
Building 1061, Fort Cronkhite
Sausalito, CA 94965
(415) 331-8716

February 2002

Prepared for the
National Park Service
Golden Gate National Recreation Area
Division of Natural Resource Management and Research

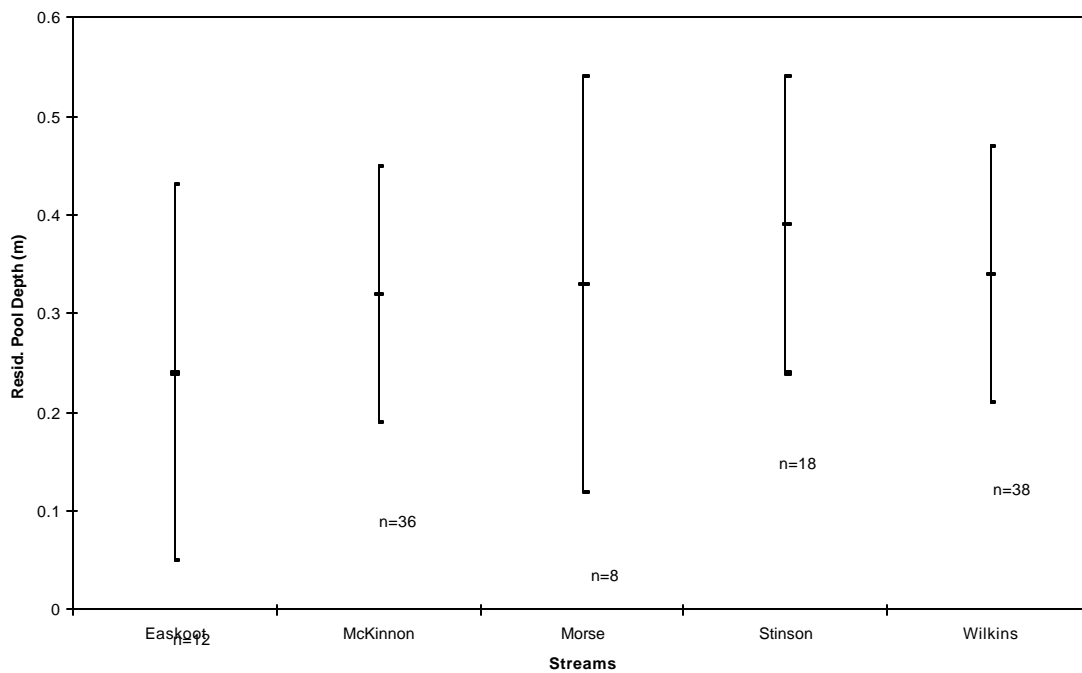
Figure 6: Mean residual pool depths and standard deviation for 5 streams draining Bolinas Lagoon (1997-1998)

Residual pool depth represents the mean depth of water for pools should surface flows drop to zero. We did not find any significant differences amongst the Bolinas tributary streams in their residual pool depths (single-factor ANOVA, Fischer's PLSD, Figure 6). However, West Union Creek (San Mateo Co.) had significantly deeper pools than any of the Bolinas tributary streams. (single factor ANOVA, Fisher's PLSD, $p < 0.05$).

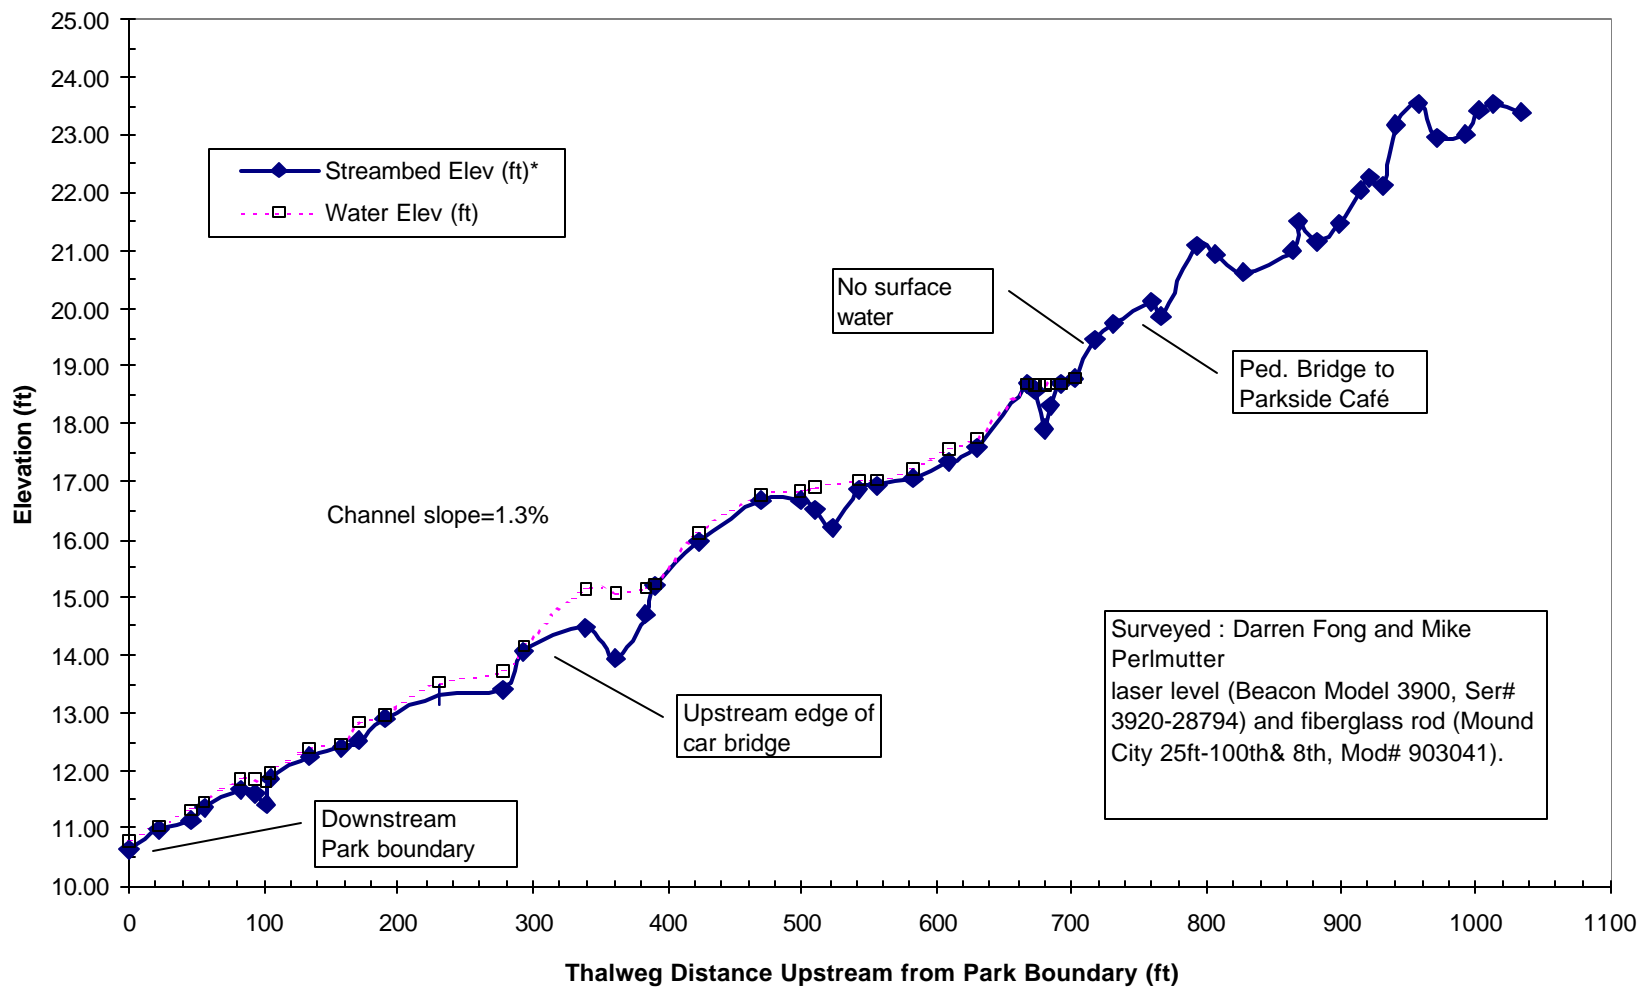
Figure 7: Lower Easkoot Creek Stream Thalweg Profile at Stinson Beach, Marin Co., August 1999

We only collected stream profile data for Easkoot Creek in 1999. Mean channel slope was 1.3 percent. The topographic profile and habitat classification data both indicate the scarcity of deep pool habitats within the Park boundaries, between Calle Pinos and the Arenal bridge. Topographic surveys in summer 1999 found just two shallow pools with mean depths of less than 0.5 m and representing less than 20% of project length (Figure 7). Slight depressions in the streambed indicate that

a few pools could be present upstream of the Parkside Café if surface water is present.

The absence of deep pools reduces the total number of juvenile steelhead produced within Park waters as well as the size they can attain. Larger individuals have a higher likelihood of returning as adults (Ward and Slaney 1988).

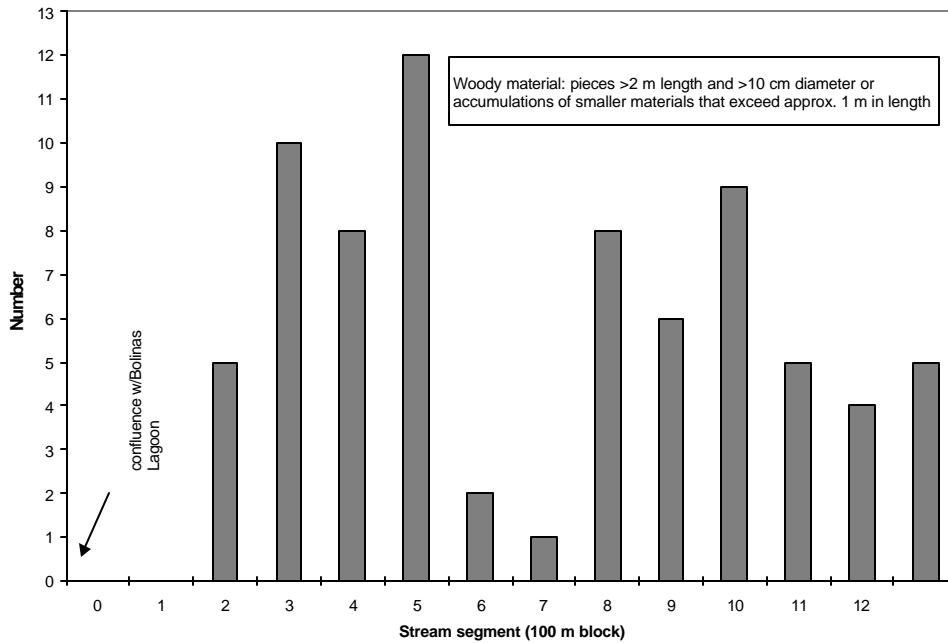
Figure 8 Distribution of woody materials in Wilkins Gulch, Marin Co., August 12-17, 1998.

WILKINS GULCH(Figure 8). This creek displayed the highest densities of woody materials of the sampled creeks. Mean densities of 5.8 units of wood were found per 100 m. Many of these pieces included long-term pool-forming rootwads and materials >50 cm in diameter.

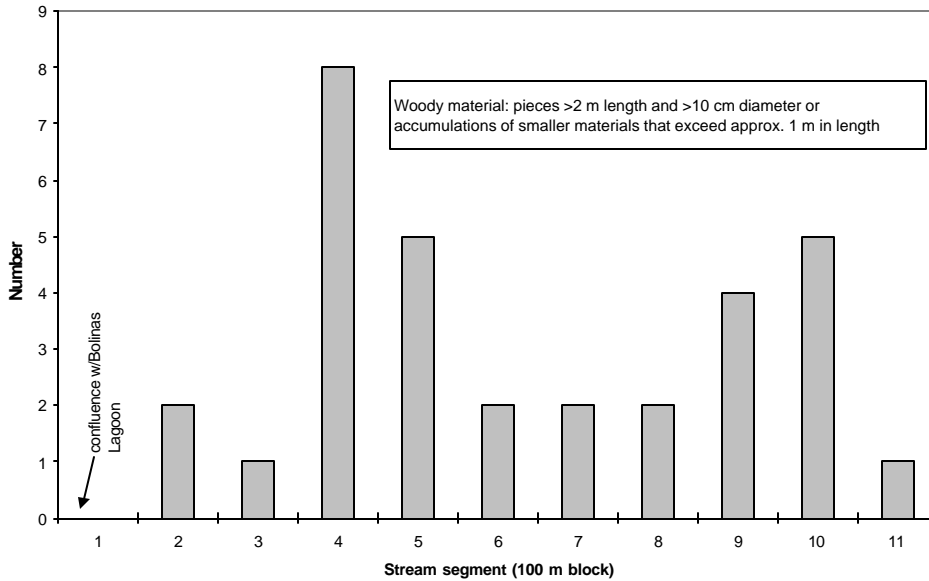
Figure 9: Distribution of woody materials in Morse Gulch, Marin Co., July 21-22, 1998.

MORSE GULCH (Figure 9). Low densities of woody materials were found in Morse Gulch. However, mean densities of 3.2 units per 100 m were higher than those reported for Easkoot Creek. Woody materials were present in almost all sections.

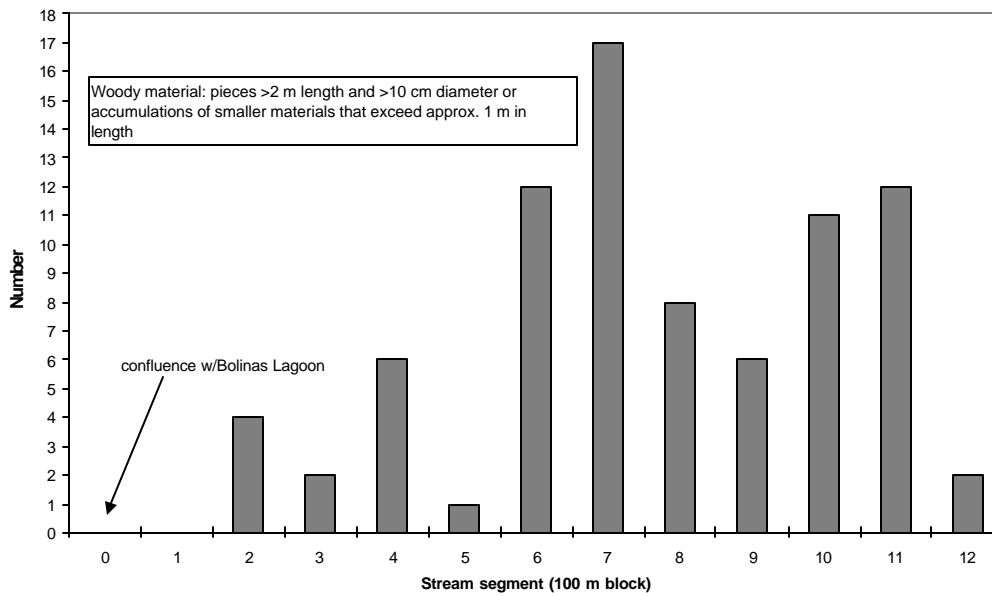
Figure 10: Distribution of woody materials in McKinnan Gulch, Marin Co., July 28-August 4, 1998.

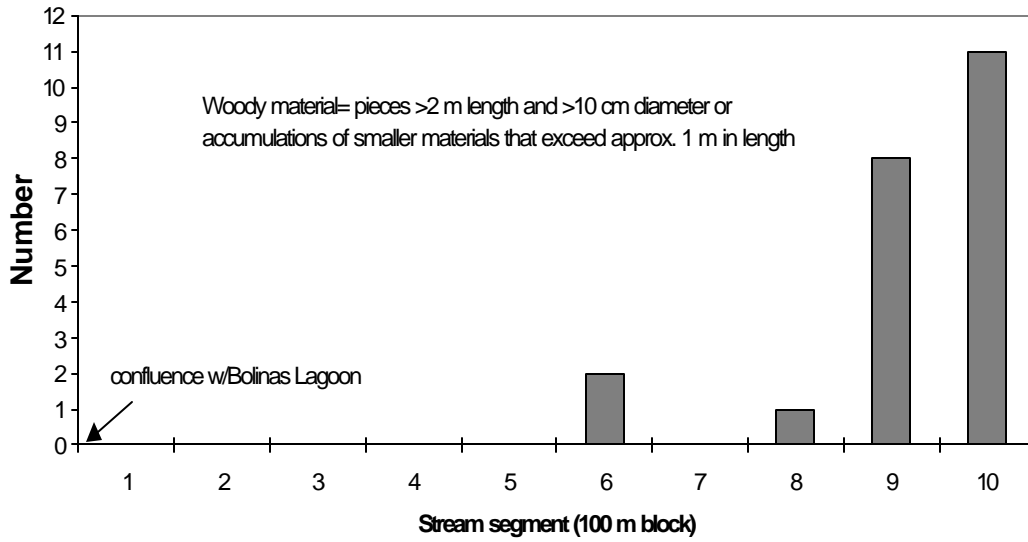
Figure 11: Distribution of woody debris in Stinson Gulch, Marin Co., July 9-10, 1997.

STINSON GULCH (Figure 11). As with Easkoot Creek, very little wood was available in the lower portion of the channel above the lagoon. While the mean density of wood (2.2 units per 100 m) was higher than Easkoot Creek, 85% of the observed wood were within the last 200 m of the surveyed channel.

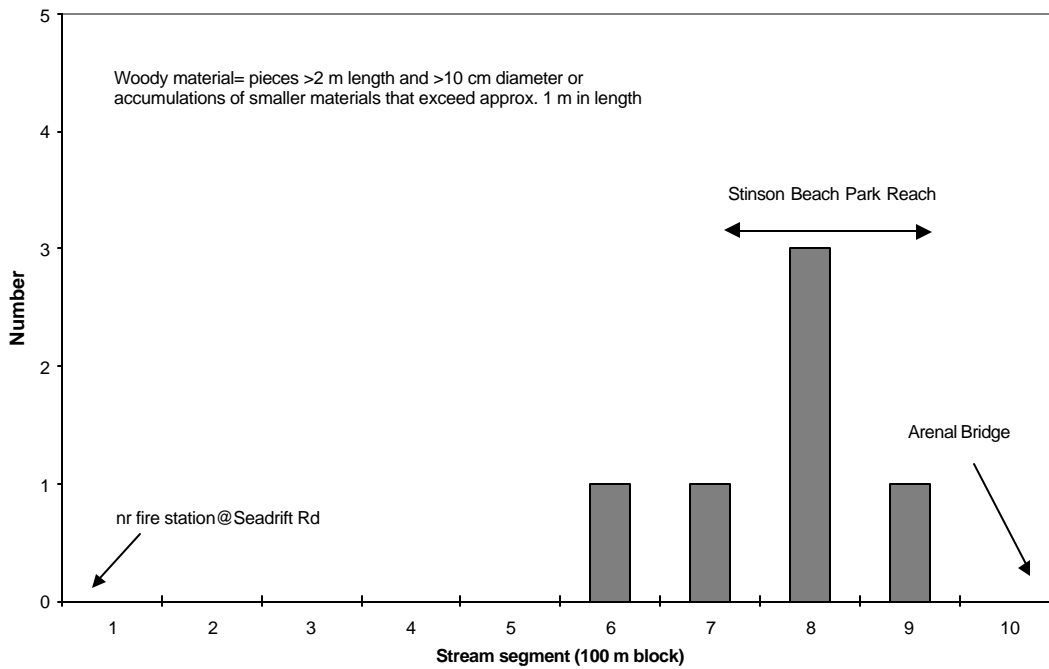
Figure 12: Distribution of instream woody material in lower Easkoot Creek (nr mouth to Arenal Bridge), Marin Co., August 7, 1997

EASKOOT CREEK (Figure 12). There was little woody material within the channel. For the sampled 1000 m, a mean density of 0.6 units per 100 m was counted. No woody material was found within the first 600 m (Figure 12). This low density may partly be explained by the absence of large riparian trees in the lower section, particularly in the tidally influenced portion (0-400 m). Above the tidally influenced areas, the local flood control district conducts an annual cleanup of the creek which includes the removal of large woody materials that could potentially be transported and lodged at bridge locations. In addition, almost all of the infrequently encountered woody materials are either downed alders or willows—species whose wood does not persist as long in the water as large conifers such as douglas fir. This removal prevents the establishment of main channel or scour pools that are formed by wood.

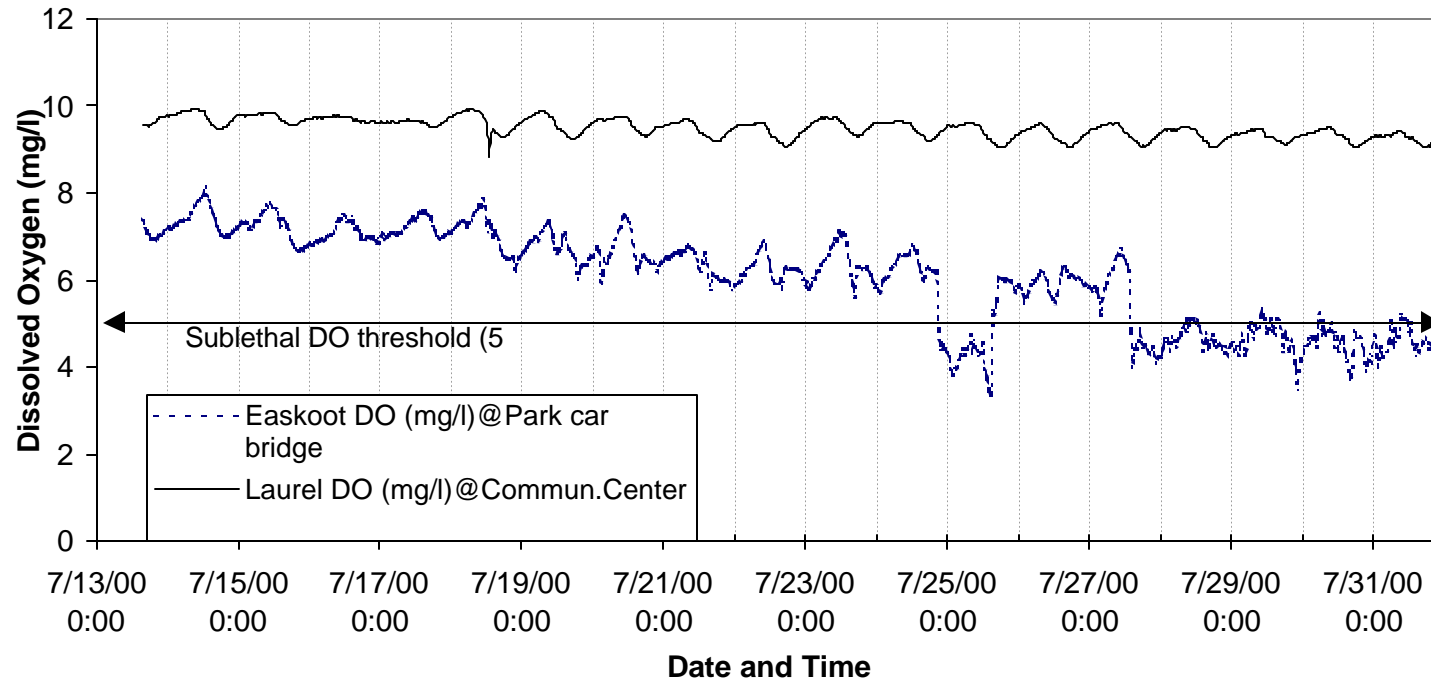
Figure 14: Dissolved oxygen concentration at Laurel and Easkoot Creek Sampling Stations, Marin Co., August 2000

Both sites exhibited seasonal trends and diel fluctuations in temperature, dissolved oxygen, and specific conductance. In general, dissolved oxygen concentrations declined at both sites from July through October coinciding with a general decrease in instream flows. The diel fluctuations are similar to studies elsewhere which found peaks in dissolved oxygen in the afternoon corresponding to peak photosynthesis and minimum levels during the early morning corresponding to net respiration. Dissolved oxygen concentrations at the Laurel station consistently reached minimum levels around 2000 HR (Pacific Standard Time) and maximum levels around 1000 HR (PST) (Figures 13-16).

Of note, the Easkoot Creek station exhibited the largest swings in diel oxygen fluctuations. This station consistently had differences in maximum and minimum dissolved oxygen concentrations that were 3 times greater than the Laurel Creek station. Such difference might be explained by the amount of aquatic vegetation and algae facilitated by the open canopy within the Easkoot Creek station. The larger amount of plant life (and associated decaying vegetation) may explain the much lower dissolved oxygen levels during the early morning. Also, several residences and businesses are located along the creek just upstream of our Easkoot station.

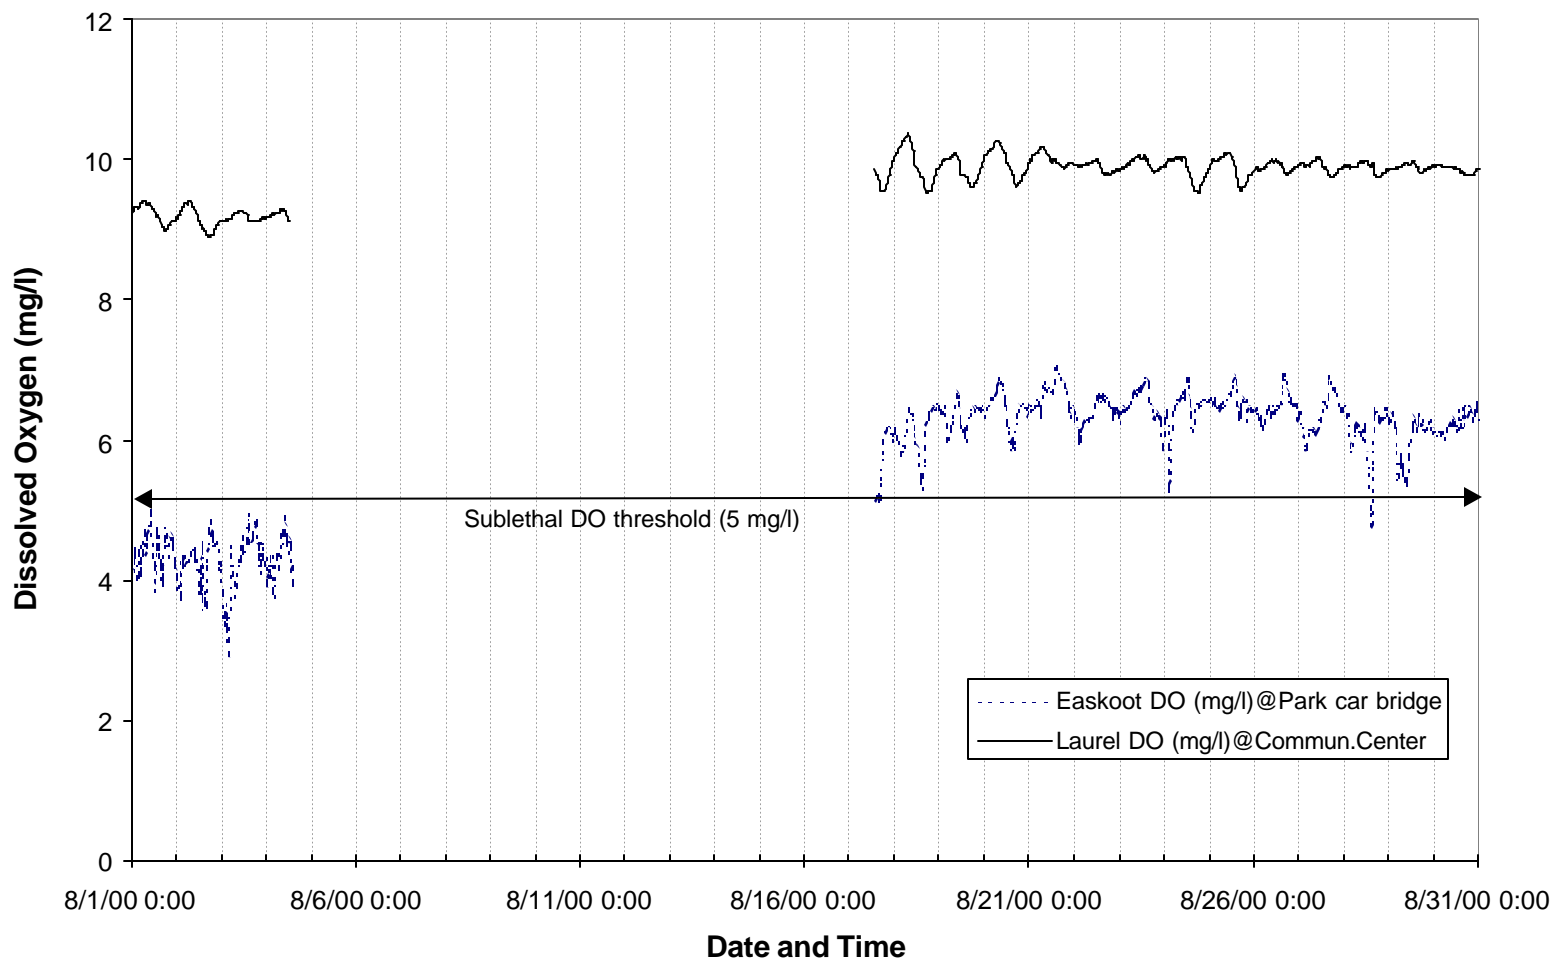
Figure 15: Dissolved oxygen concentration at Laurel and Easkoot Creek Sampling Stations, Marin Co., September 2000

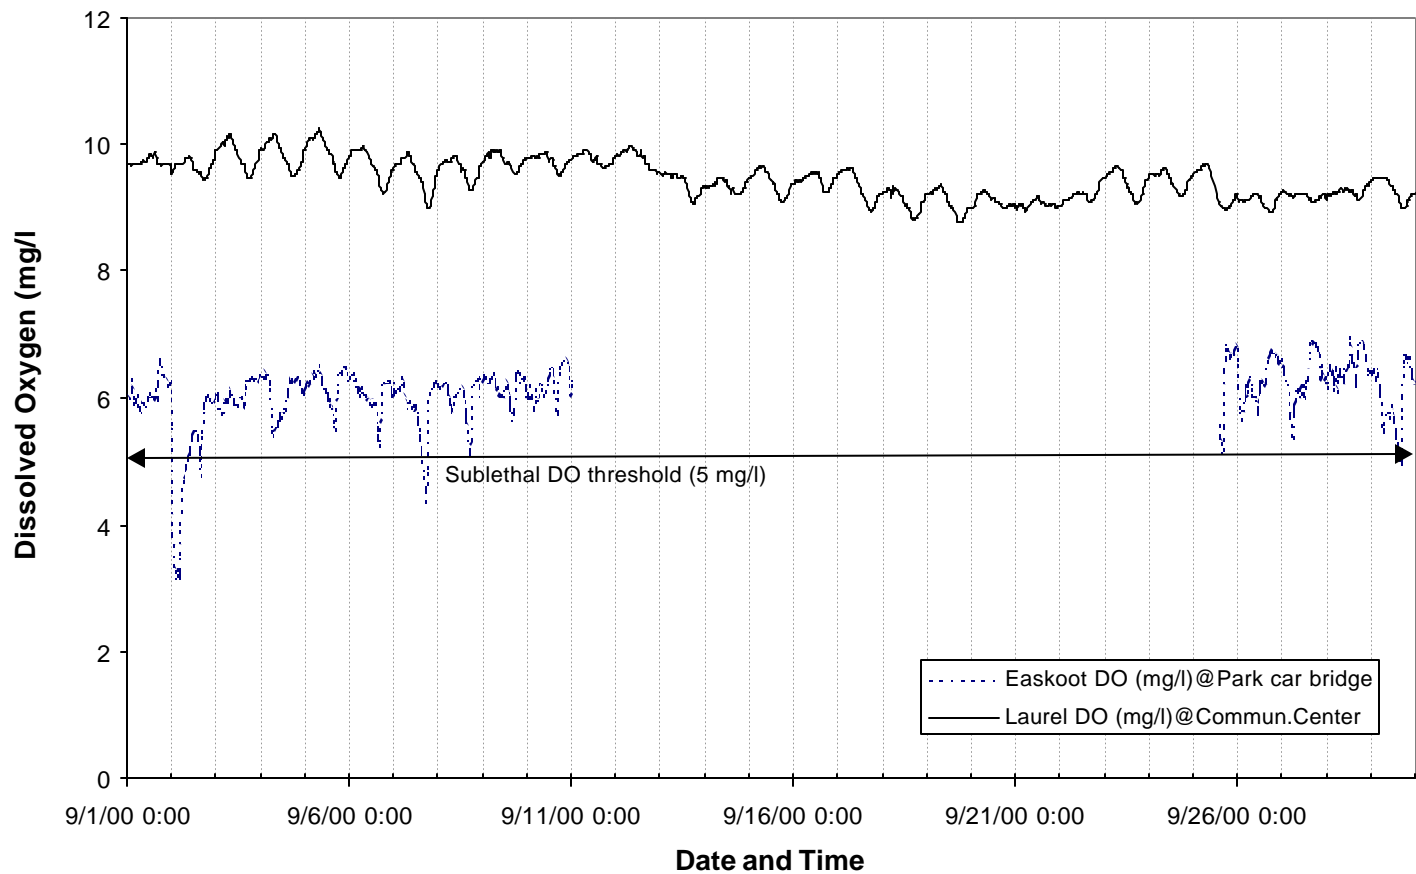
Figure 16: Dissolved oxygen concentration at Laurel and Easkoot Creek Sampling Stations, Marin Co., October 2000

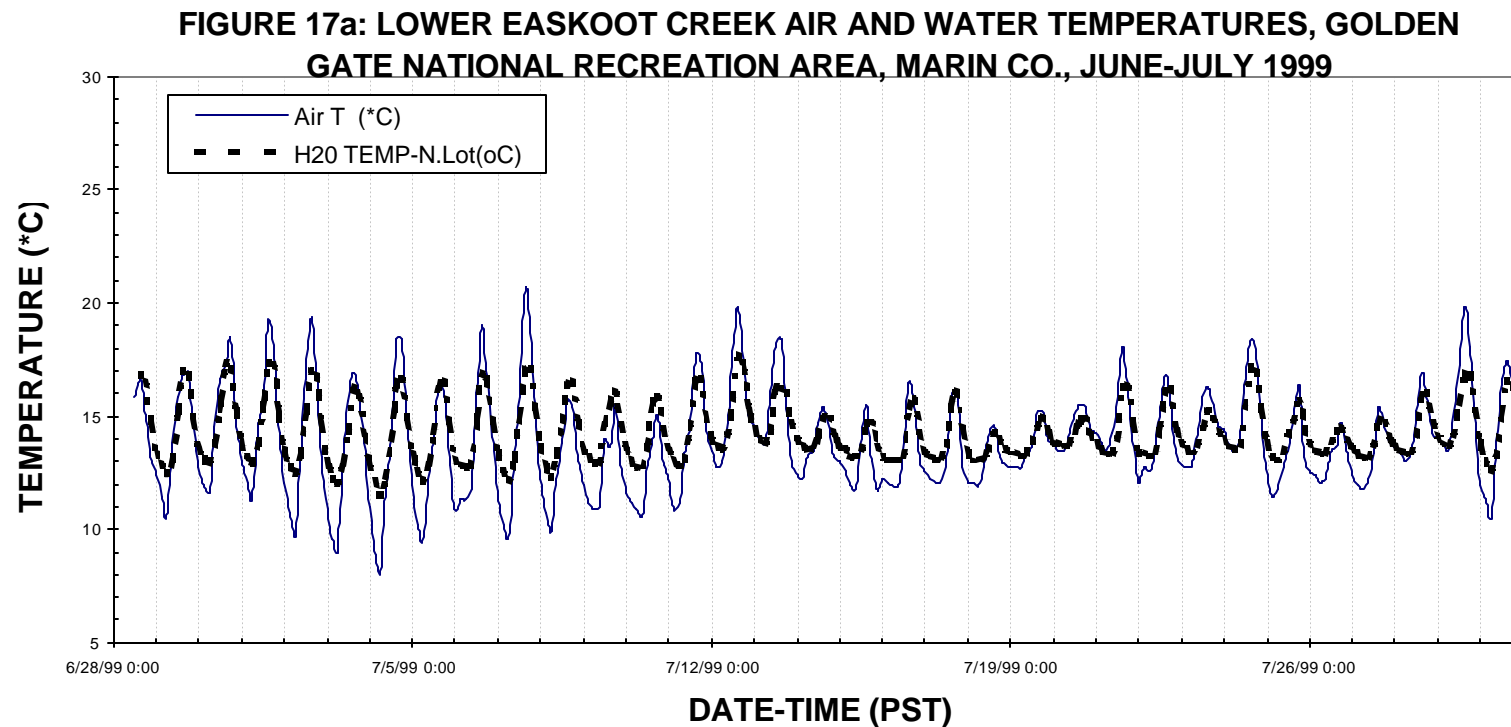
FIGURE 17b: LOWER EASKOOT CREEK AIR AND WATER TEMPERATURES, GOLDEN GATE NATIONAL RECREATION AREA, MARIN CO., AUGUST 1999

TEMPERATURE. Stream water temperatures in summer 1999 and 2000 were adequate for growth and survival of juvenile steelhead at the two sampled sites in the Easkoot Creek watershed. No stream temperatures exceeded 20°C in either summer-fall 1999 or 2000 (Tables 10,12; Figures 17-18).

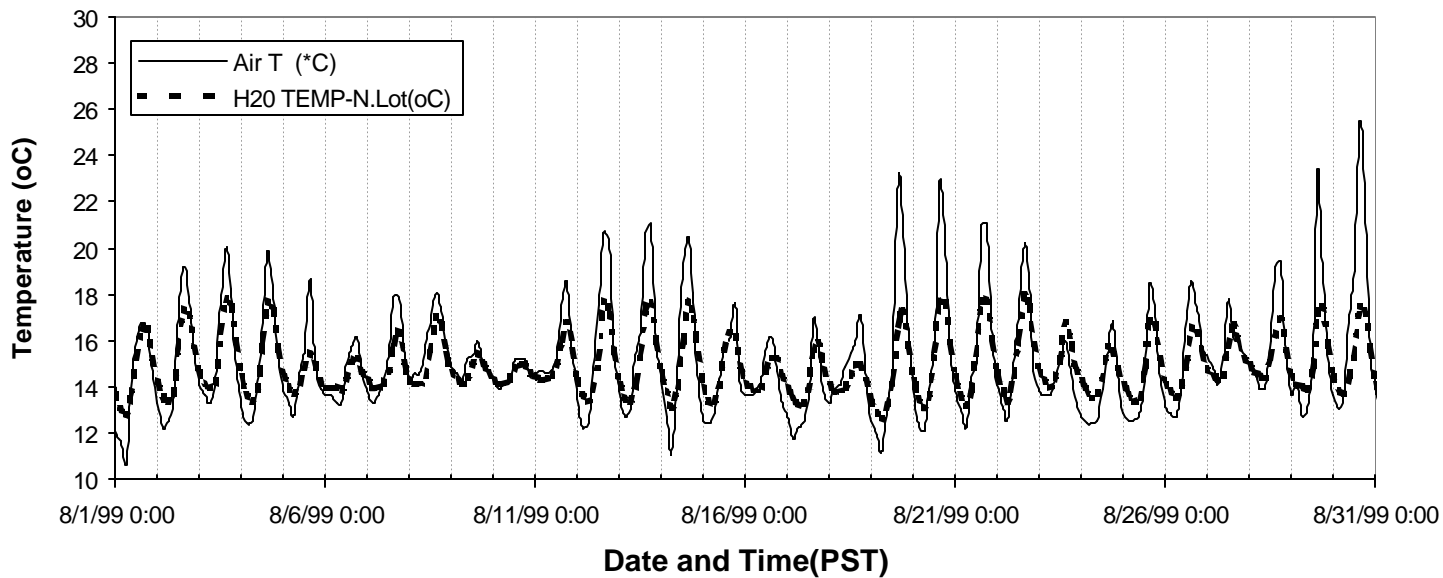
FIGURE 17c: LOWER EASKOOT CREEK AIR AND WATER TEMPERATURES, GOLDEN GATE NATIONAL RECREATION AREA, MARIN CO., September 1999

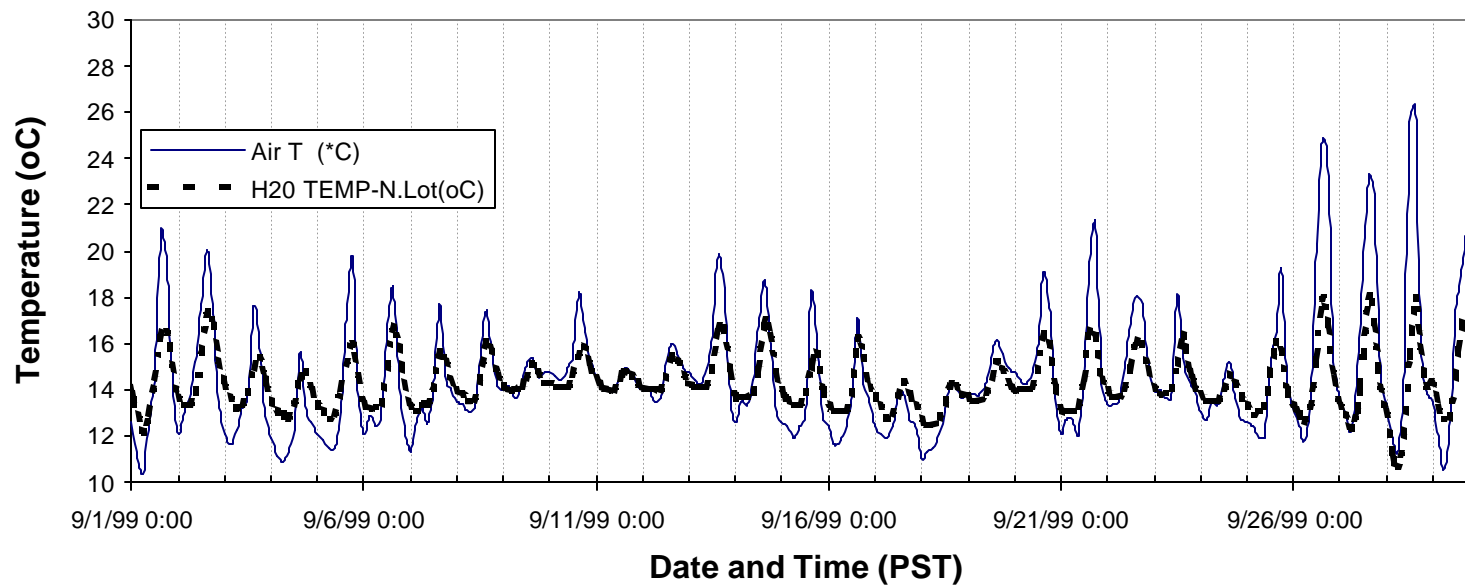
FIGURE 17d: LOWER EASKOOT CREEK AIR AND WATER TEMPERATURES, GOLDEN GATE NATIONAL RECREATION AREA, MARIN CO., OCTOBER 1999

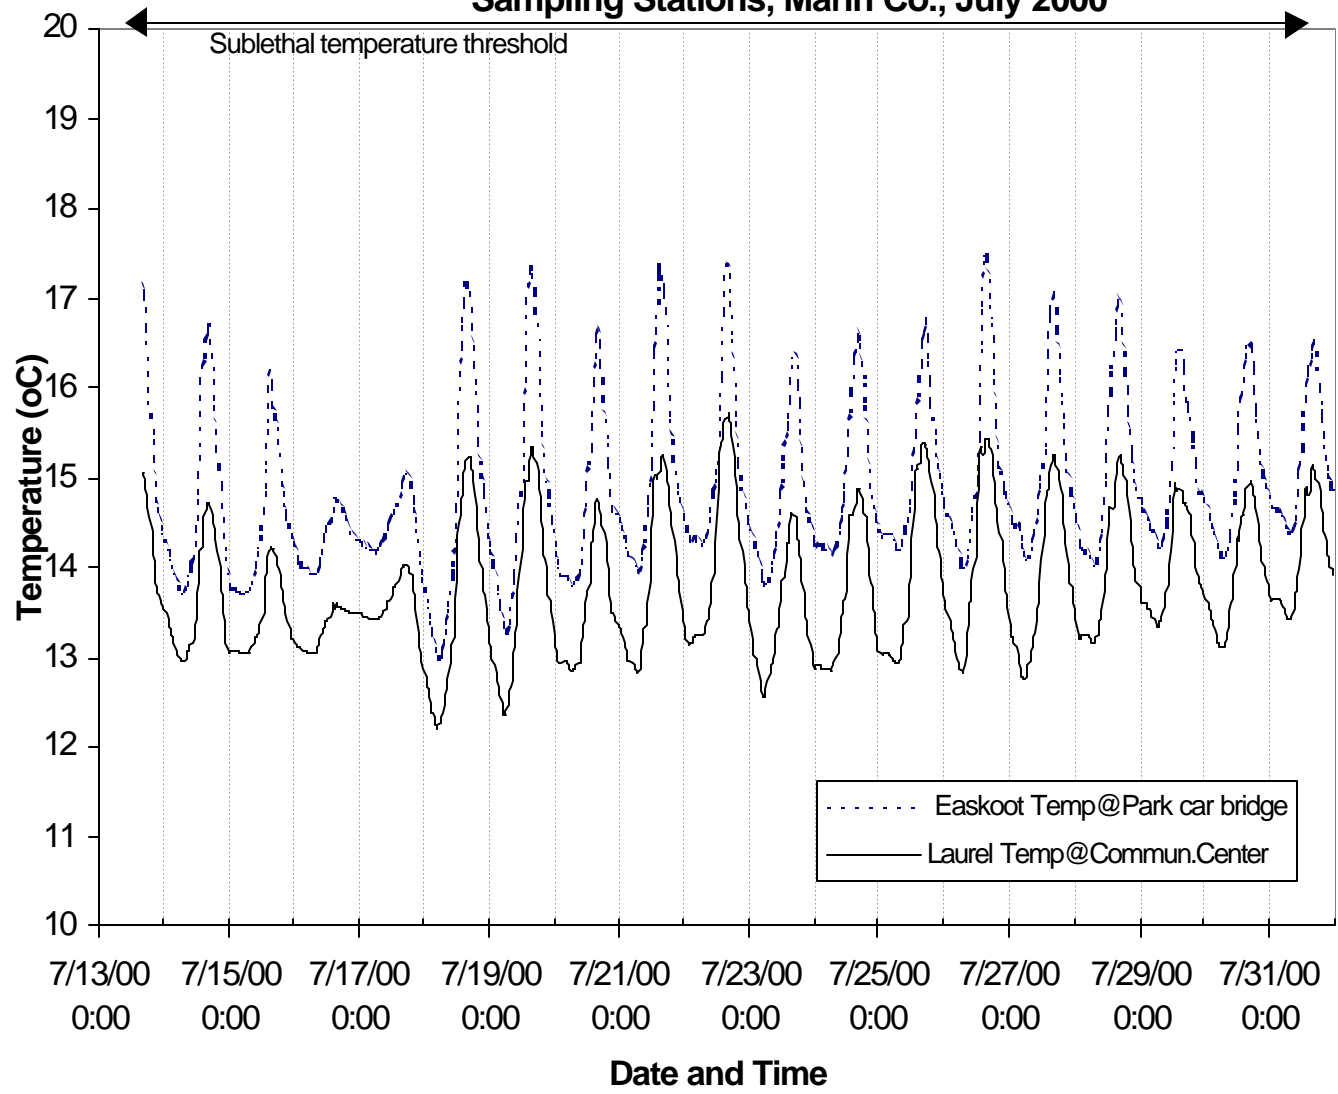
Figure 18b: Instream water temperature at Laurel and Easkoot Creek Sampling Stations, Marin Co., August 2000

Fluctuations in maximum and minimum temperatures were smaller at the Easkoot Creek station relative to upstream Laurel Creek despite shaded conditions at both sites. There are a variety of factors that might explain this difference. Differences in the source of instream flows could be one explanation. It is possible that most flow in Laurel occurs as surface flow. Changes in water diversion rates are quickly reflected in instream flows at the Laurel Creek station within hours. Furthermore, the flow data indicate that changes in instream flow match the reported rate of diversion closely, suggesting minimal contribution or loss from banks or underflow. Also, temperatures in Laurel Creek closely track air temperatures. However, the reduced fluctuations in temperature at the Easkoot station despite lower discharge than the Laurel station indicate that streamflow at the lower station might result more from subsurface and bank contributions than surface flows (Figure 18). No surface flows upstream of the Park's Easkoot station are observable in late summer between the Arenal Bridge to Parkside Café. However, surface flows are present downstream. Subsurface flows through stream bed material would dampen the effects of temperature fluctuations. Other factors affecting temperature fluctuation could include input from other surface water streams (e.g., Black Rock) and discharge from septic systems.

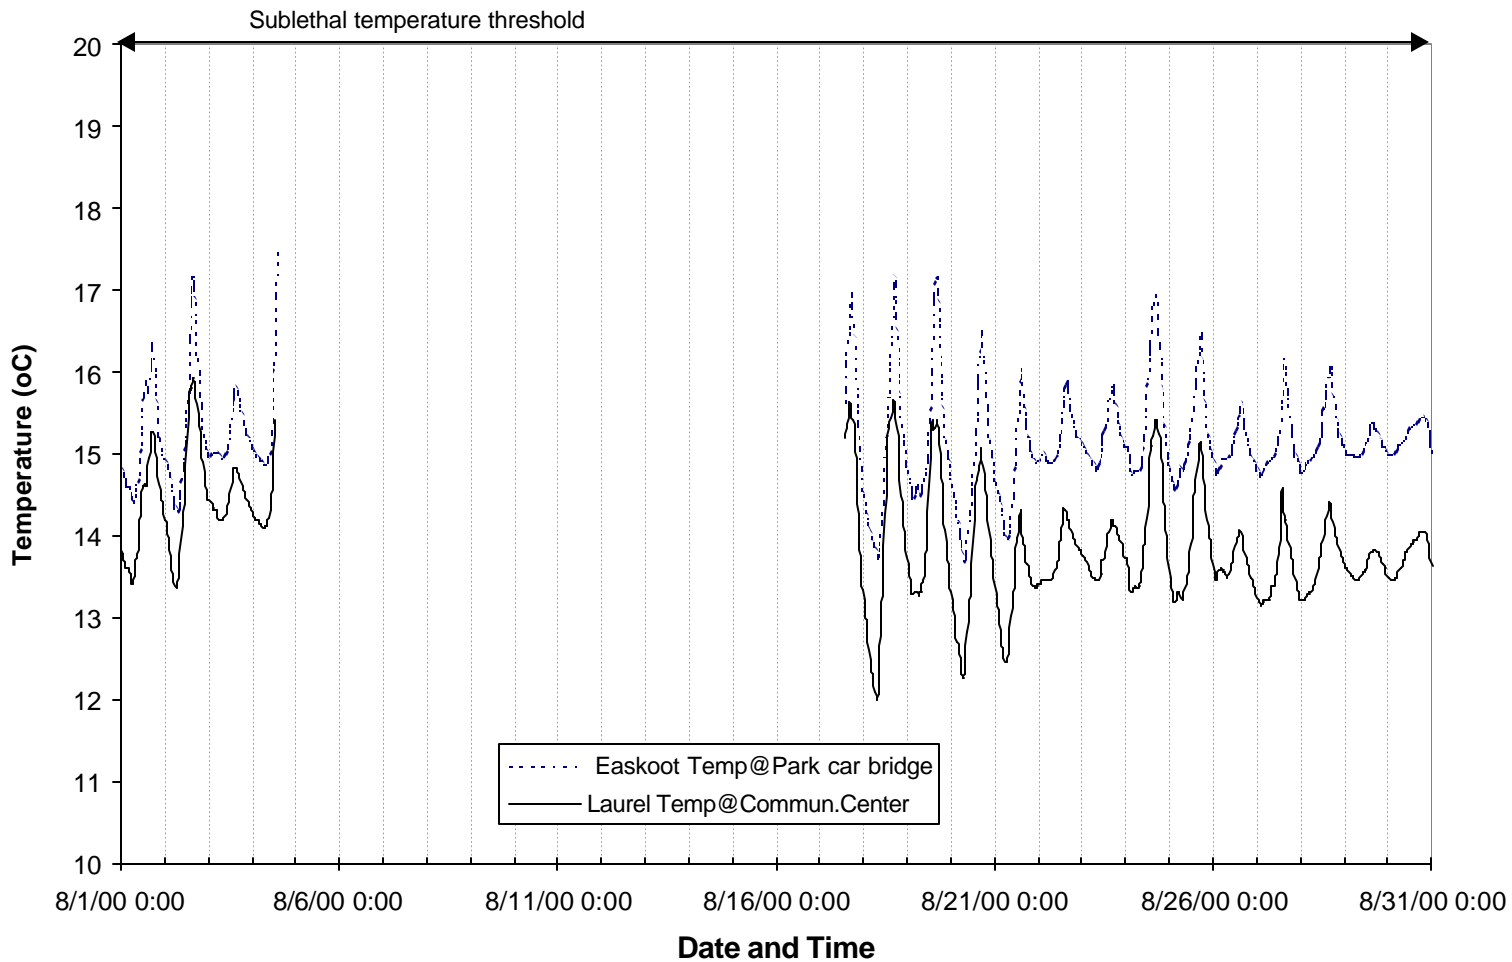
Figure 18c: Instream water temperature at Laurel and Easkoot Creek Sampling Stations, Marin Co., September 2000

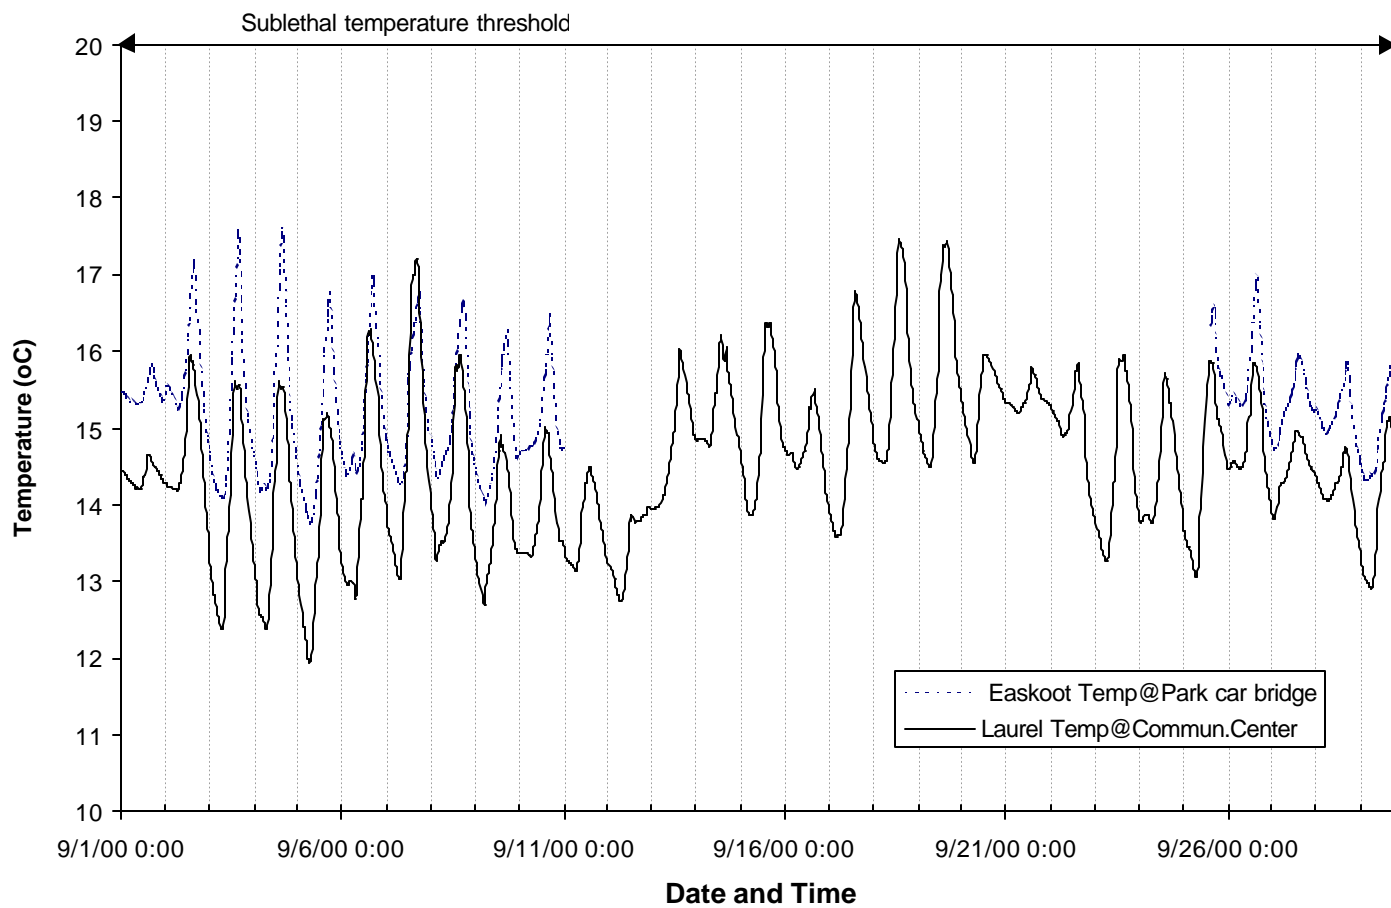
Figure 18d: Instream water temperature at Laurel and Easkoot Creek Sampling Stations, Marin Co., October 2000

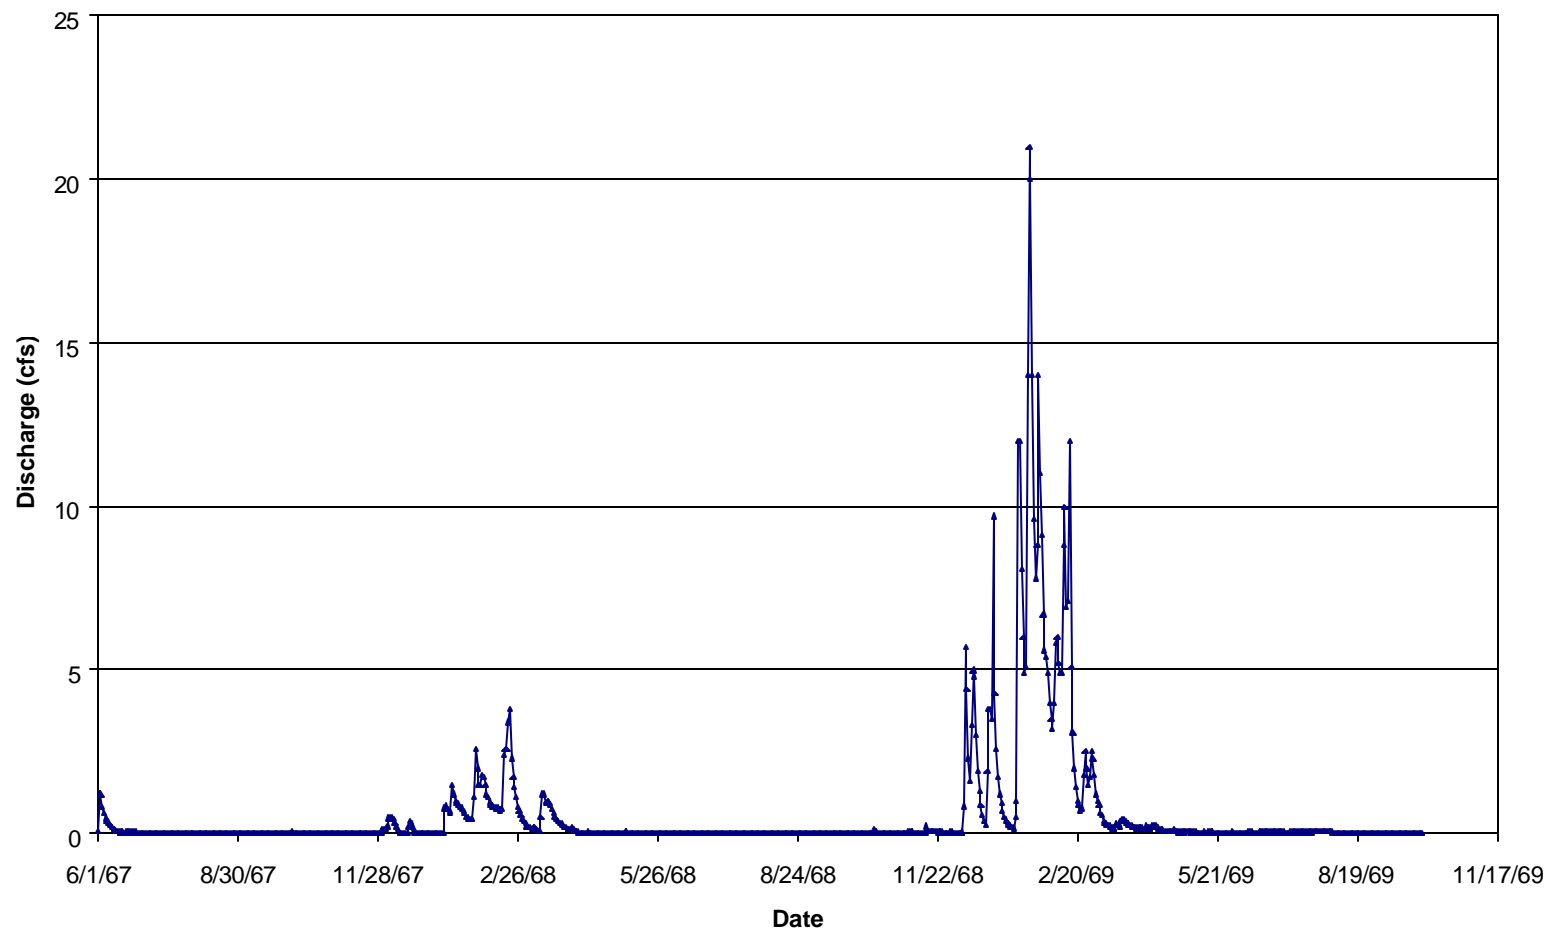
Figure 19: Daily mean discharge (cfs) at Morse Creek, Stinson Beach, CA 1967-1969.

Flow information to date indicates perennial flow at the gaging station during the period of record. However, late summer base flows were typically around 0.01 cfs (Figure 20a). Maintenance staff at the Park routinely check the creek and record the date when lower Easkoot Creek becomes disconnected. We considered the stream disconnected when no surface water connecting pool segments was observed. This "disconnection" occurred in July 2000 when flows of 0.3 cfs were recorded at the gaging station. This dry reach occurs from just above the Arenal Bridge to just below the Parkside pedestrian bridge. Smolt trap data from local streams (Redwood Creek) indicate that most smolt outmigration is completed by June (Fong 1997).

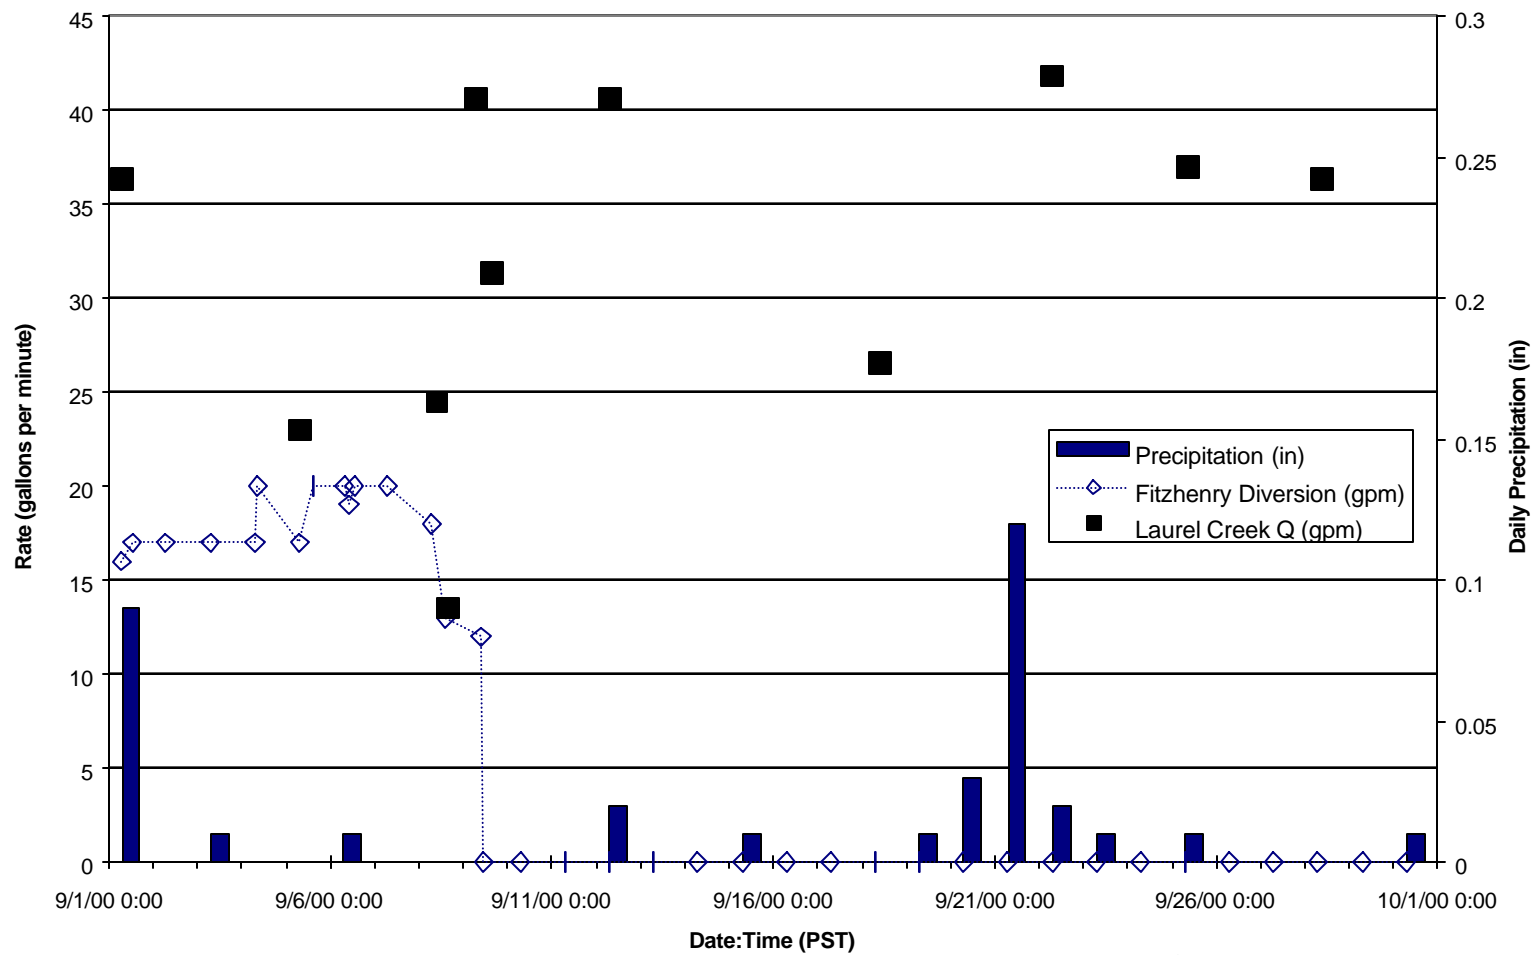
Figure 21b: Instream flows (gpm) below Fitzhenry diversion on Laurel Creek, Marin Co., California, September 2000

Point measurements at the Laurel Creek station also show the strong influence exerted by water withdrawals on instream habitat conditions (Table 14a, Figure 20b). Prior to water diversion, instream flows at Laurel on August 10, 2000 (0730 HR PST), were measured at 57.5 gallons per minute. On August 10, 2000 (1030 HR PST), the water district started to withdraw 20 gallons per minute. Following this action, instream flows dropped nearly 20 gpm the following day. Conversely, cessation of water diversions resulted in a gain in an equivalent amount the following day. Also, minor amounts of precipitation (around 0.1 in/day) resulted in relatively quick increases in instream flow (Figure 21b) in September.
