FISHERIES ASSESSMENT FOR BOLINAS
LAGOON TRIBUTARIES WITHIN THE
GOLDEN GATE NATIONAL RECREATION
AREA, 1995-2000

Darren Fong
Aquatic Ecologist
Golden Gate National Recreation Area
Building 1061, Fort Cronkhite
Sausalito, CA 94965
(415) 331-8716

February 2002

Prepared for the
National Park Service
Golden Gate National Recreation Area
Division of Natural Resource Management and Research

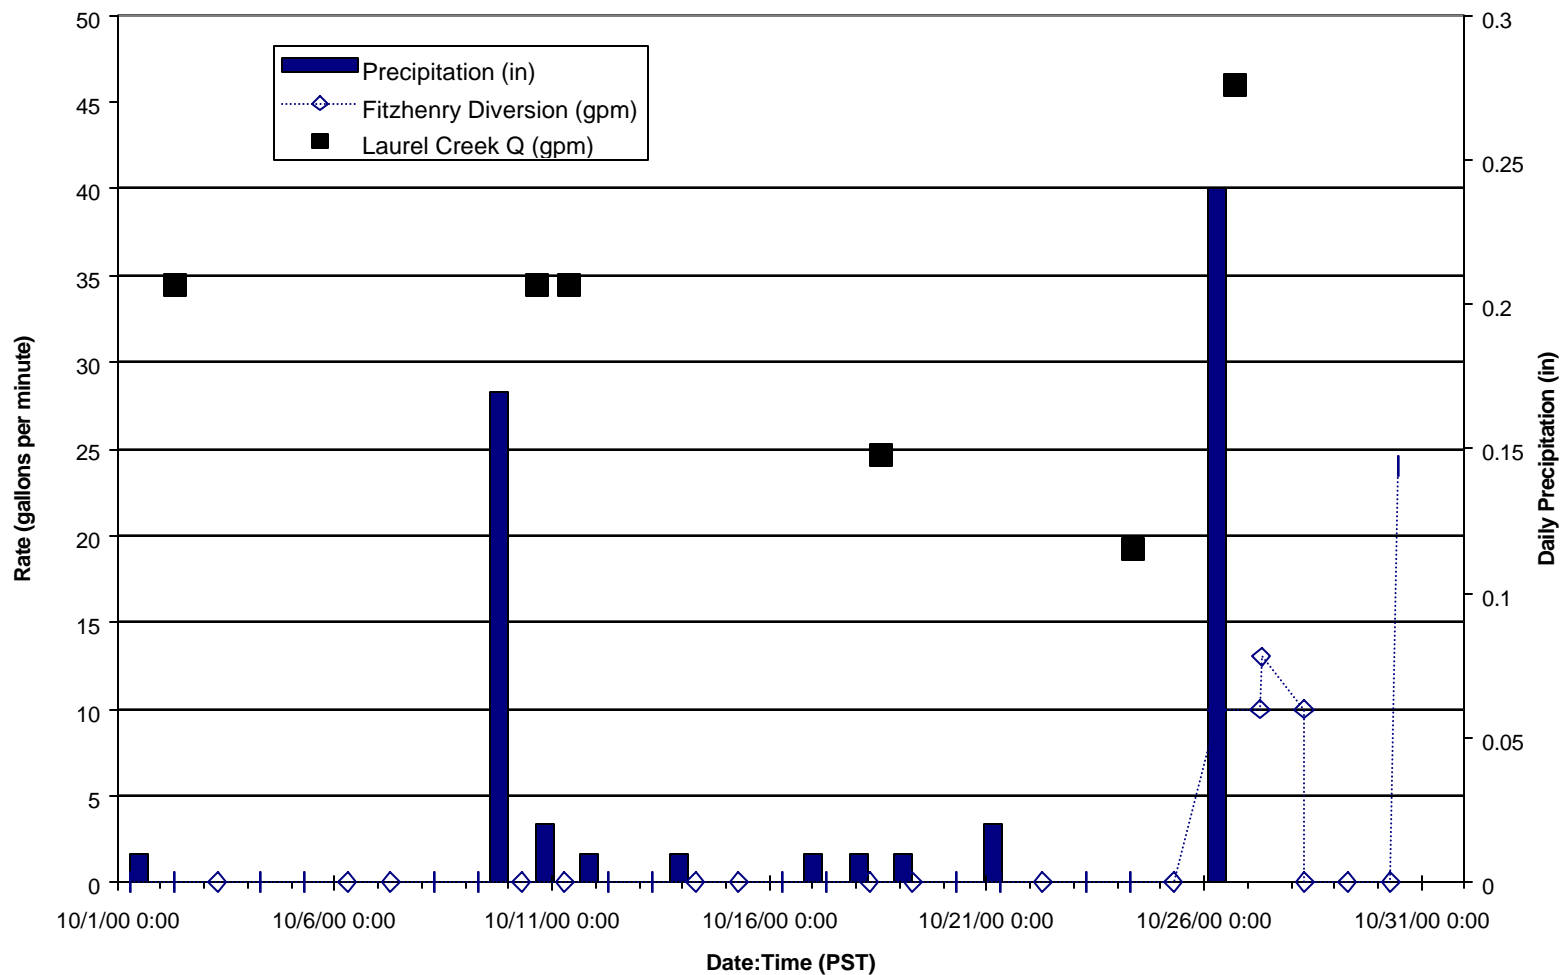
Figure 21c: Instream flows (gpm) below Fitzhenry diversion on Laurel Creek, Marin Co., California. October 2000

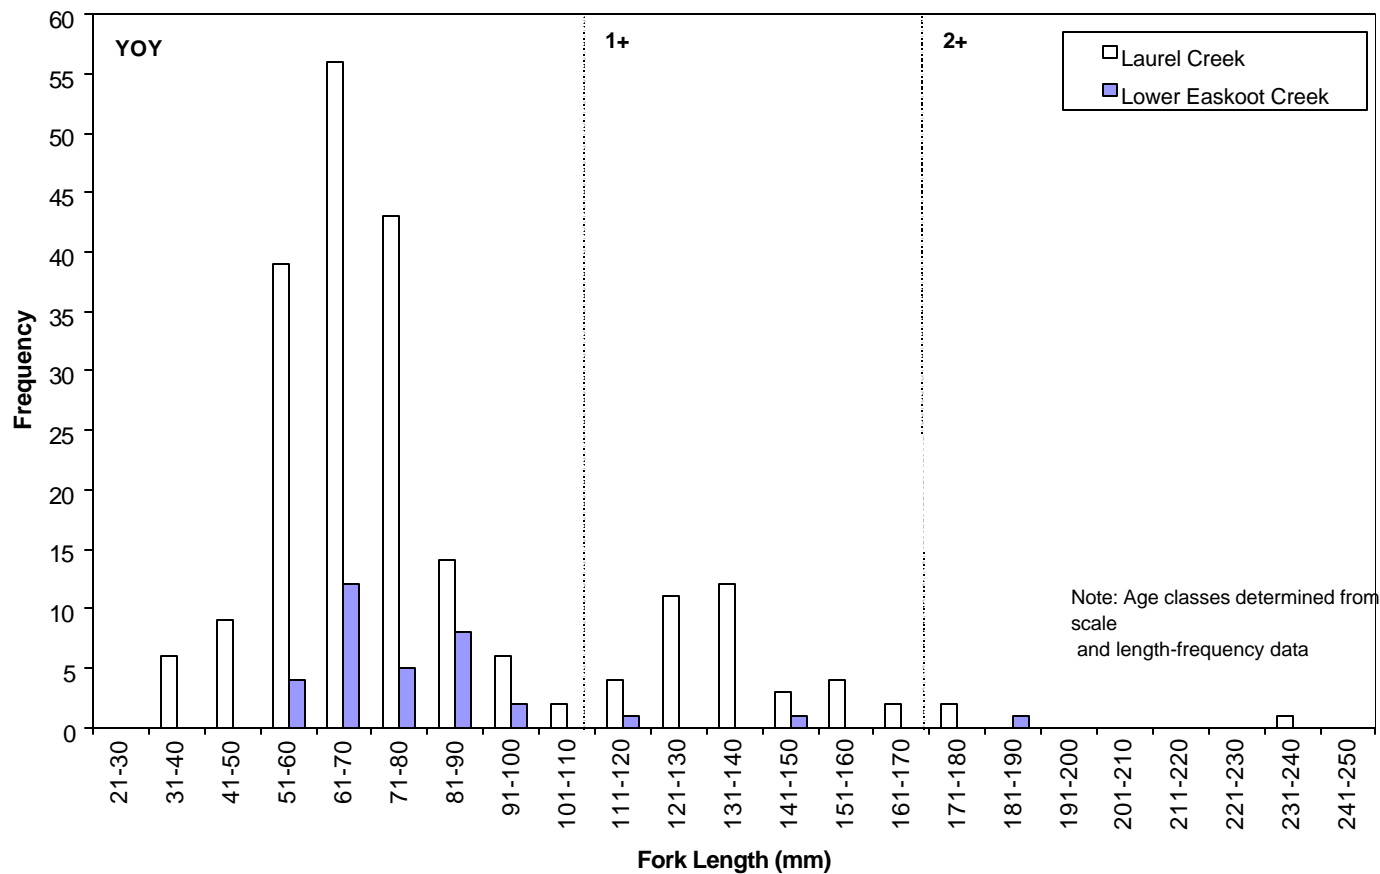
Figure 22: Length-frequency distribution of juvenile steelhead (*Oncorhynchus mykiss*) from two reaches in Easkoot Creek, Marin Co., Aug 3-4, 2000.

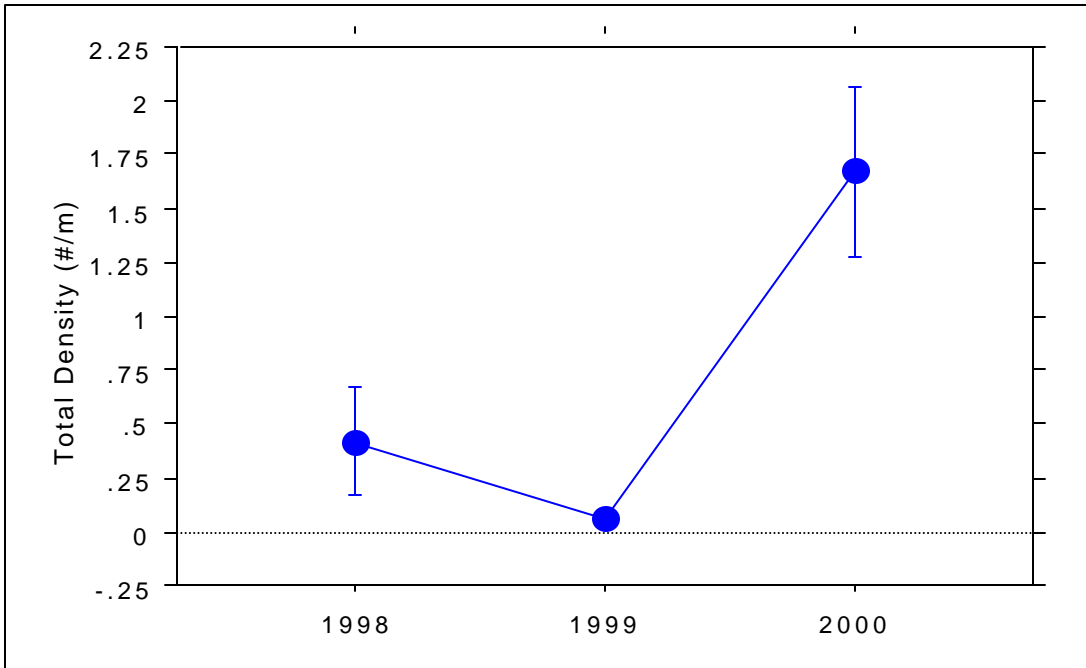
Figure 24: Total density of fish sampled using multiple pass electrofishing at lower Easkoot Creek, Stinson Beach Park, Marin Co., Summer 1998-2000.

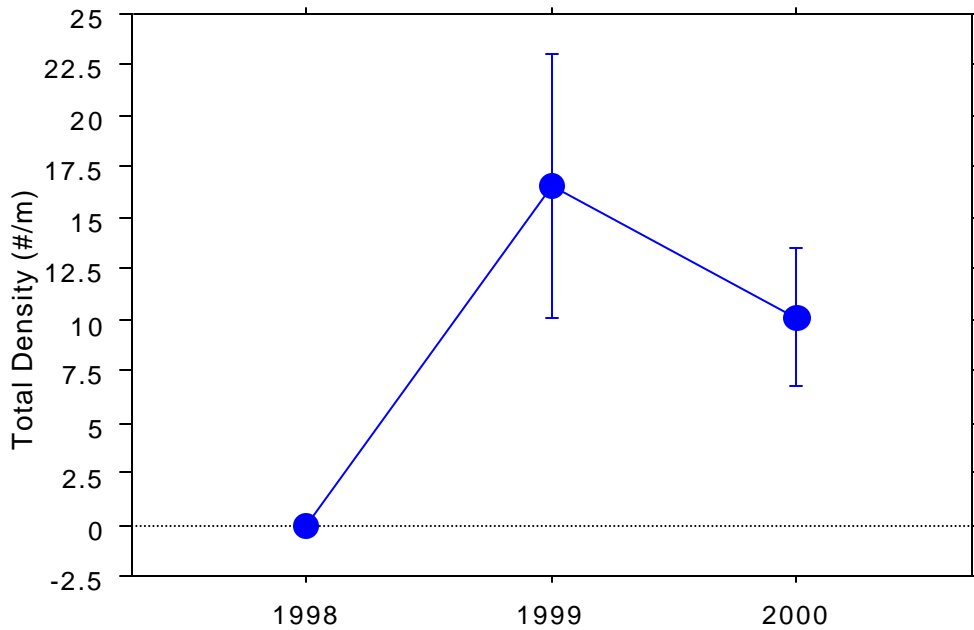
Figure 25: Total density of fish sampled using multiple pass electrofishing at Laurel Creek, Marin Co., Summer 1998-2000.

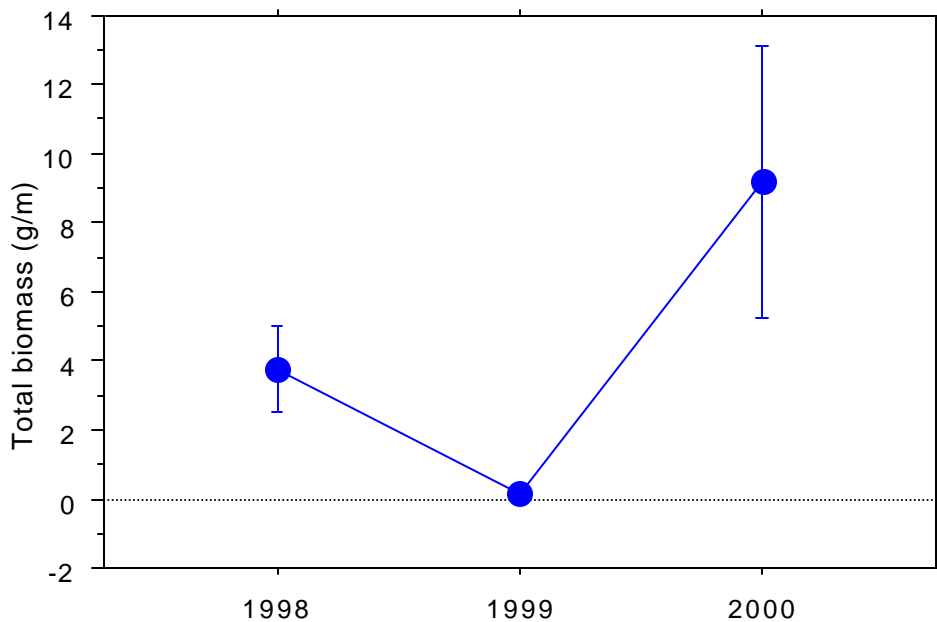
Figure 26: Total standing biomass sampled using multiple pass electrofishing at lower Easkoot Creek, Stinson Beach Park, Marin Co., Summer 1998-2000.

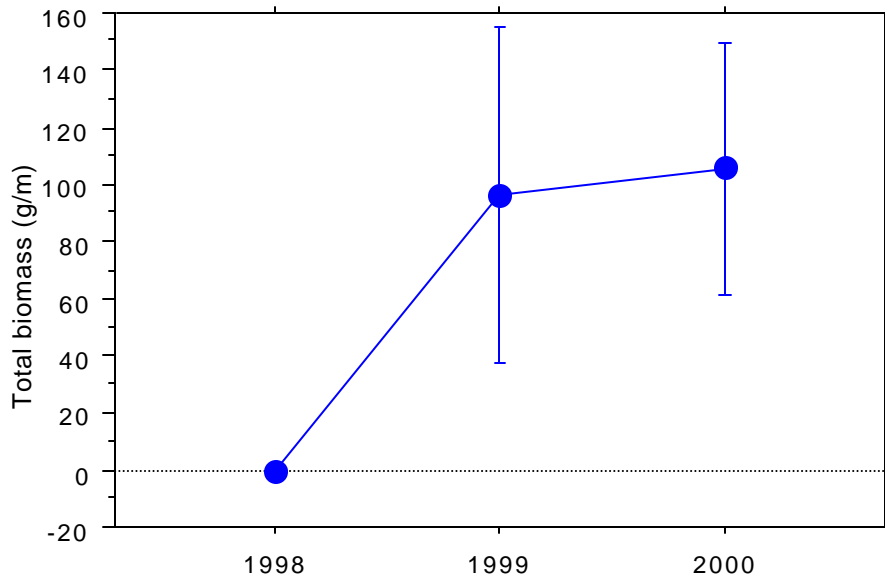
Figure 27: Total standing biomass sampled using multiple pass electrofishing at Laurel Creek, Marin Co., Summer 1998-2000.

Following the creation of step pools in Laurel Creek, mean standing biomass of vertebrates was around 100 g/ linear m for both 1999 and 2000 (Figure 27). This similarity in standing biomass was both astounding and indicative of the

recuperative capacities of aquatic systems after a single disturbance. In October 1999, several months after the August 1999 fish sampling event, heavy water appropriation by the Stinson Beach County Water District caused all pools to dewater and resulted in the mortality of fish. Less than a year later, similar biomass of aquatic animals were present in these areas. However, repeated dewatering events may ultimately overwhelm the recuperative abilities of the system.

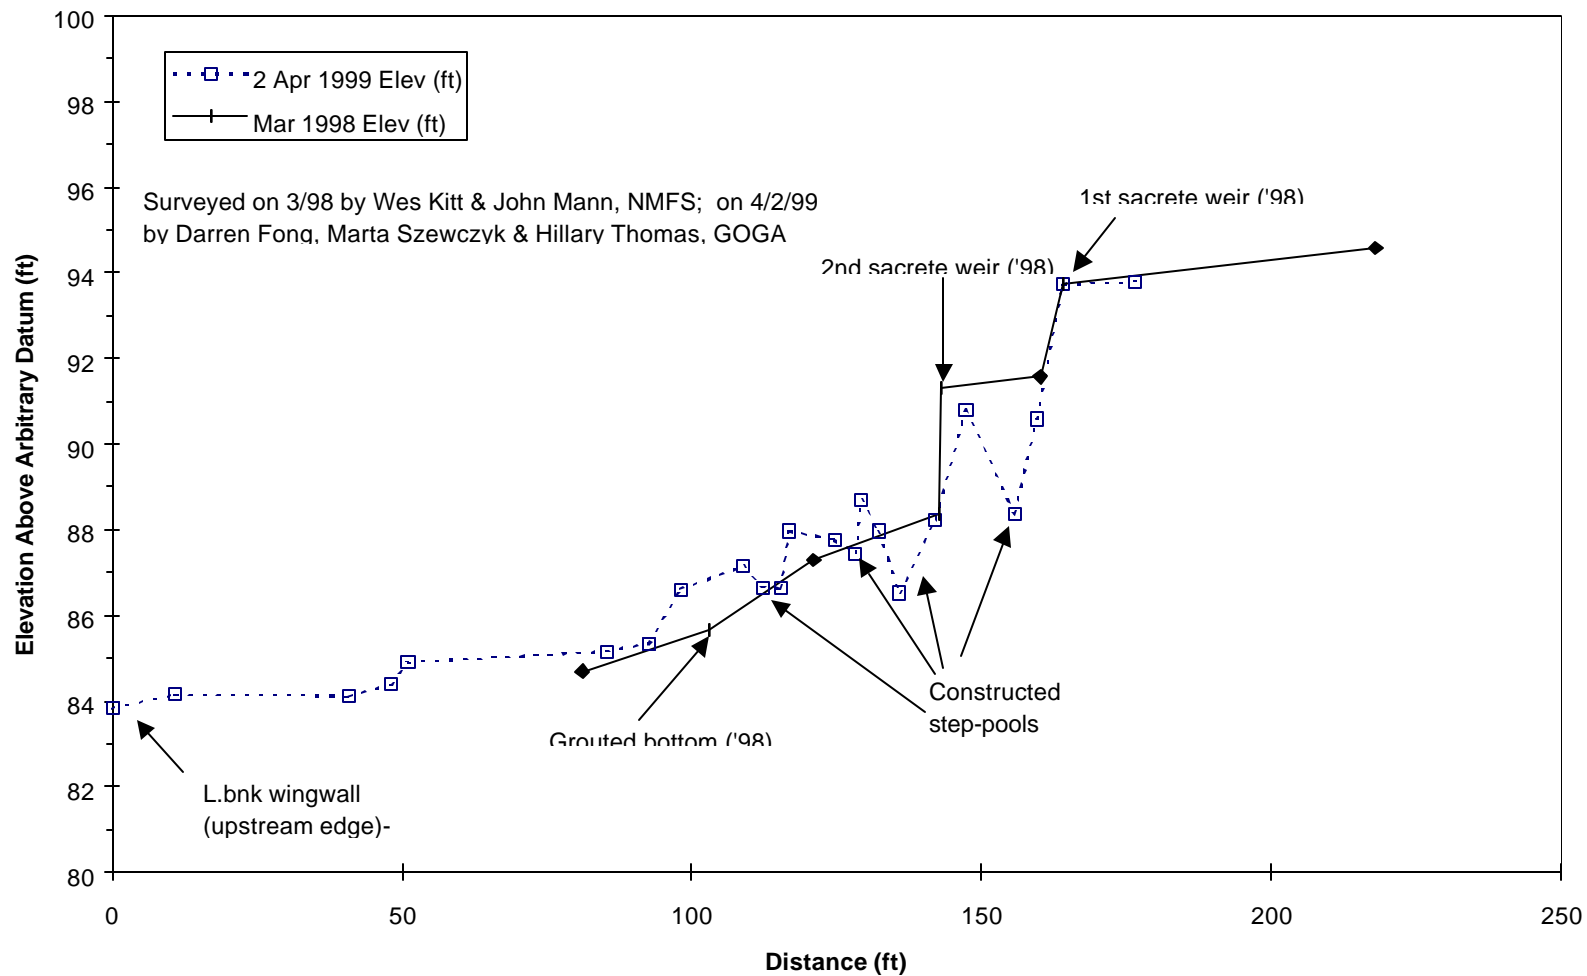
Figure 30: Pre- (3/1998) and Post-Restoration Project (4/2/1999) Longitudinal Profile of Easkoot Creek, Marin Co., CA

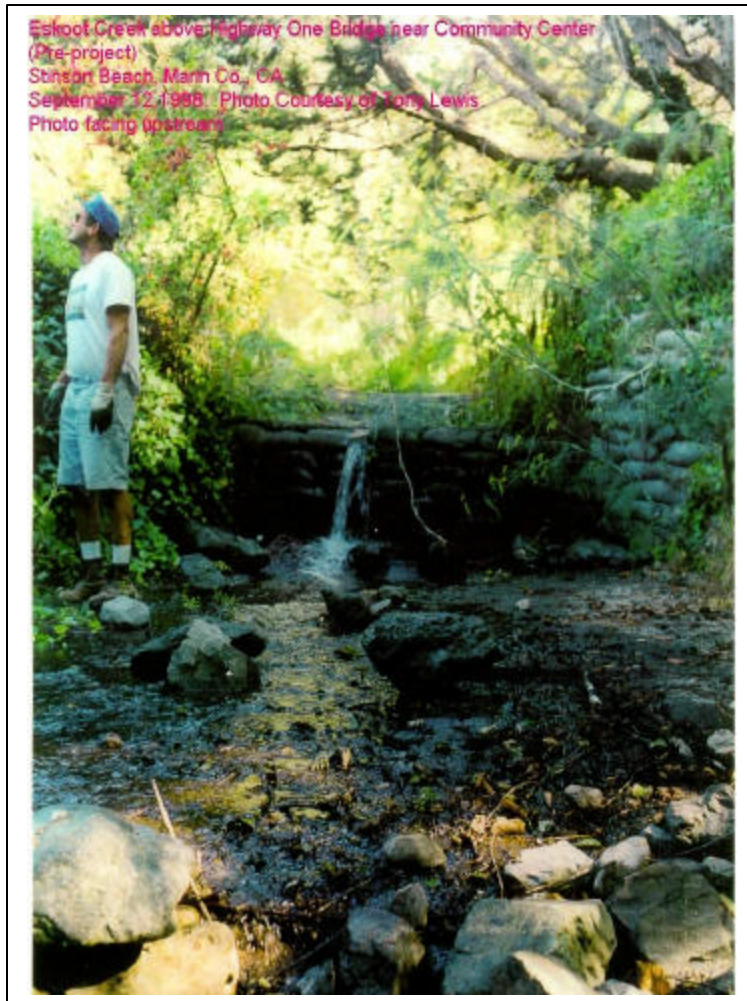
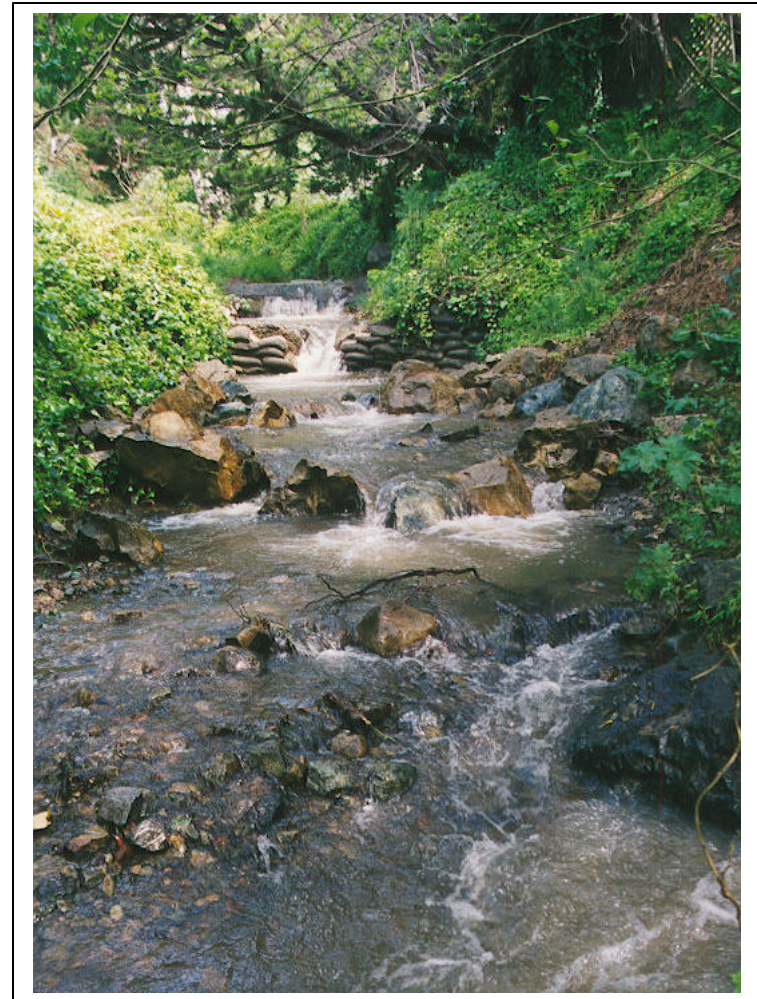
Figure 31: Photo (at left) looking upstream Laurel Creek at sacrete weir and grout structure just prior to construction (September 12, 1998) and photo (at right) looking upstream post-construction (1999) at created step-pools.

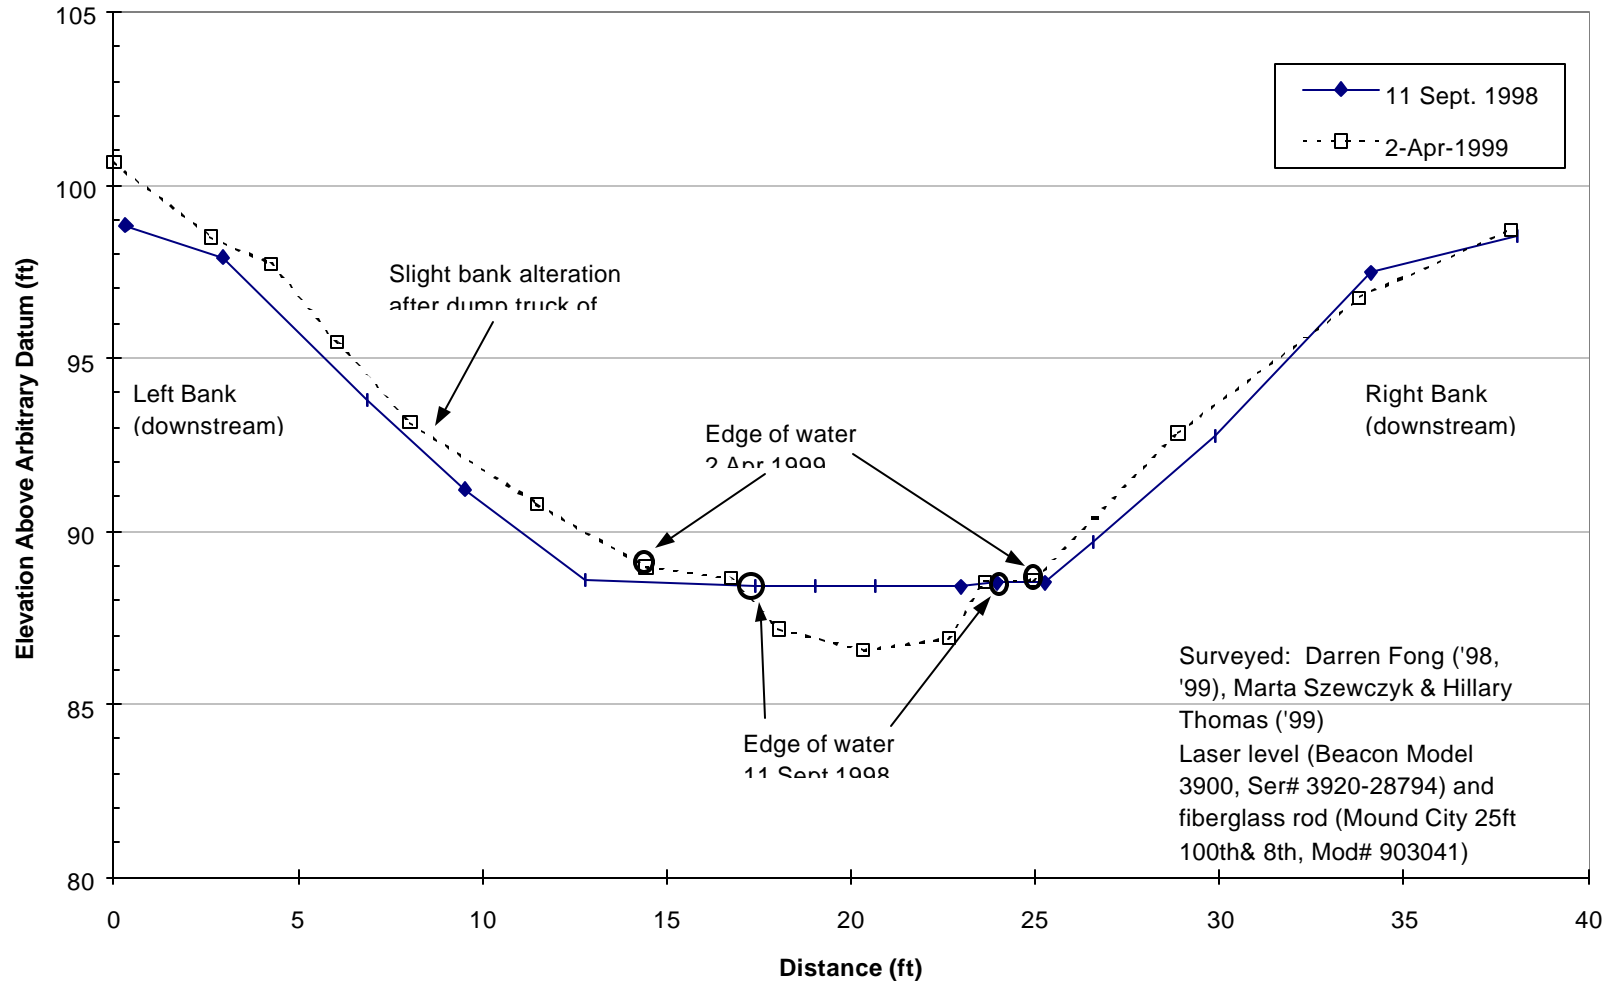
Figure 32: Pre- (3/1998) and Post-Restoration Project (4/2/1999) cross-section of Easkoot Creek at the Community Center above Highway 1, Marin Co.

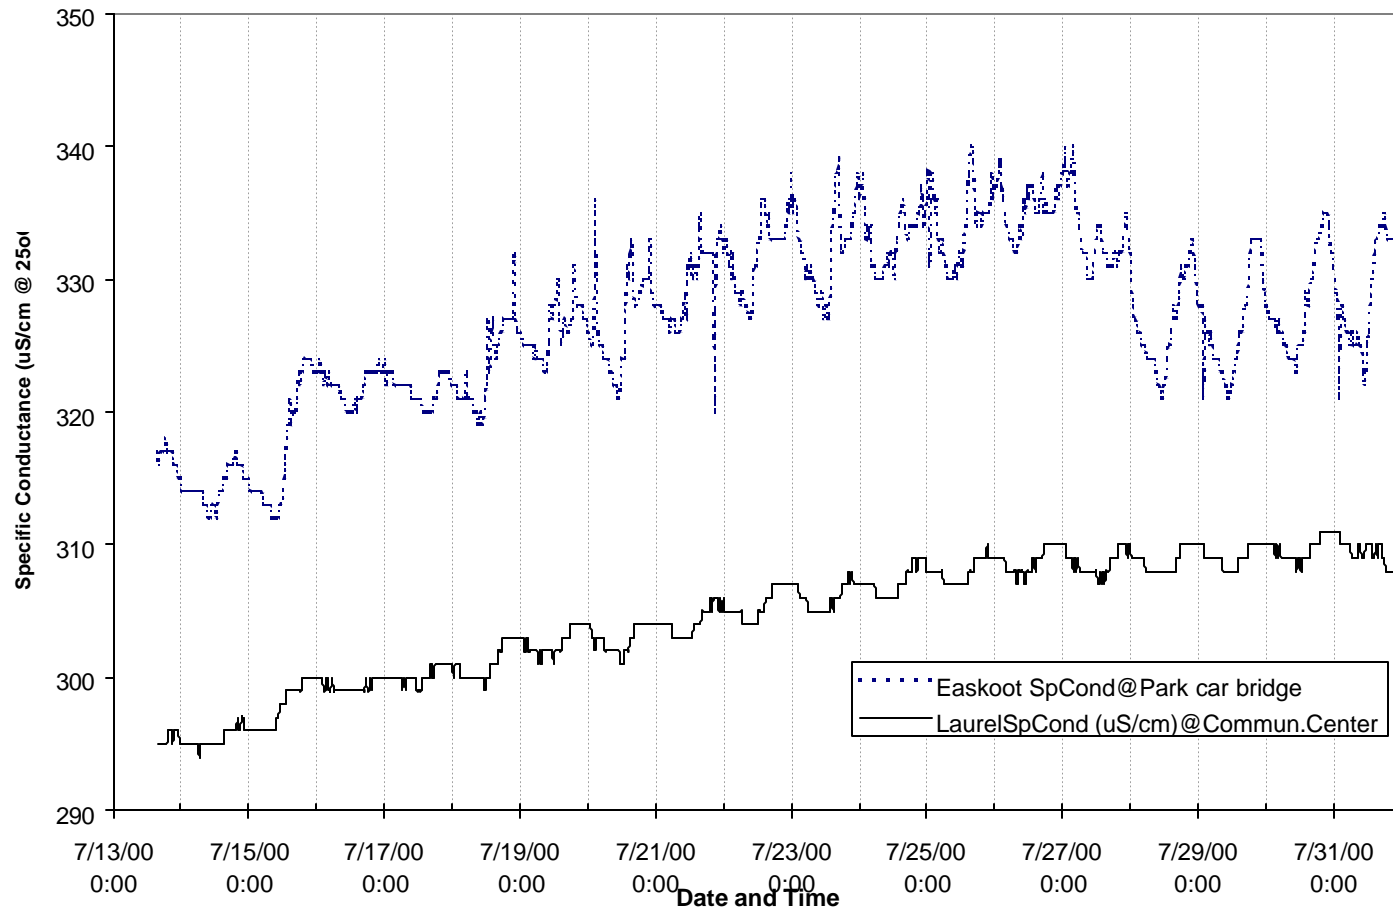
Specific conductance at Laurel and Easkoot Creek Sampling Stations, Marin Co., July 2000

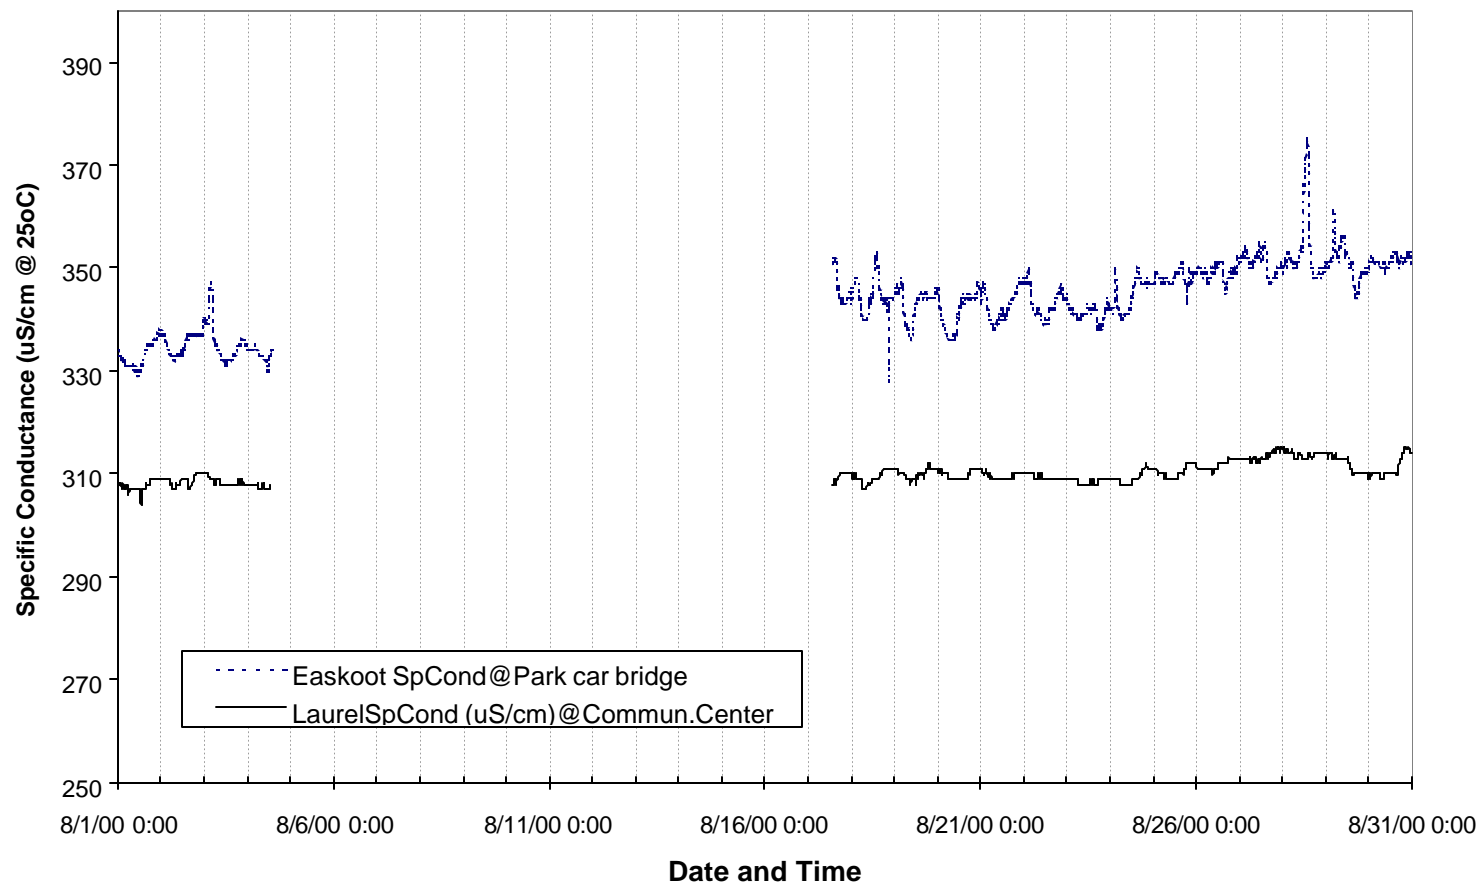
Specific conductance at Laurel and Easkoot Creek Sampling Stations, Marin Co., August 2000

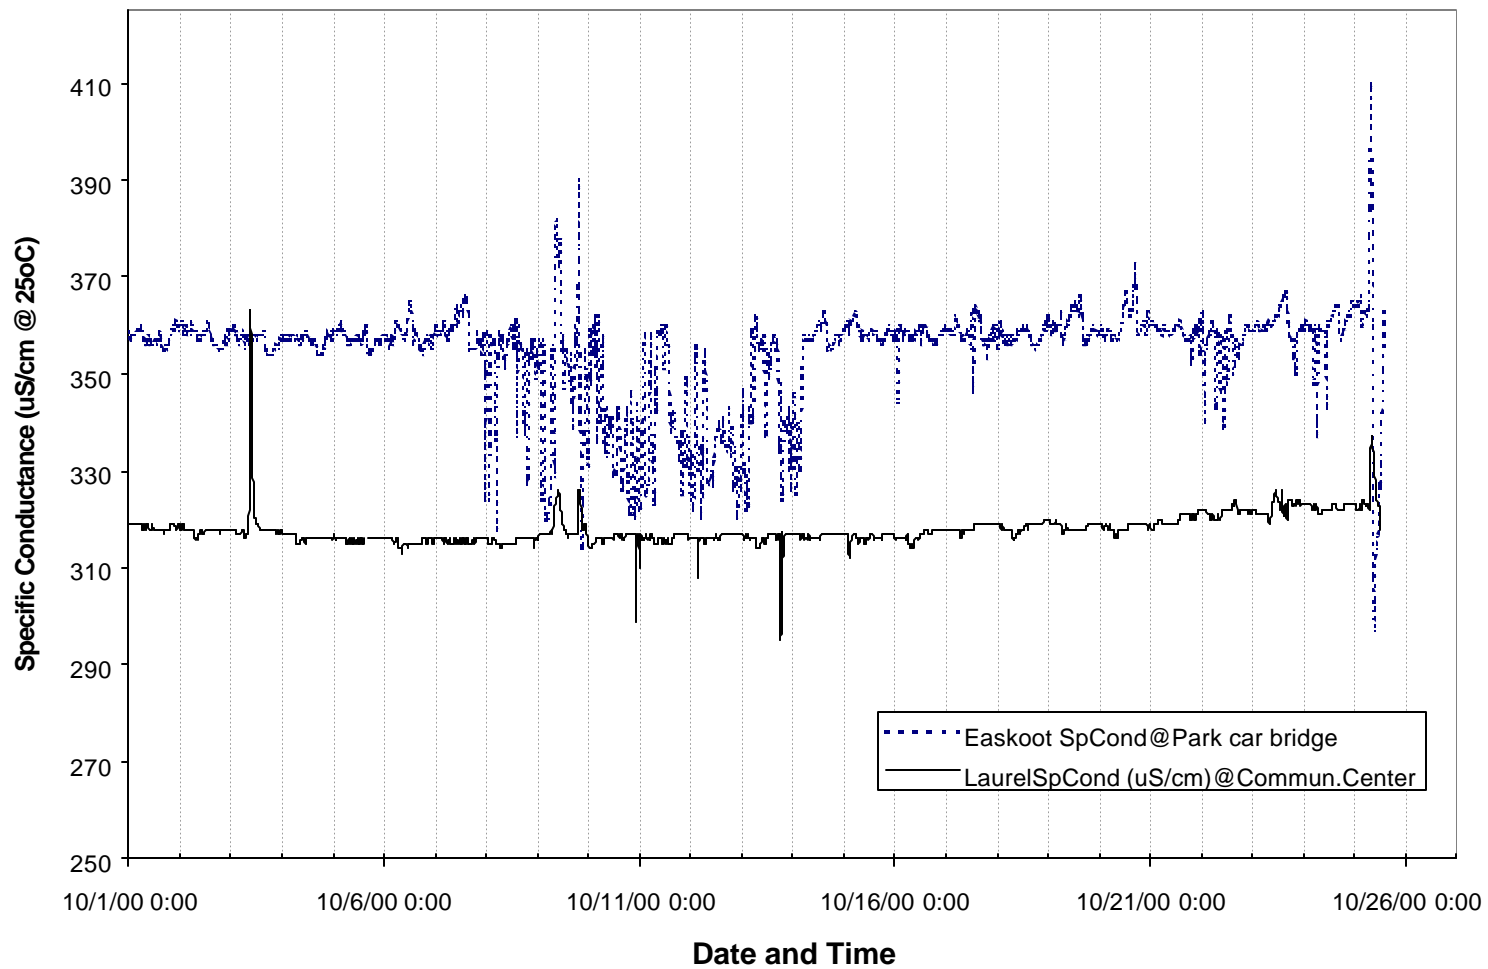
Specific conductance at Laurel and Easkoot Creek Sampling Stations, Marin Co., October 2000
