# Upper Russian River Steelhead Distribution Study

**Sonoma County Water Agency**  
2150 West College Avenue  
Santa Rosa, California 95401

Prepared by  
David Cook – Senior Environmental Specialist

March 2003

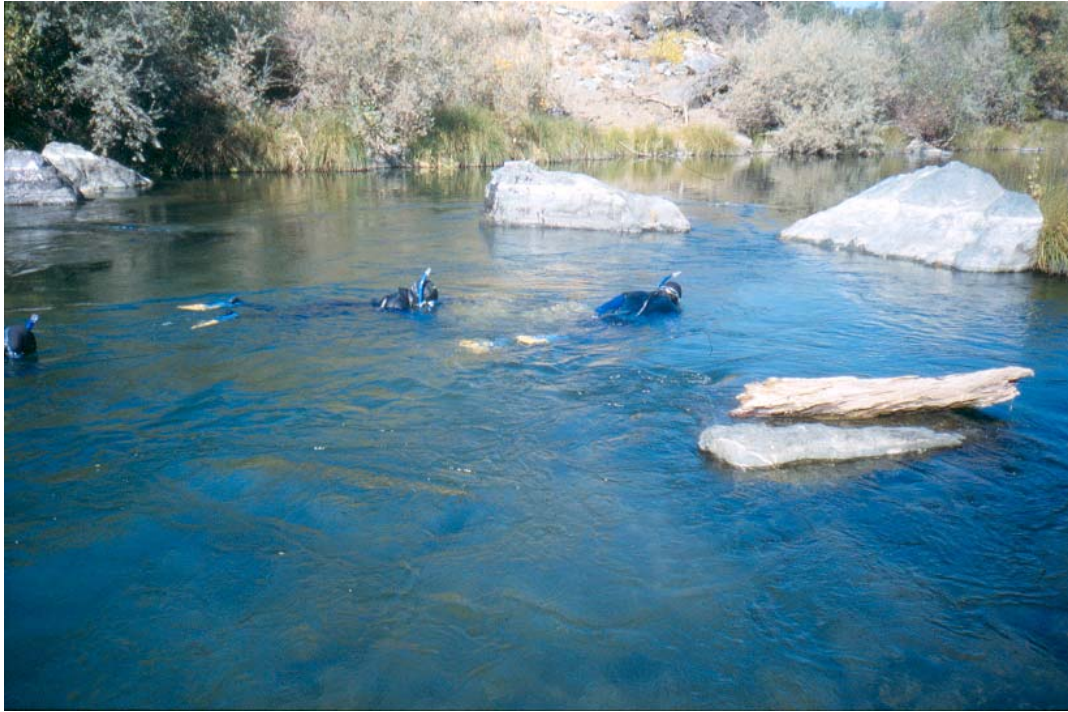
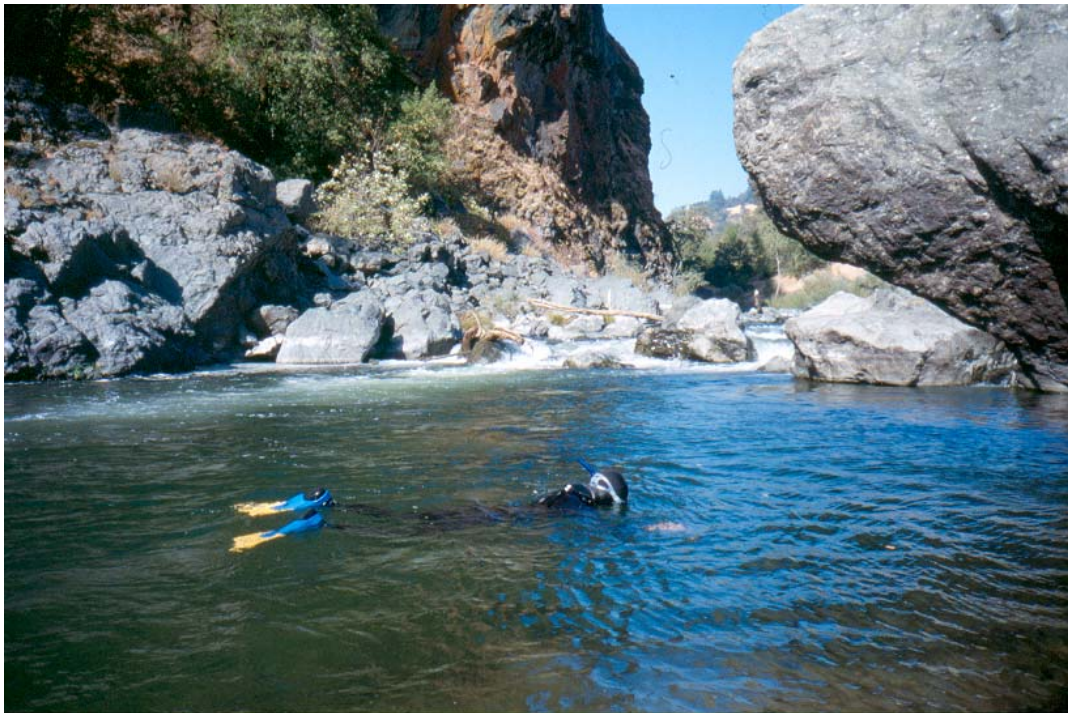
Figure 2: Dive survey techniques. Divers identified and counted all fish species observed during visual underwater surveys.

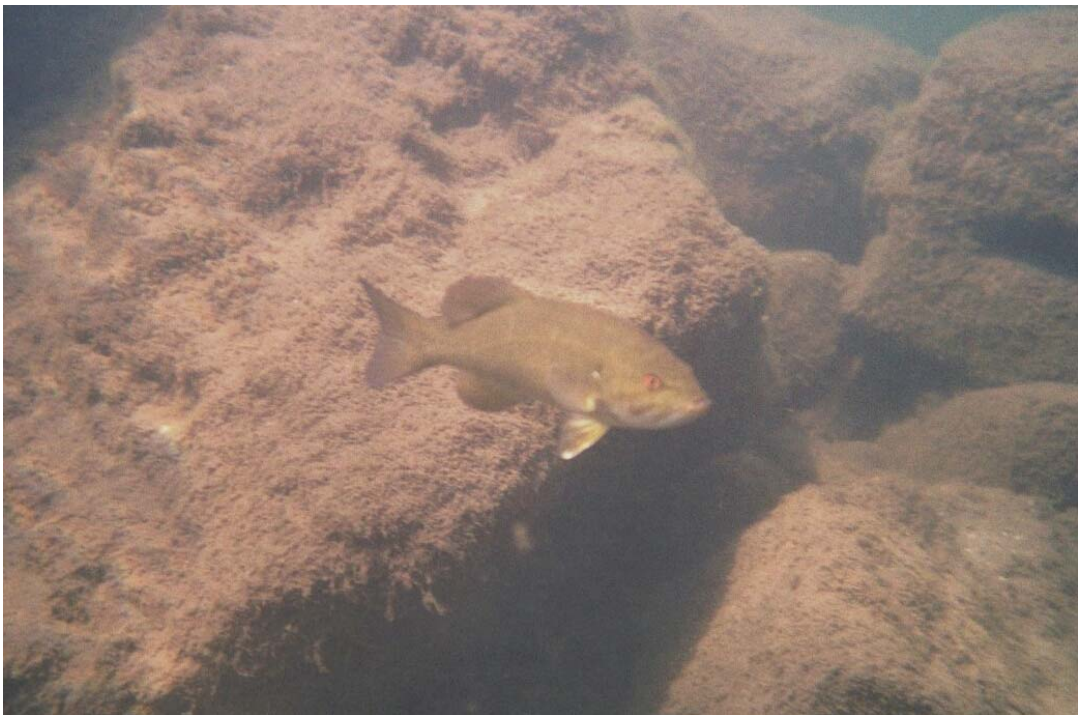
Figure 3: Fish in flatwater habitats. Pikeminnow and Russian River tuleperch (top) and smallmouth bass (bottom) observed during dive surveys.

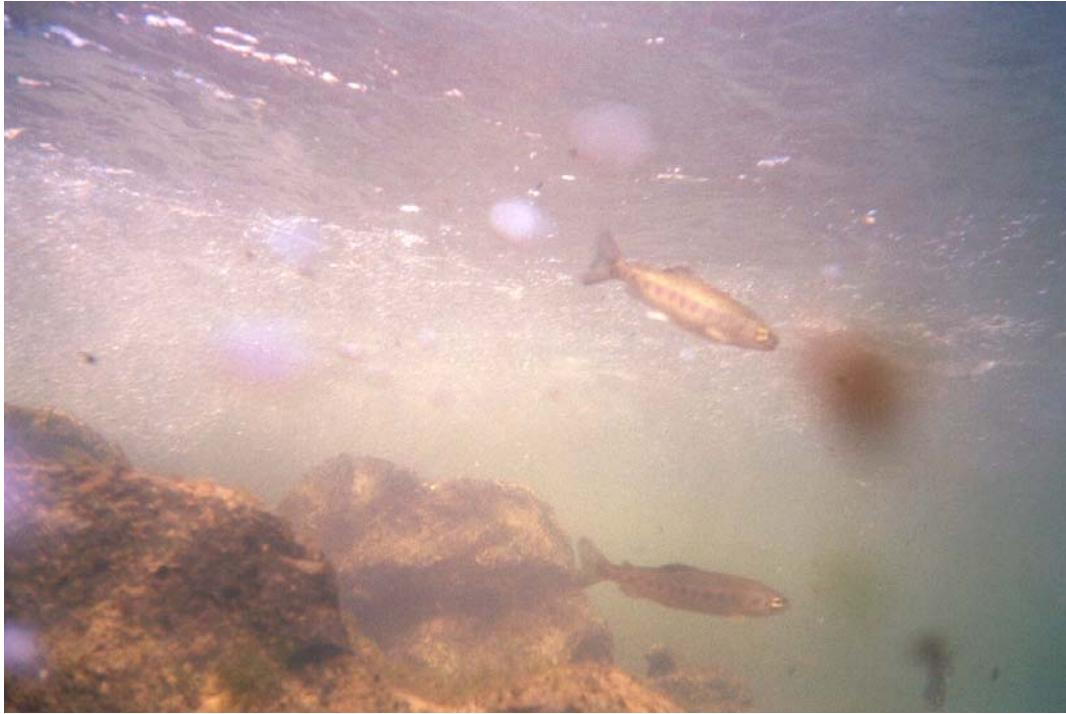
Figure 4: Fish in riffle habitats. Young steelhead (top) and Sacramento sucker (bottom) observed in fast-moving flows in the Canyon reach.

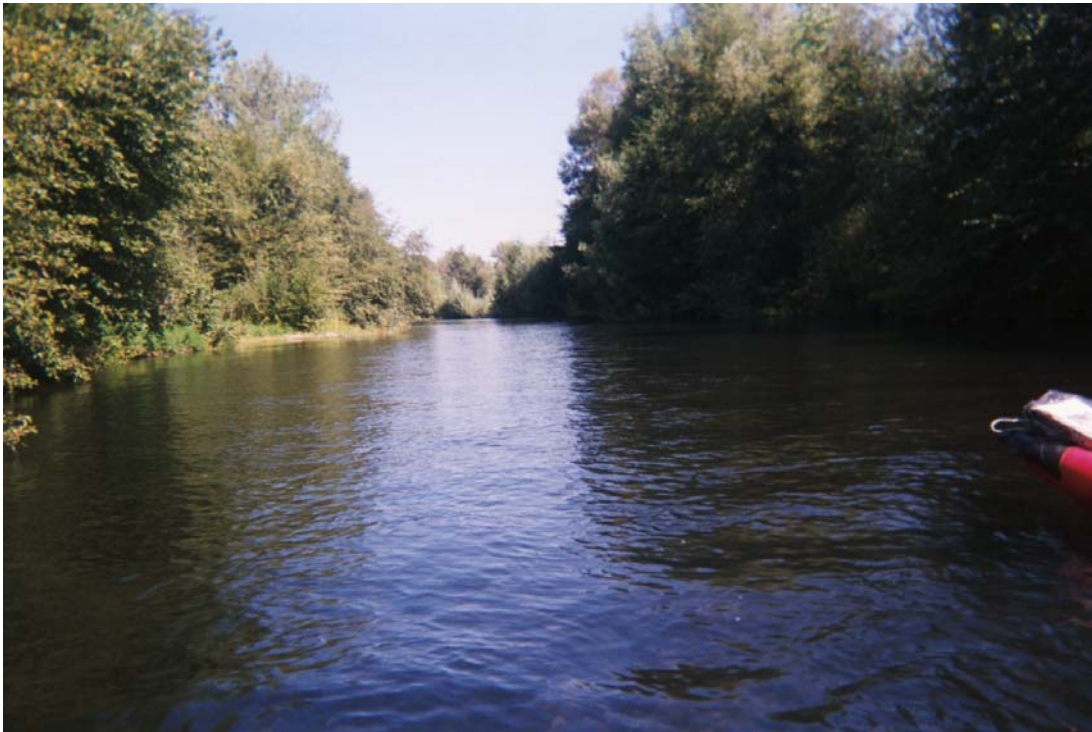
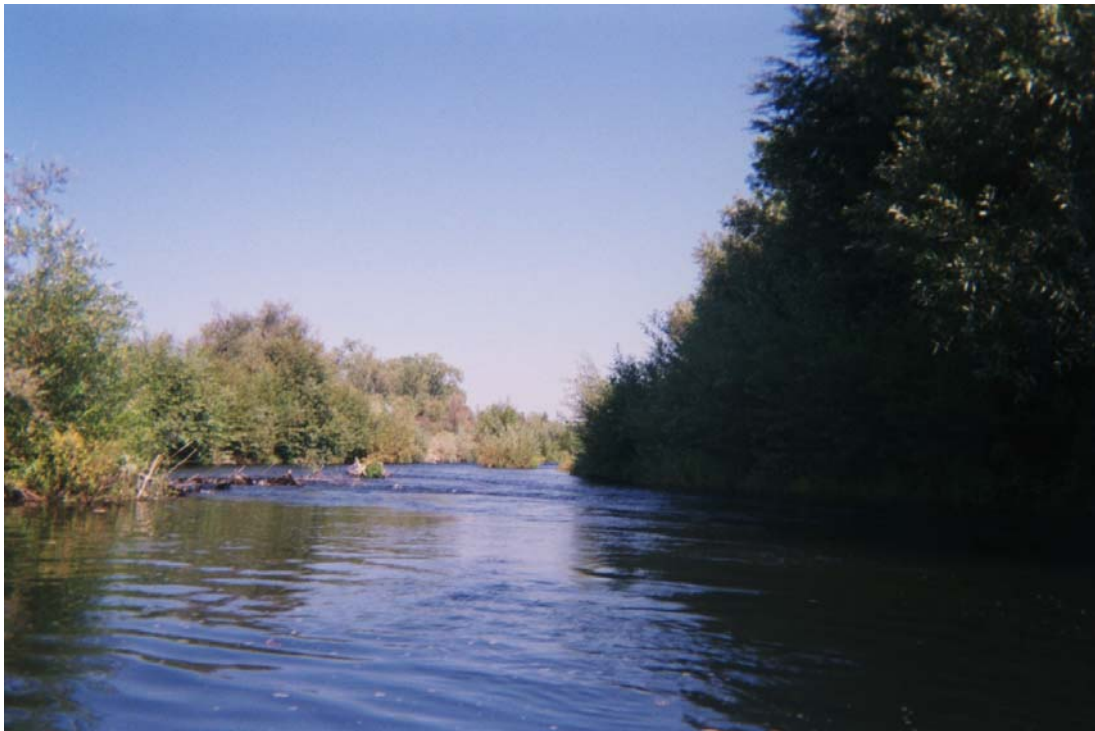
Figure 5: Ukiah Reach, Segment U1. This segment has a well-developed riparian cover and contained 25% riffle habitat. Most of the 55 steelhead observed in this segment were found in riffles.

habitats (Figures 11 and 12). Segment U1, where 55 steelhead were observed, contained cascade habitat and the highest percentage of riffle habitat in the reach. Segment U2 contained the third highest percentage of riffle and 7 steelhead were counted. Segment U4 had the largest count of steelhead at 161, contained riffle habitat, and the highest percentage of cascade habitat located at Norgard Dam. As shown in Figure 12, 3 steelhead age groups were present in the reach and most steelhead were 1+ fish (64%) followed by young-of-the-year (35%) and 2+ fish (1%). The disproportionately high frequency of 1+ fish suggests a relatively large population of resident steelhead.

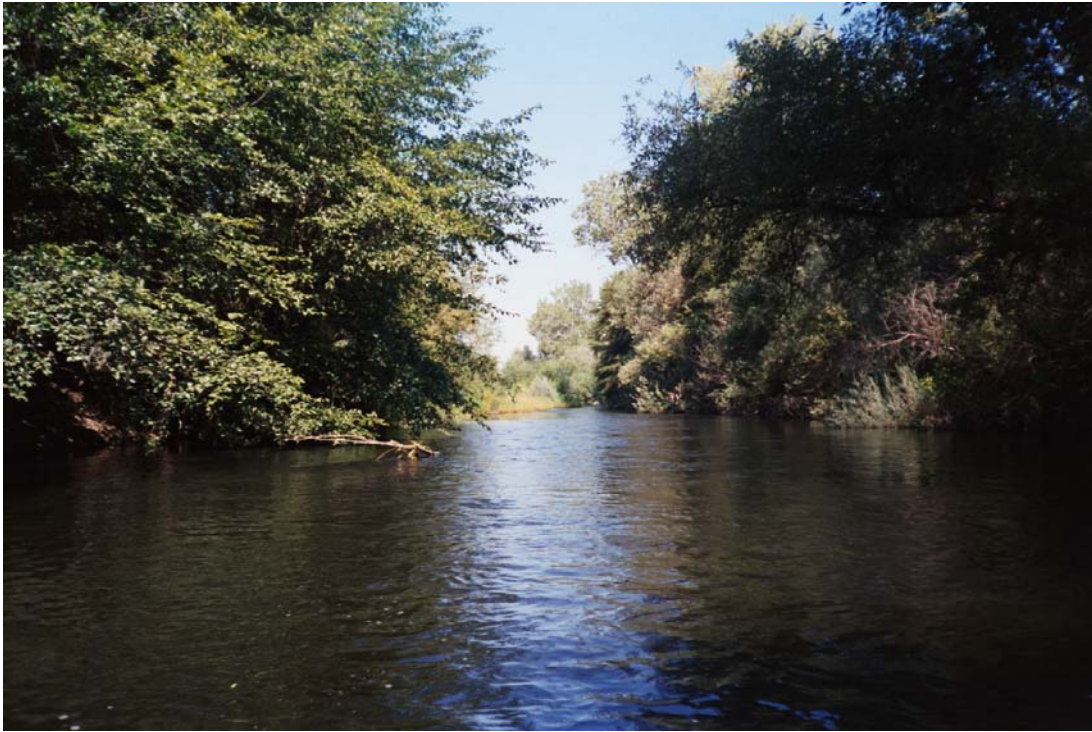
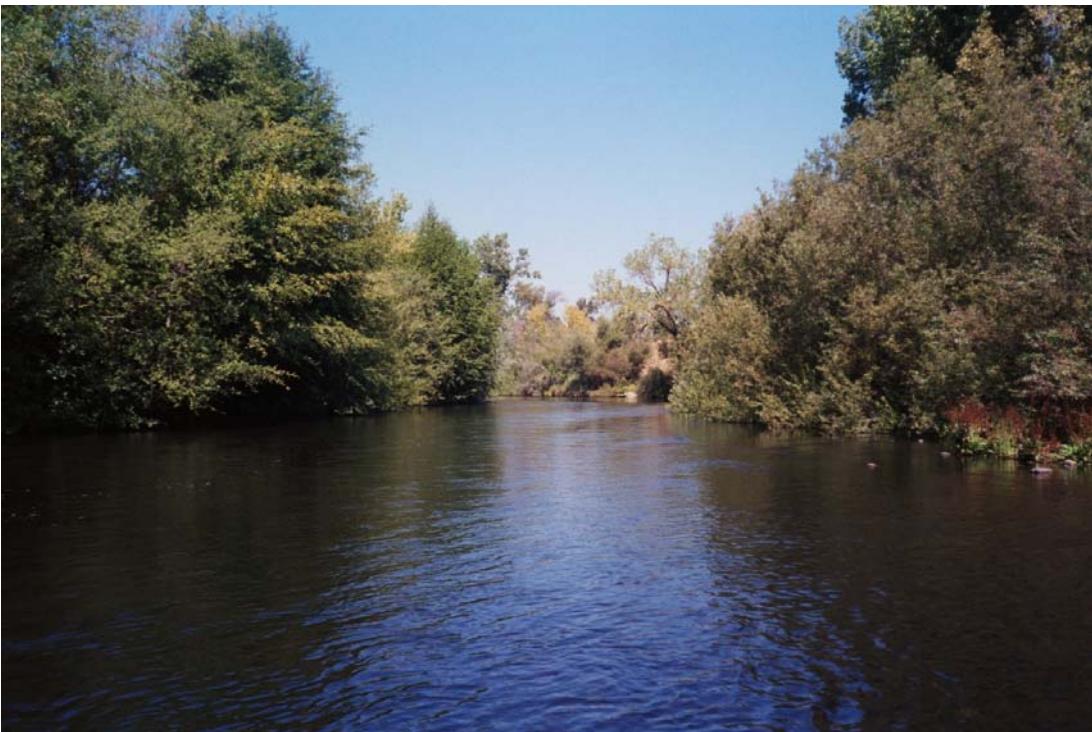
Figure 6: Ukiah Reach, Segment U2. This segment has a well-developed riparian cover, contained 7% riffle habitat, and a total of 7 steelhead were observed.

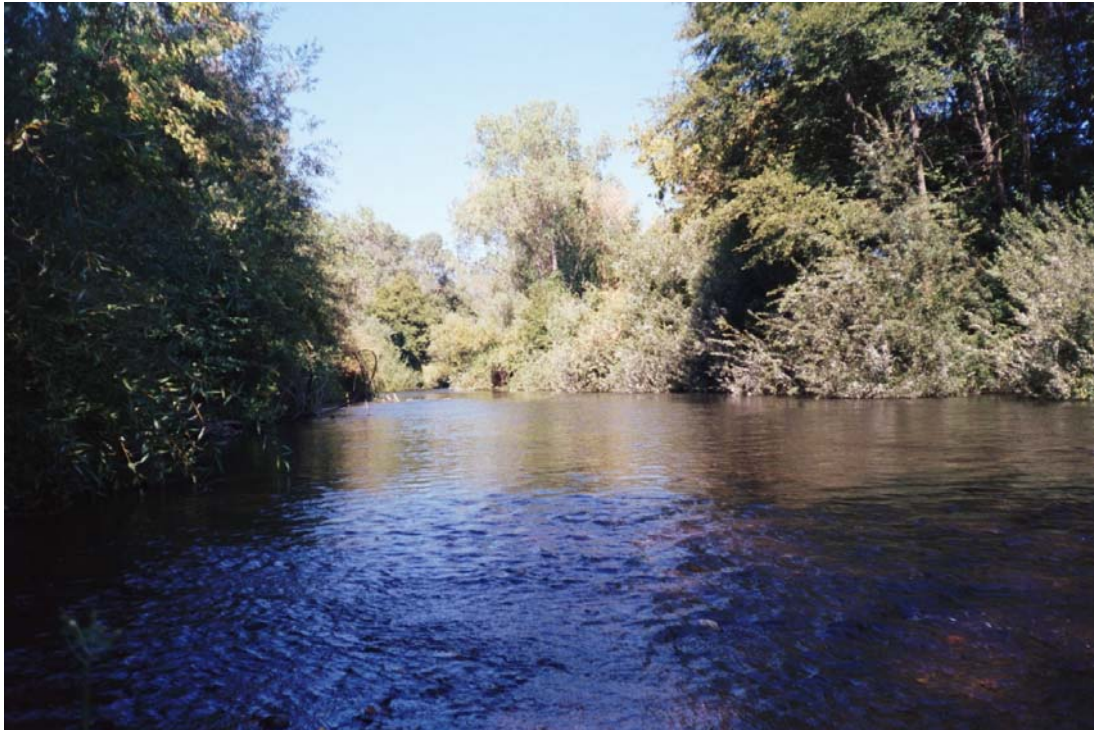
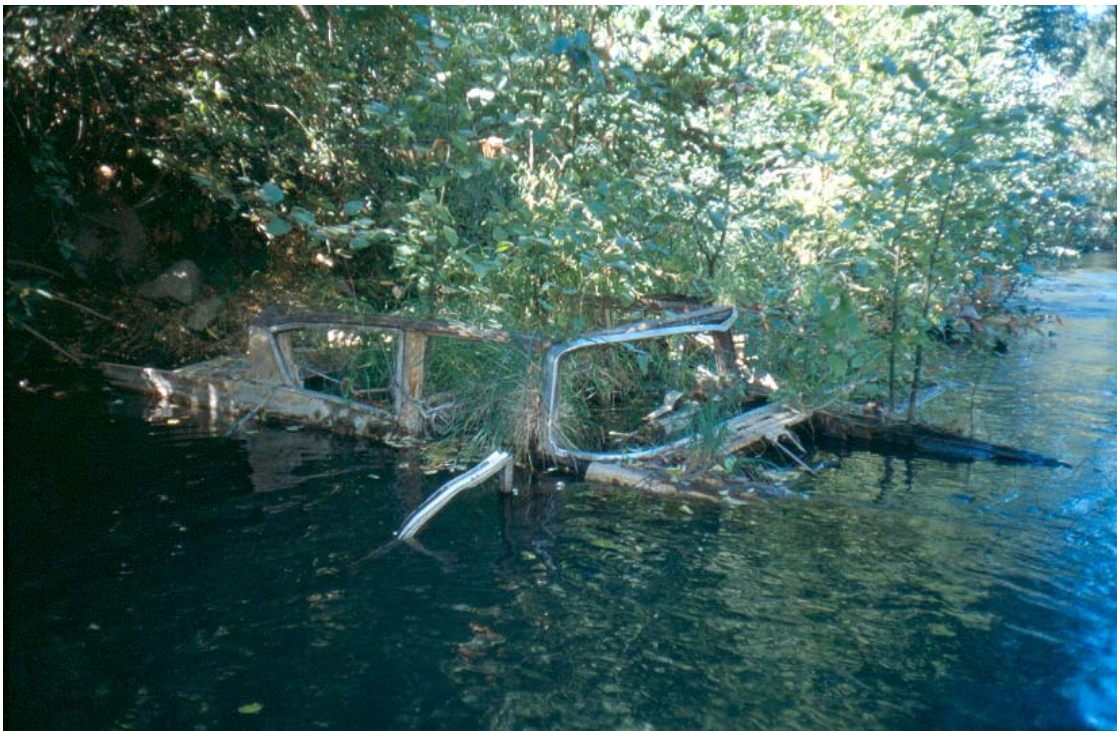
Figure 8: Ukiah Reach, Segment U4. This segment contained primarily flatwater habitat with well-developed riparian vegetation (top). Also, typical in this reach are past erosion control attempts that included lining the banks with automobile bodies (bottom).

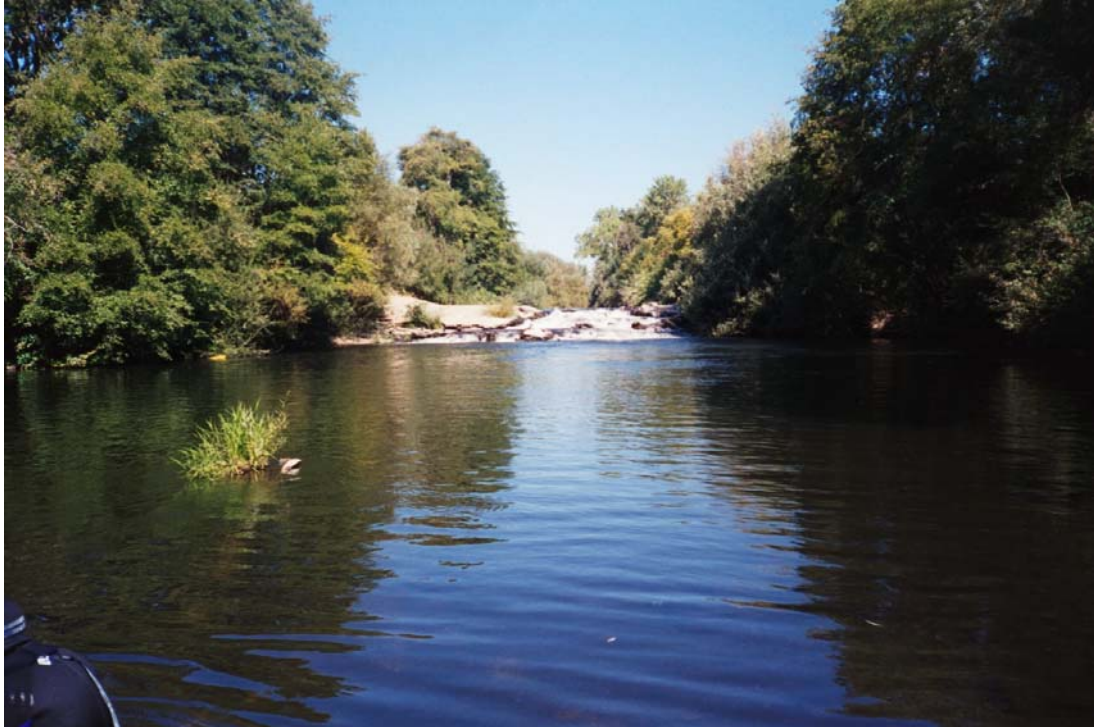
Figure 9: Ukiah Reach, Segment U4, Norgard Dam. This segment contained artificial cascade and riffle habitats at the Norgard Dam and downstream weir. A deep pool is located below the dam (top). Most of the 161 observed steelhead were found in the artificial cascade habitat at the dam (bottom).

The habitat characteristics in the survey segments ranged from a mosaic of well-developed riparian forest along an incised channel to a moderately broad channel with exposed gravel bars and adjacent riparian forest. Flatwater was the dominant habitat throughout the reach and consisted of 94% of the sampled reach, while other habitats included 0.8% deep pool, 5% riffle, and 0.2% cascade (Figure 2). Fastwater habitat (i.e., riffle and cascade) occurred in the upper portion of the reach while the lower reach was entirely flatwater (Figure 11). Cascade habitat occurred in 2 segments, including the upstream end of the reach at U1 and at the Norgard Dam located in U4. The cascade at Norgard Dam consisted of riprap boulders and concrete slabs below the dam (see Figure 9 of the Appendix). Deep pool habitat was concentrated in the central portion of the reach and the largest pool was located below Norgard Dam. The 4 downstream segments (U9-U12) consisted entirely of flatwater habitat.

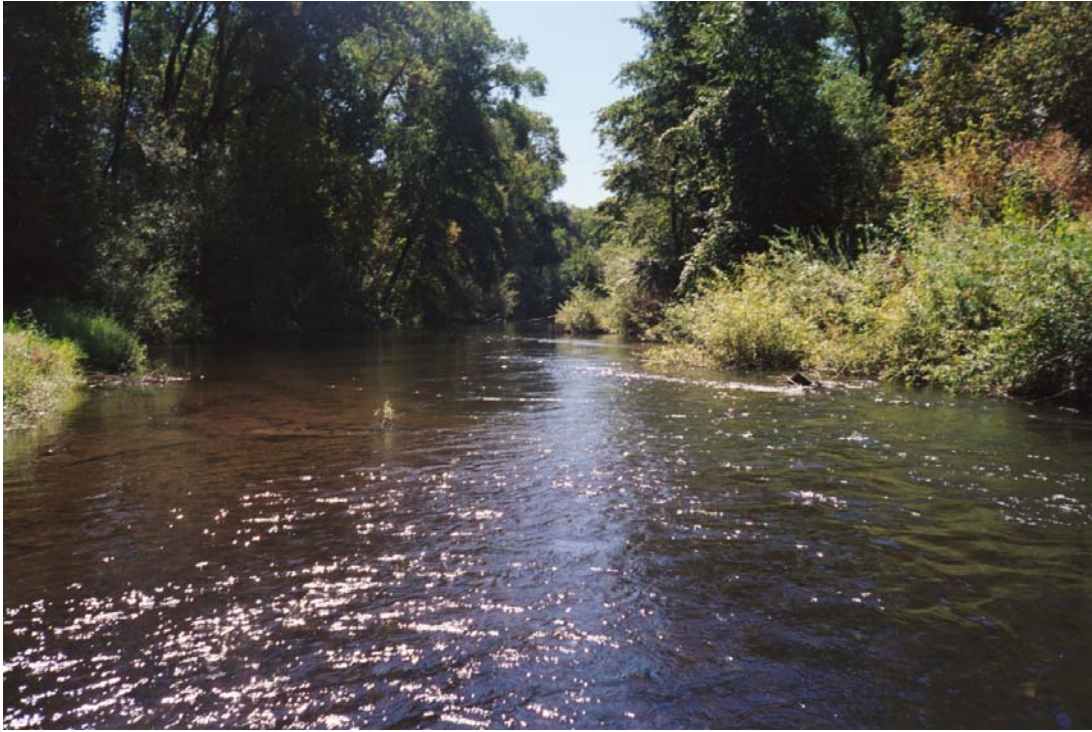
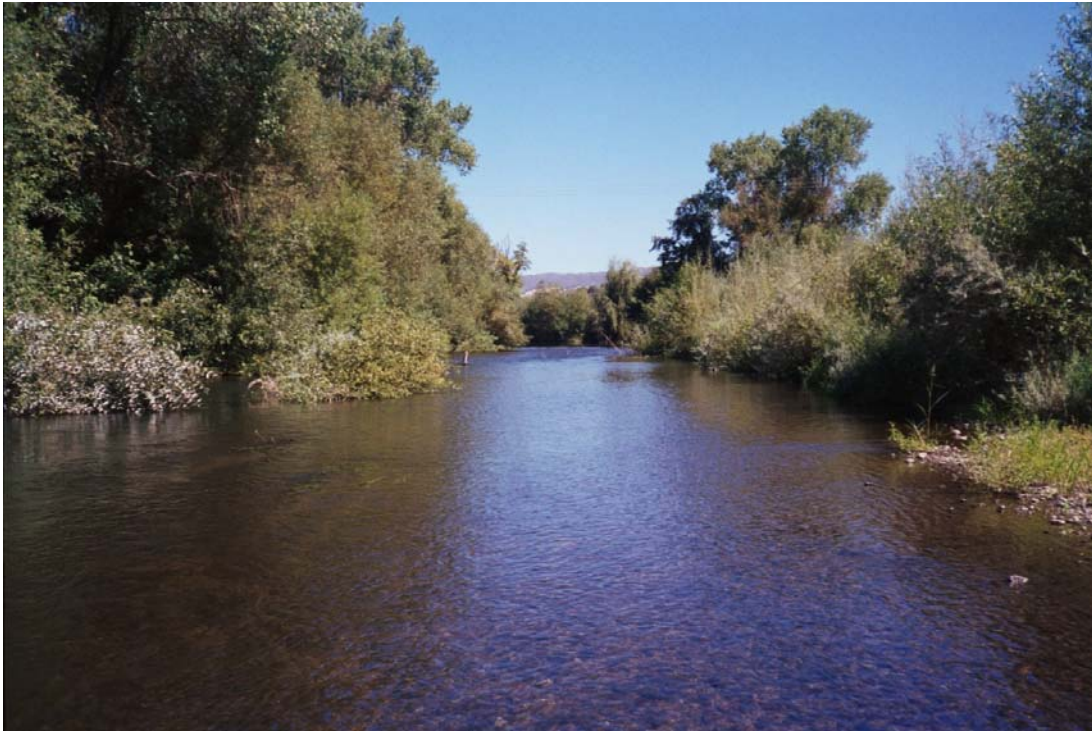
Figure 11: Ukiah Reach, Segment U6. This segment contained 97% flatwater, 1% riffle, and 2% deep pool habitats. No steelhead were observed.

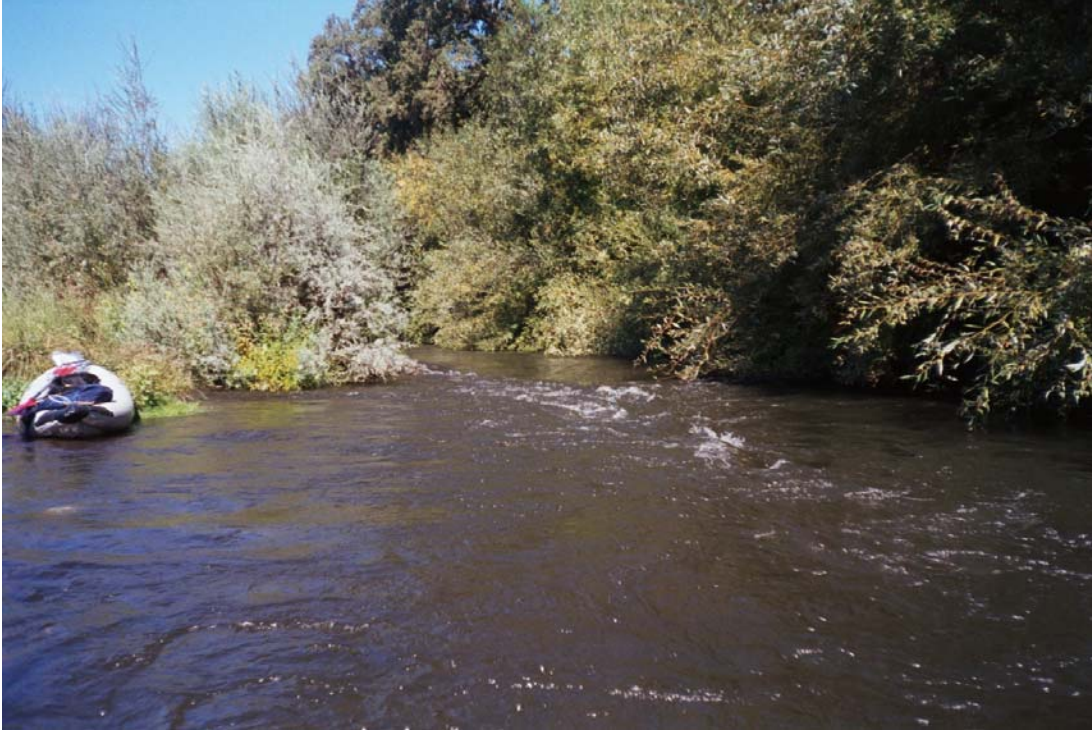
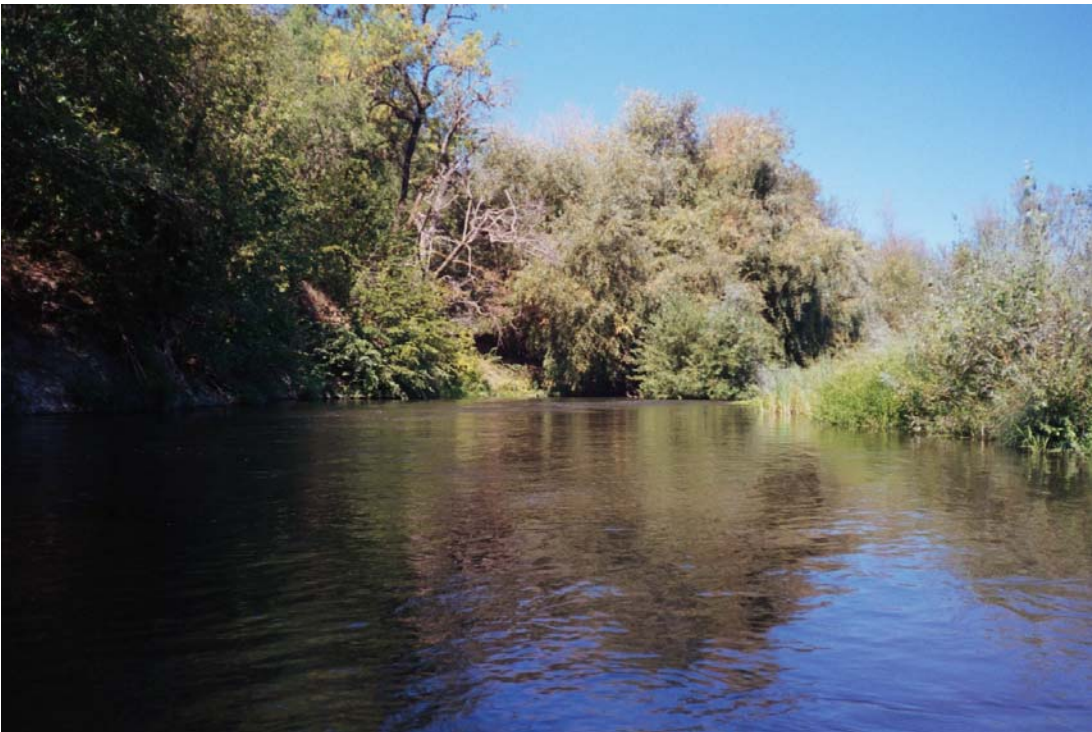
Figure 12: Ukiah Reach, Segment U7. This segment contained 91% flatwater (bottom) and 9% riffle (top) habitats. No steelhead were observed.

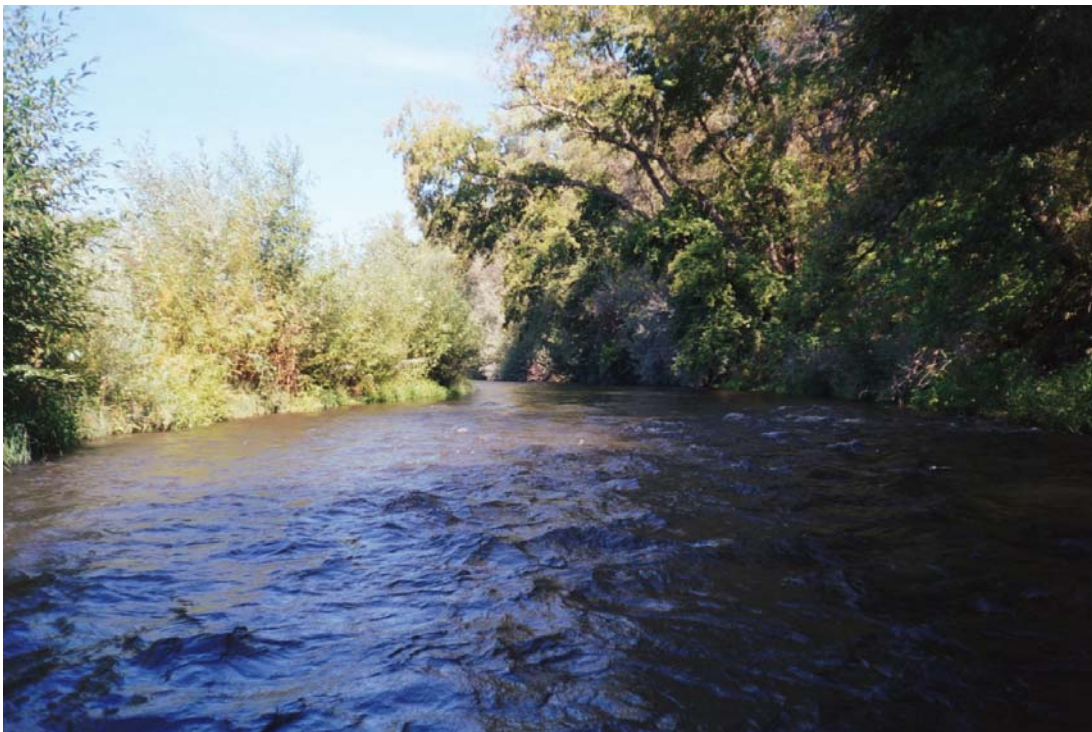
Figure 13: Ukiah Reach, Segment U8. This segment contained primarily flatwater habitat with a well-developed riparian canopy. No steelhead were observed.

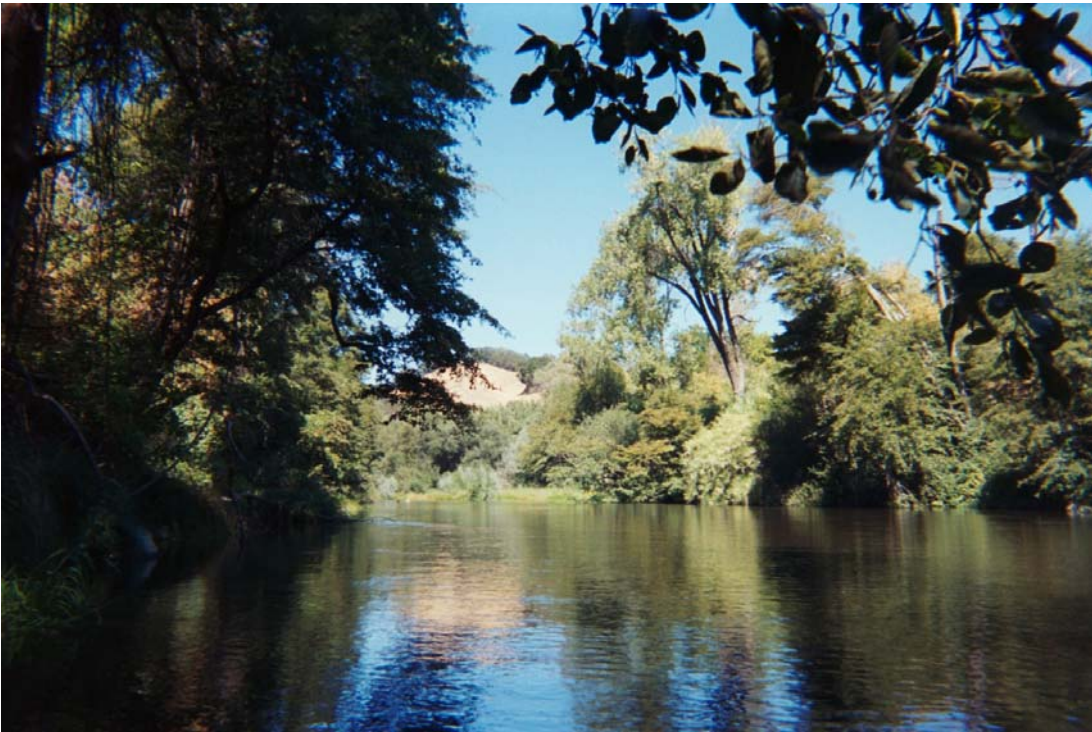
Figure 14: Ukiah Reach, Segment U9. This segment consisted entirely of flatwater habitat with vegetated gravel bars (top) and well-developed riparian canopy (bottom). No steelhead were observed.

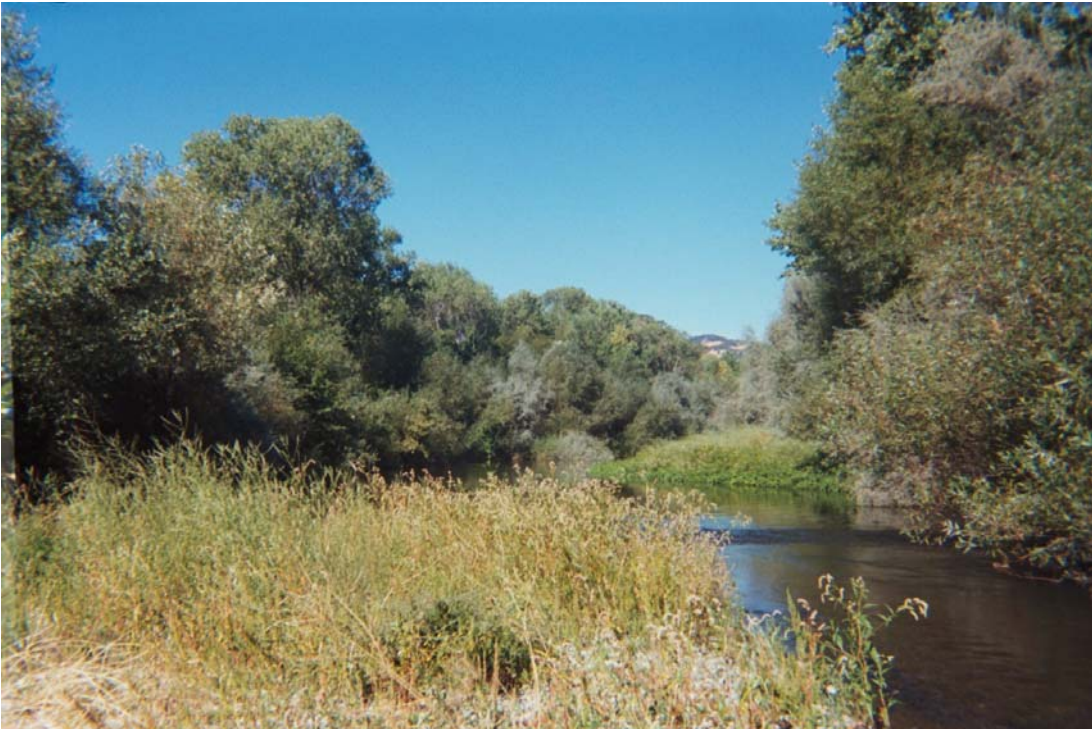
Figure 15: Ukiah Reach, Segment U10. This segment contained entirely flatwater habitat with well-developed riparian canopy (top) and broad vegetated gravel bars (bottom). No steelhead were observed.

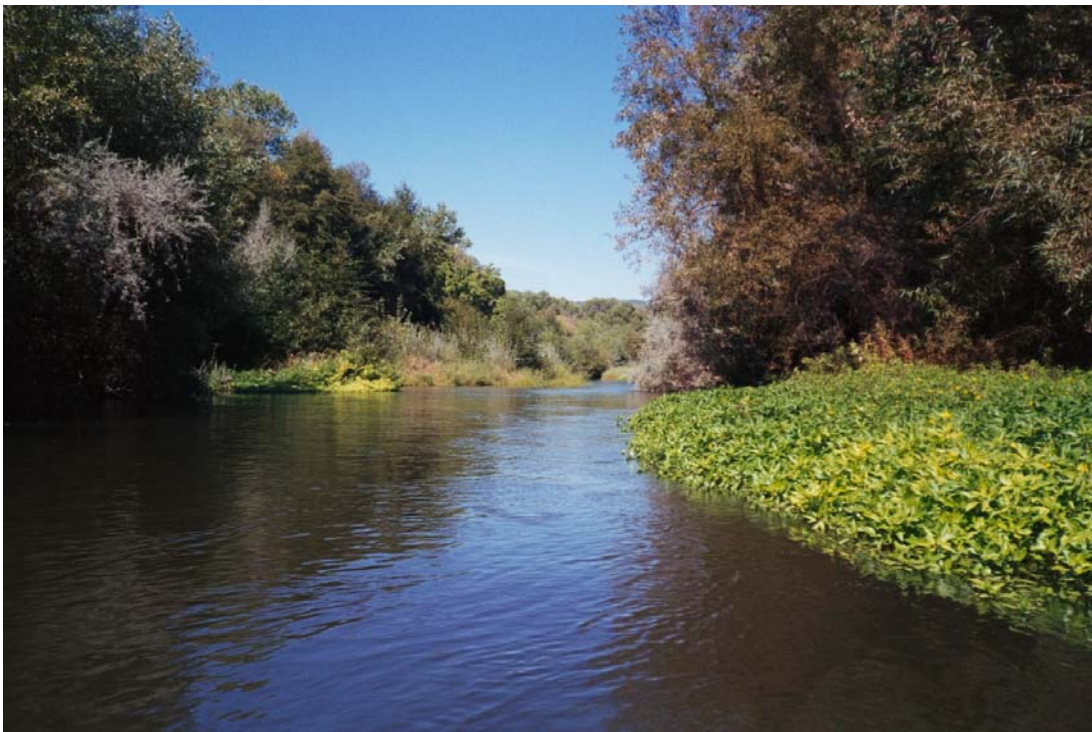
Figure 16: Ukiah Reach, Segment U11. This segment contained entirely flatwater habitat with open to dense riparian canopy and gravel bars vegetated with sandbar willow and water primrose. One steelhead was observed in this segment.

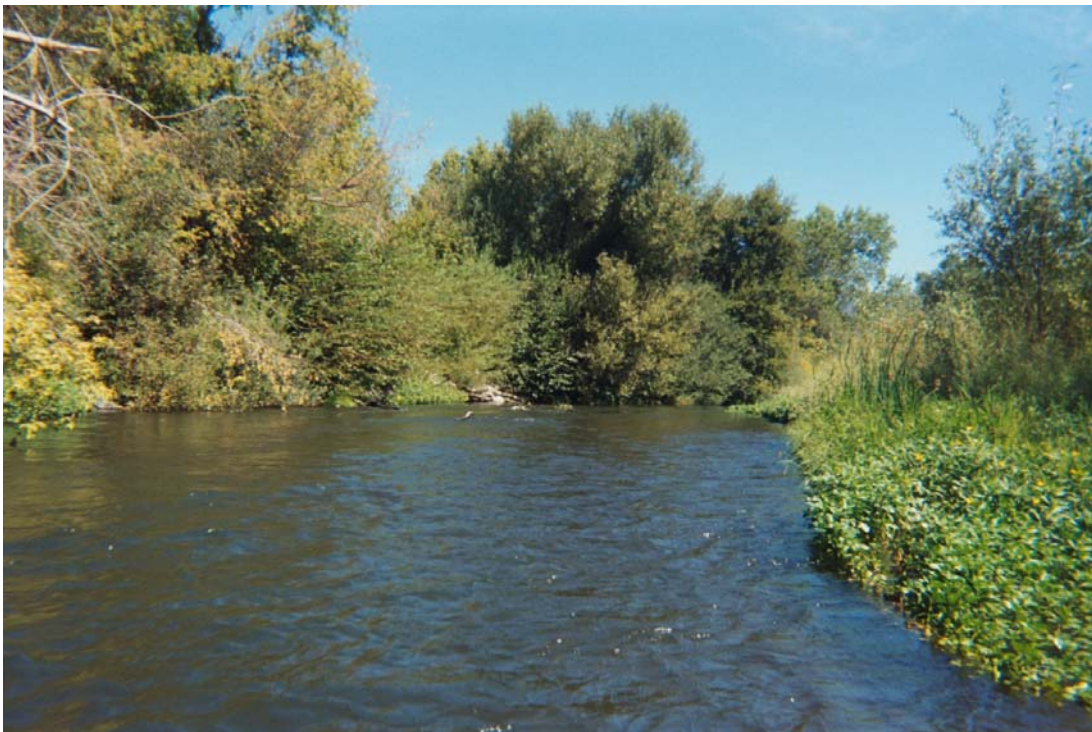
Figure 17: Ukiah Reach, Segment U12. This segment contained moderately fast-moving flatwater habitat. No steelhead were observed.

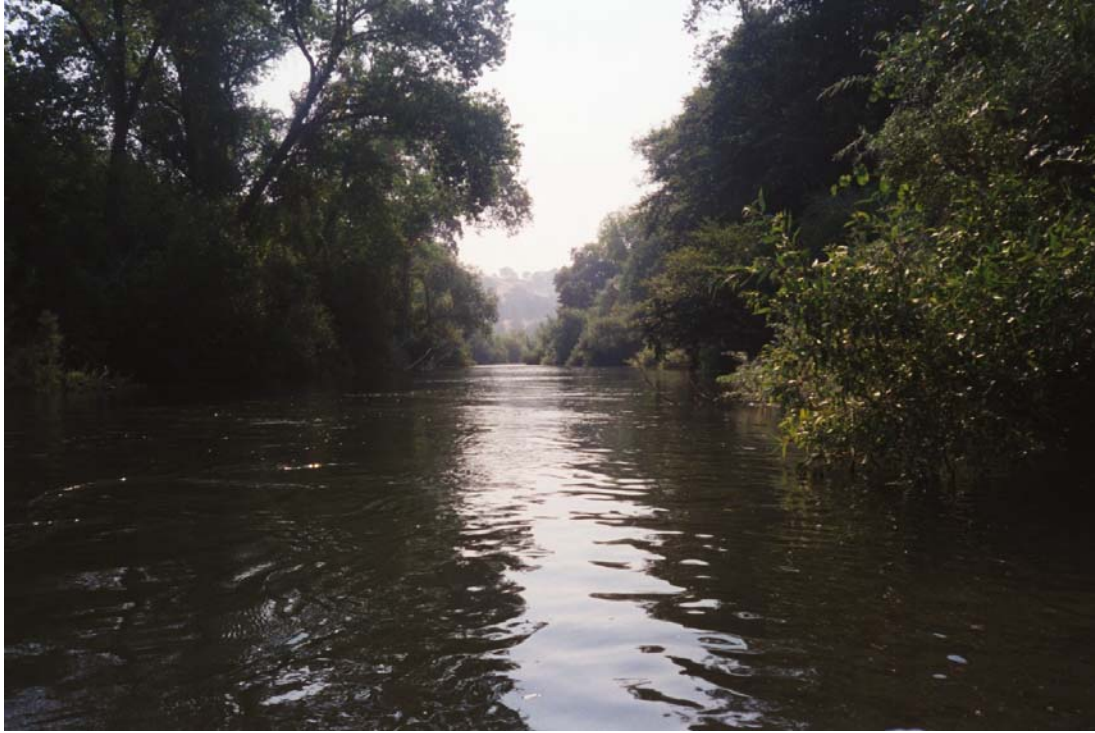
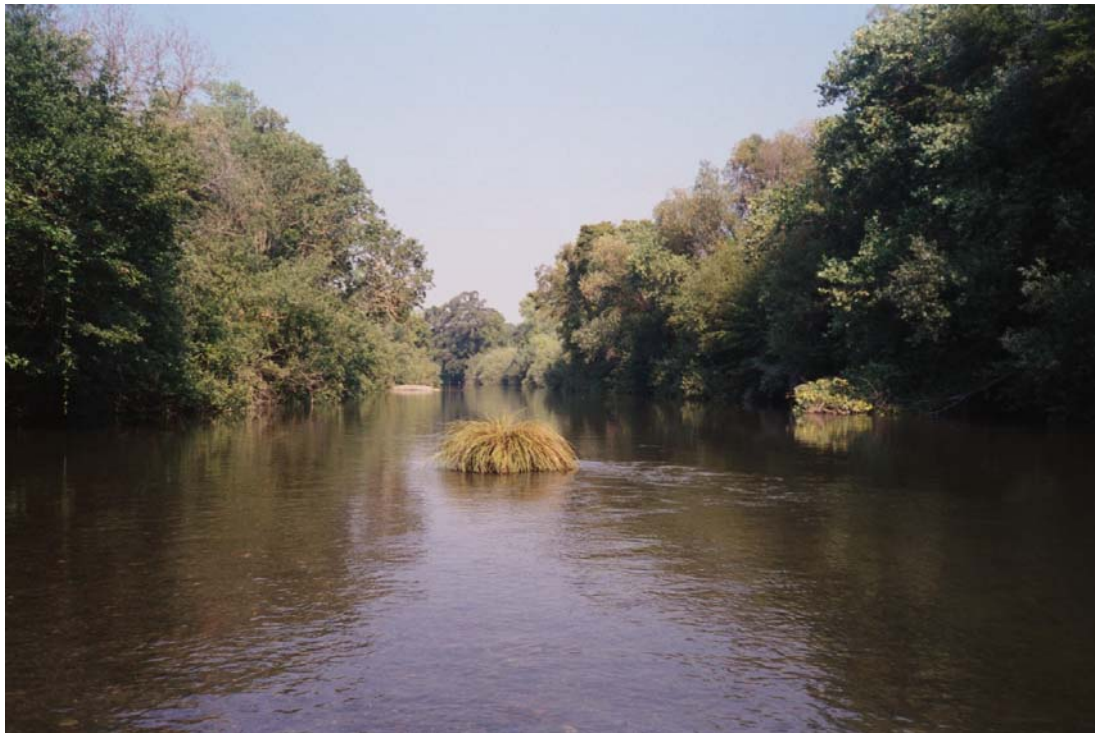
Figure 18: Canyon Reach, Segment C1. This segment contained flatwater habitat with well-developed riparian cover on both banks of the river. No steelhead were observed.

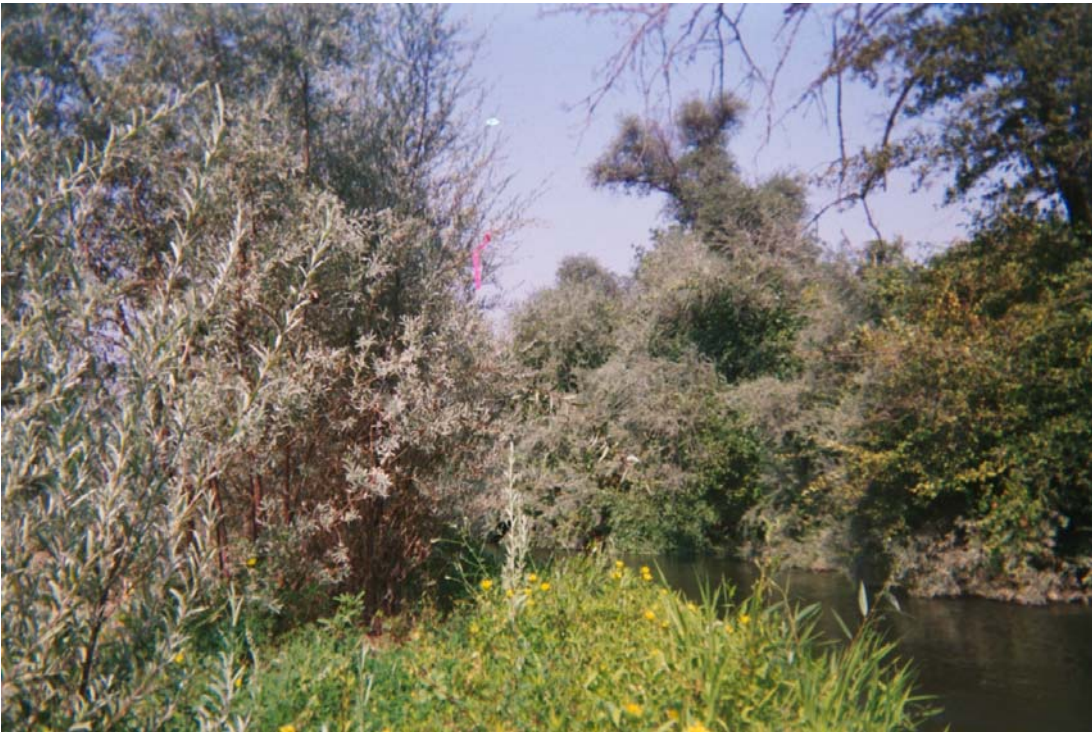
Figure 19: Canyon Reach, Segment C2. This segment contained flatwater habitat with well-developed riparian cover. Steelhead were observed in low numbers ( $n=12$ ) in this segment and was the upstream limit for steelhead in the Canyon Reach.

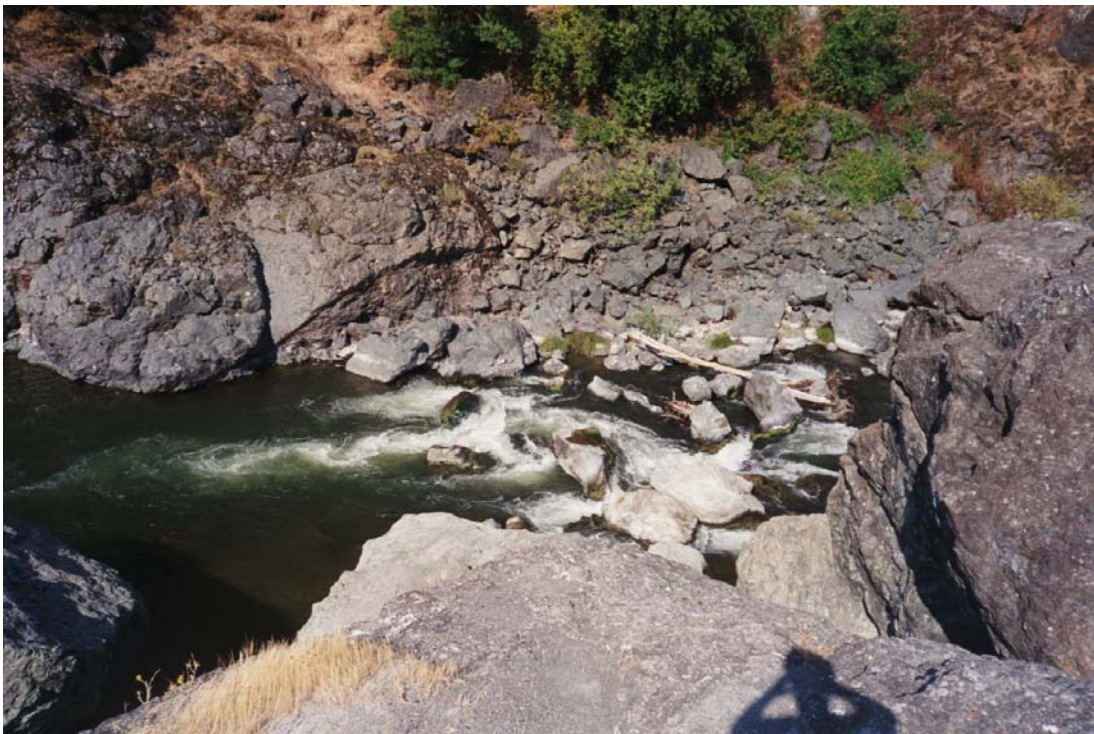
Figure 21: Canyon Reach, Segment C4. A total of 113 steelhead were observed in this segment, primarily in cascade and riffle habitats. The fast-flowing cascade shown in the bottom photograph had 74 steelhead observations.

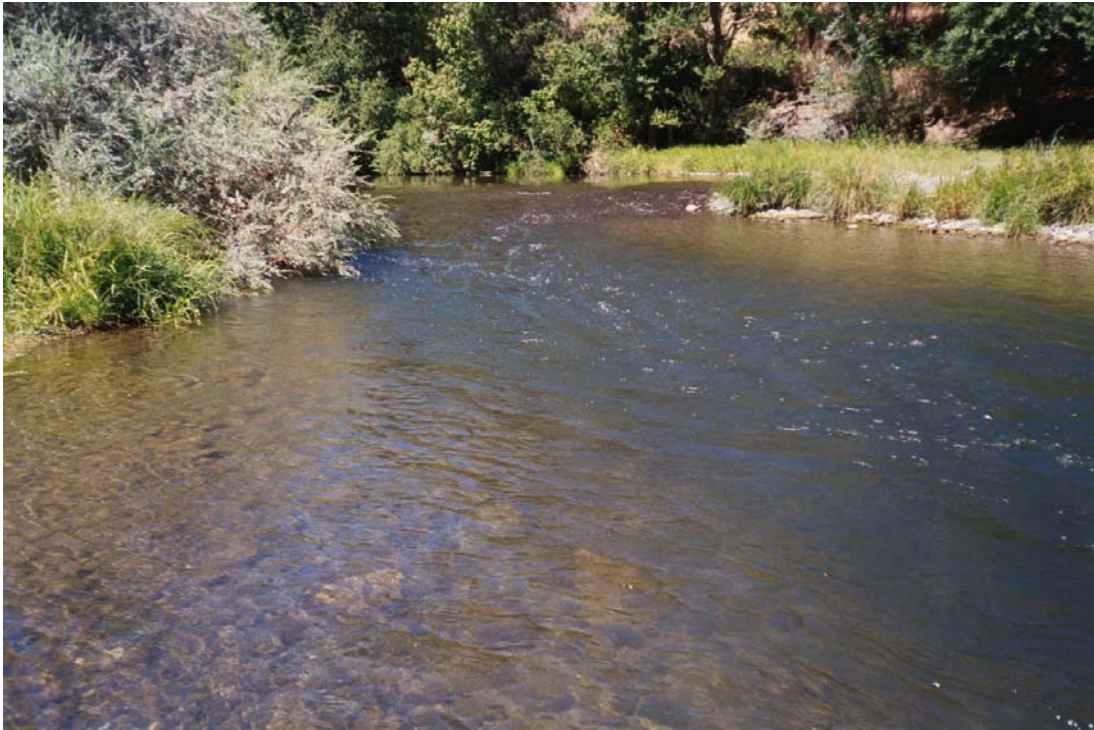
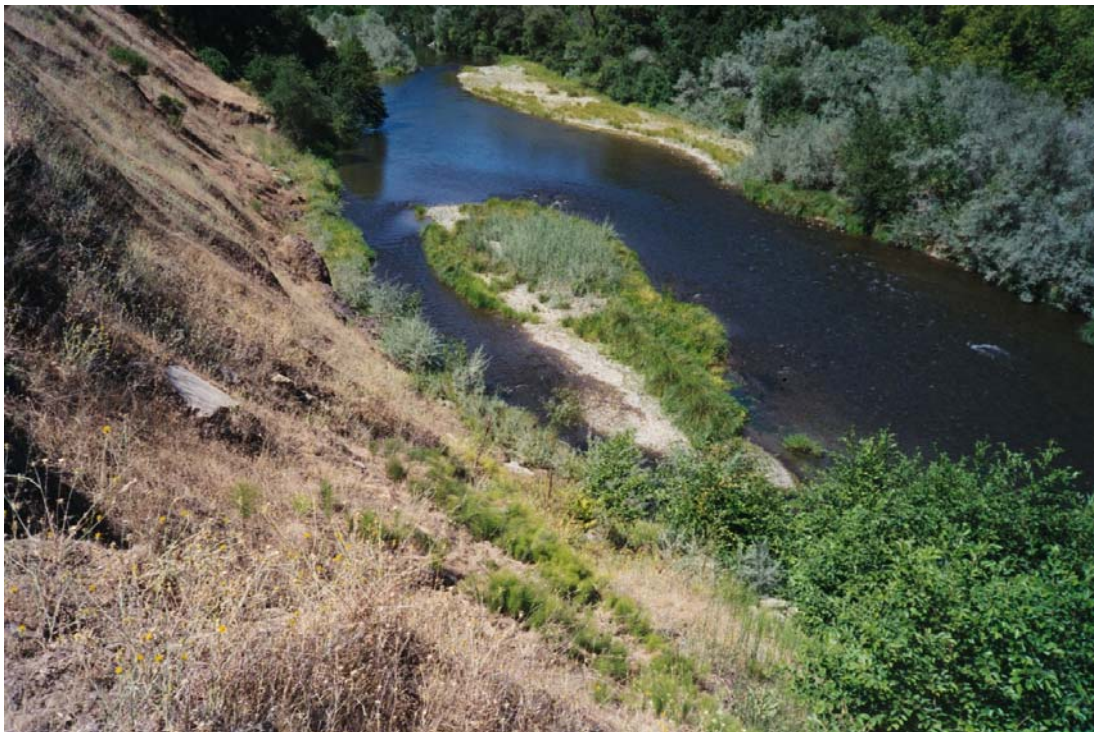
Figure 22: Canyon Reach, Segment C5. This segment contained the largest observation of steelhead ( $n=435$ ). Most steelhead were observed in riffle habitat, which consisted of 13% of the segment. The top photograph shows a steelhead-bearing deep riffle and the bottom photograph shows a narrow riffle on the left side that had 116 steelhead observations.

Steelhead were distributed throughout the reach except for the upstream segment (C1); however, most steelhead were observed in fastwater habitats located in the lower two-thirds of the reach where the gradient is relatively high. Steelhead numbers were zero or very low in segments C1 through C3 where the habitat was primarily flatwater (Figures 13 and 14). In contrast, steelhead observations were relatively high in segments C4 through C9 where fastwater habitats were abundant. The largest steelhead counts were in segment C5 at 435 fish followed by C6 and C7 at 254 and 210 fish, respectively.
