# Upper Russian River Steelhead Distribution Study

**Sonoma County Water Agency**  
2150 West College Avenue  
Santa Rosa, California 95401

Prepared by  
David Cook – Senior Environmental Specialist

March 2003

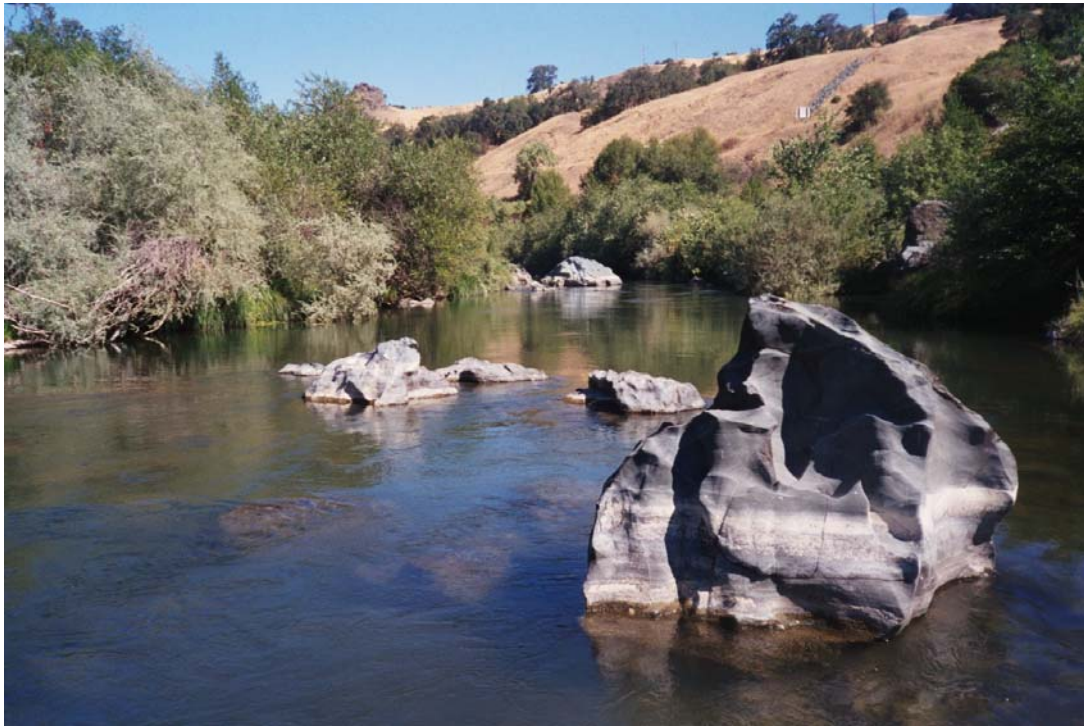
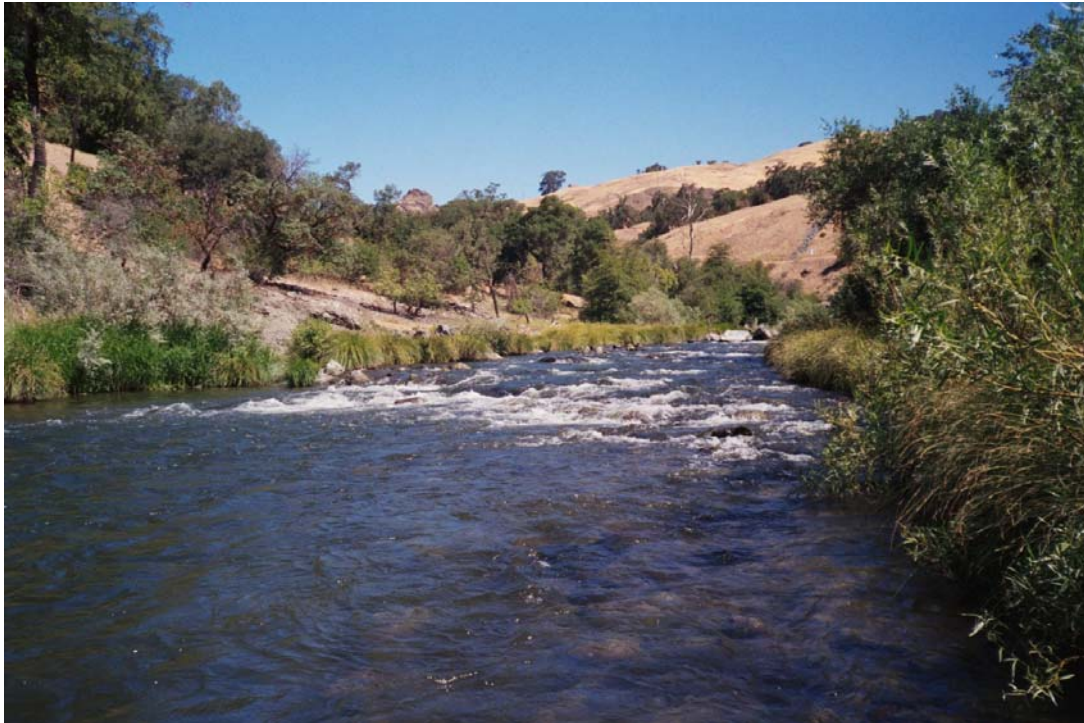
Figure 23: Canyon Reach, Segment C6. This reach was composed of 2% deep pool, 28% riffle, and 70% flatwater habitats. A total of 254 steelhead were observed primarily in riffle habitat. The top photograph shows flatwater habitat with large bedrock boulders and the bottom shows a steelhead-bearing riffle with cobble and boulder substrate.

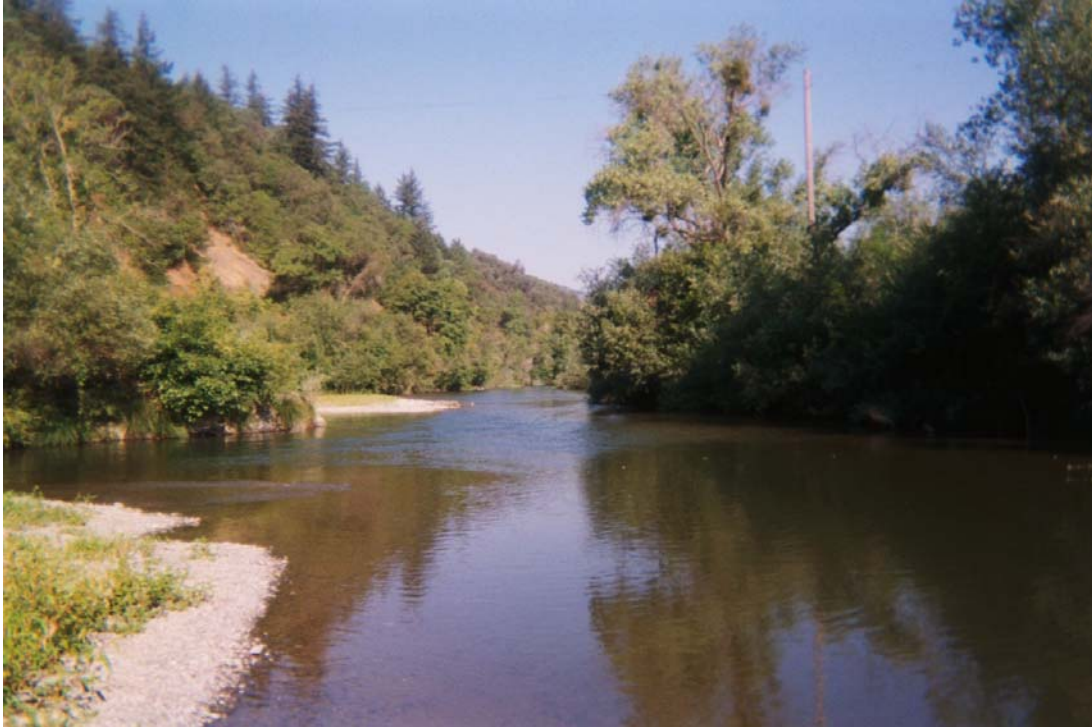
Figure 24: Canyon Reach, Segment C7. A total of 210 steelhead were observed in this segment. The photograph shows a riffle in the background and flatwater in the foreground.

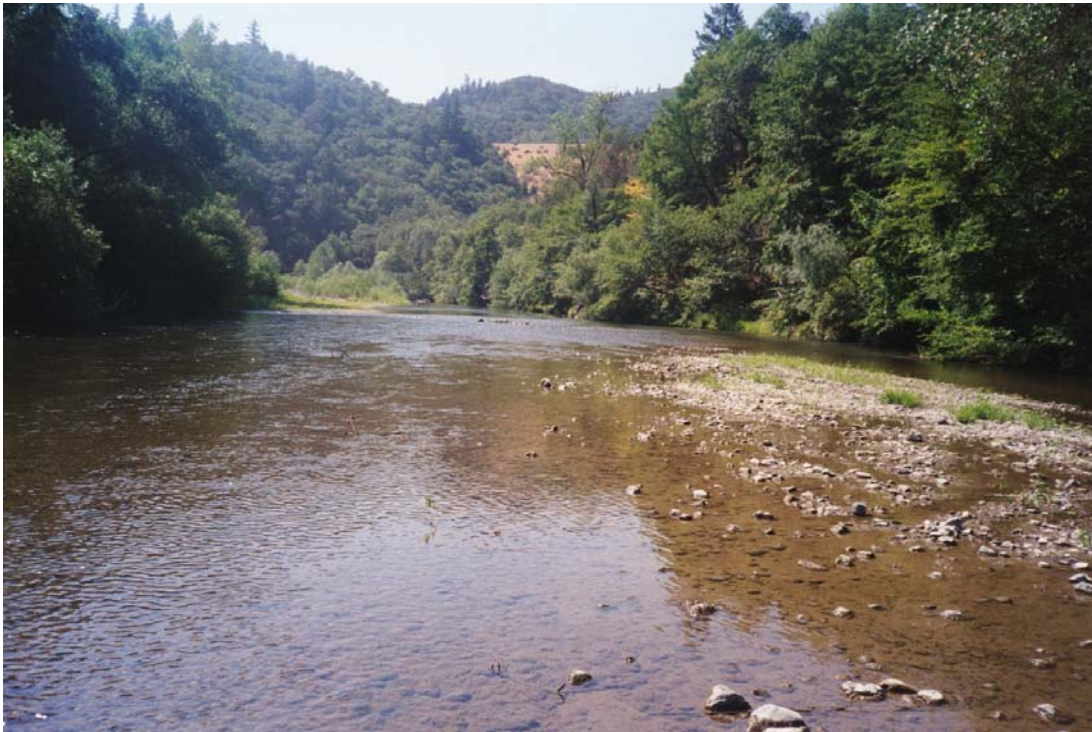
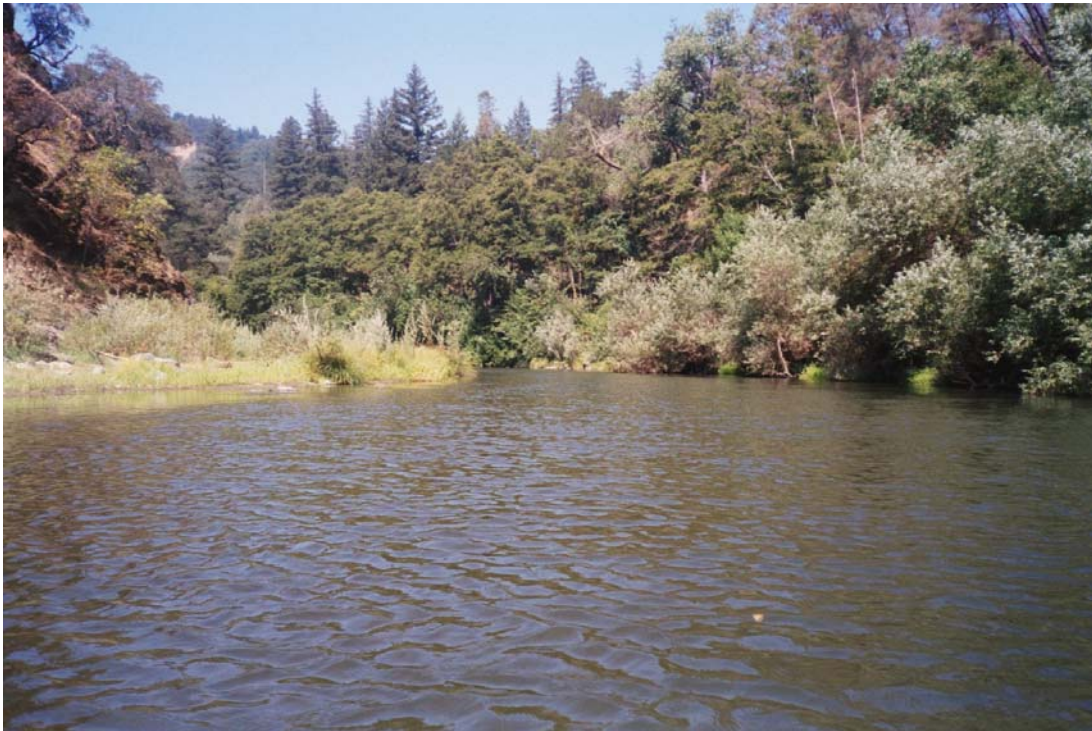
Figure 25: Canyon Reach, Segment C8. A total of 106 steelhead were observed in this segment primarily in riffle habitat. The top photograph shows a broad shallow riffle in the background and an exposed gravel bar in the foreground. The bottom photograph shows flatwater habitat.

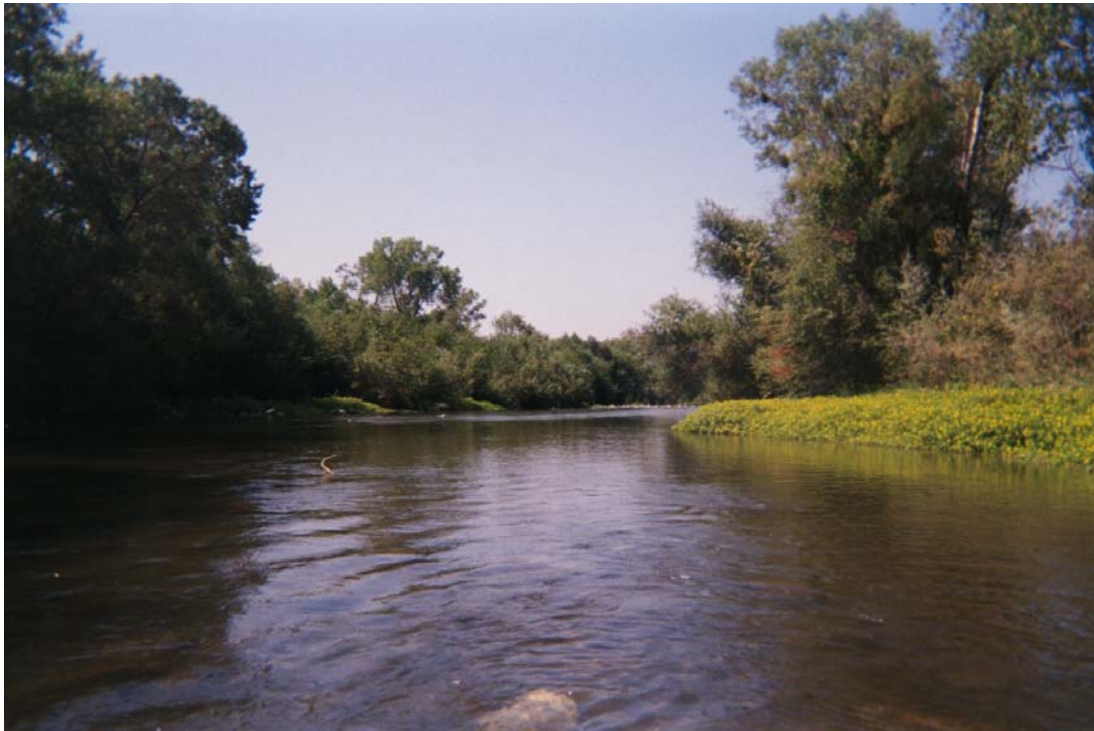
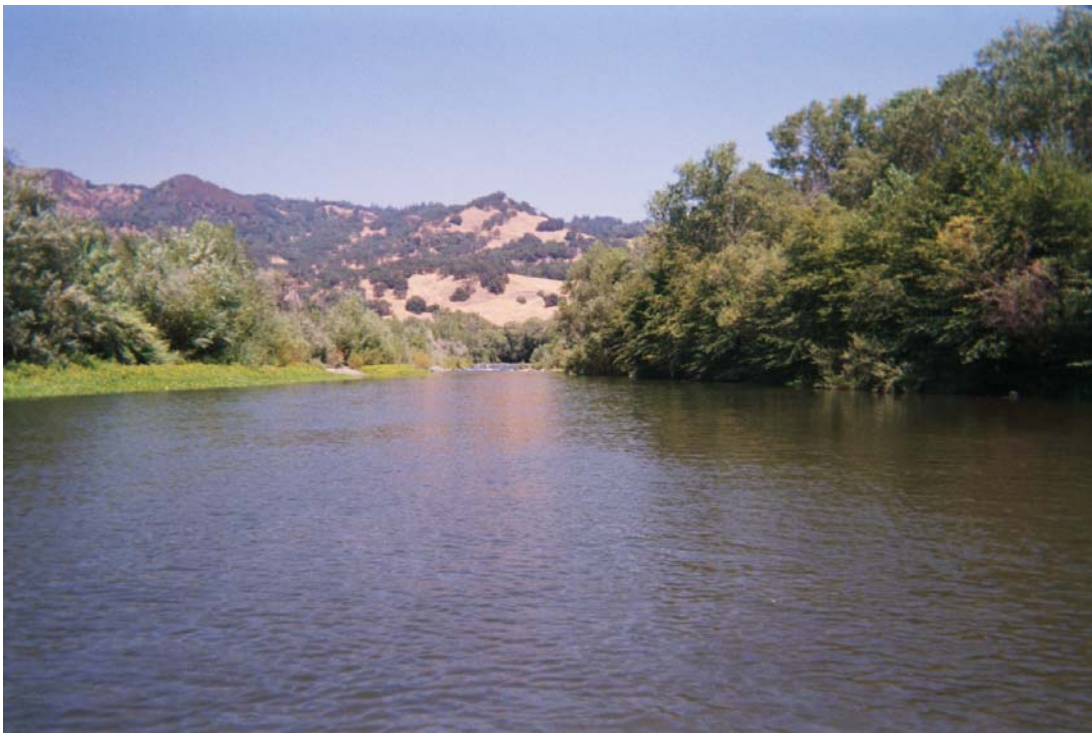
Figure 26: Canyon Reach, Segment C9. This segment is the downstream extent of relatively large steelhead observations. The segment contained 50% riffle and a total of 59 steelhead were observed primarily in this habitat type. Flatwater with riffle habitat in the far background are shown in both photographs.

The largest count of steelhead did not correlate with the highest frequency of fastwater habitat, as expected. Segment C9 contained the highest proportion of riffle habitat at 50% and had 59 observed steelhead, while C5 through C7 had steelhead counts several times this amount and less than half of the fastwater habitat. One explanation for the distribution of young steelhead within riffles is the presence of refugia from excessive water velocities. Large substrate particles in high gradient areas provide important shelter for fish from high velocities. The substrate in C9 riffles was primarily loose cobble while C4 through C7 riffle substrate was dominated by boulder and bedrock.

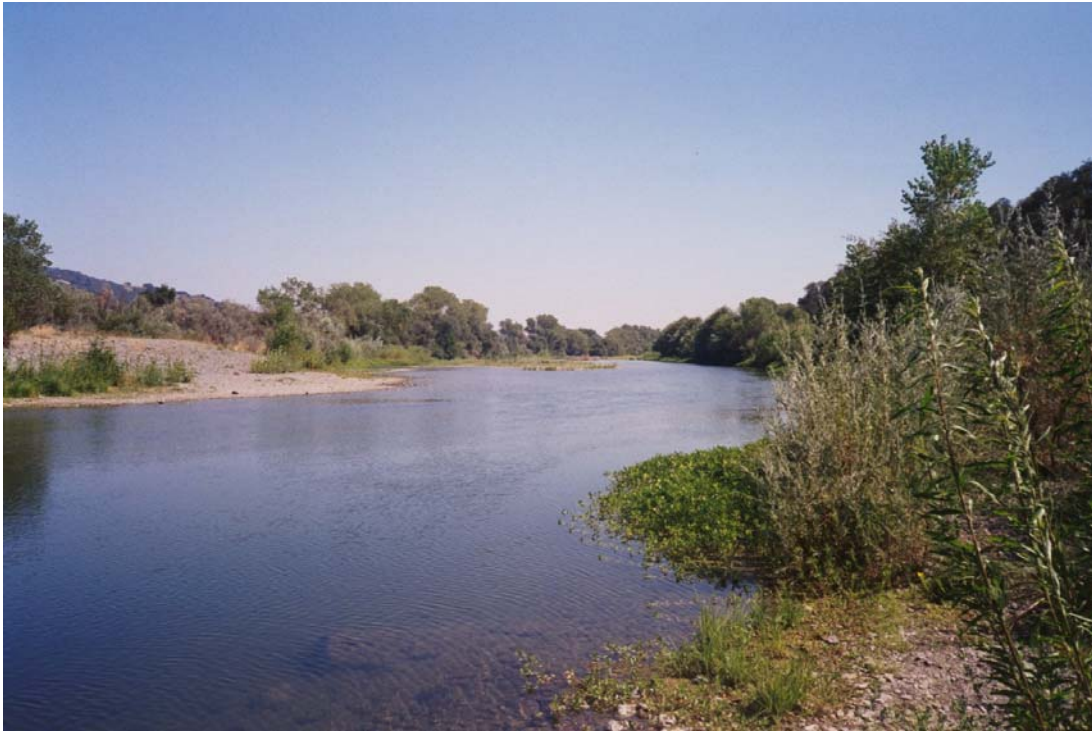
Figure 27: Alexander Valley Reach, Segment A1. This segment is dominated by flatwater habitat. Typical land use in this reach includes aggregate mining along gravel bars. No steelhead observed.

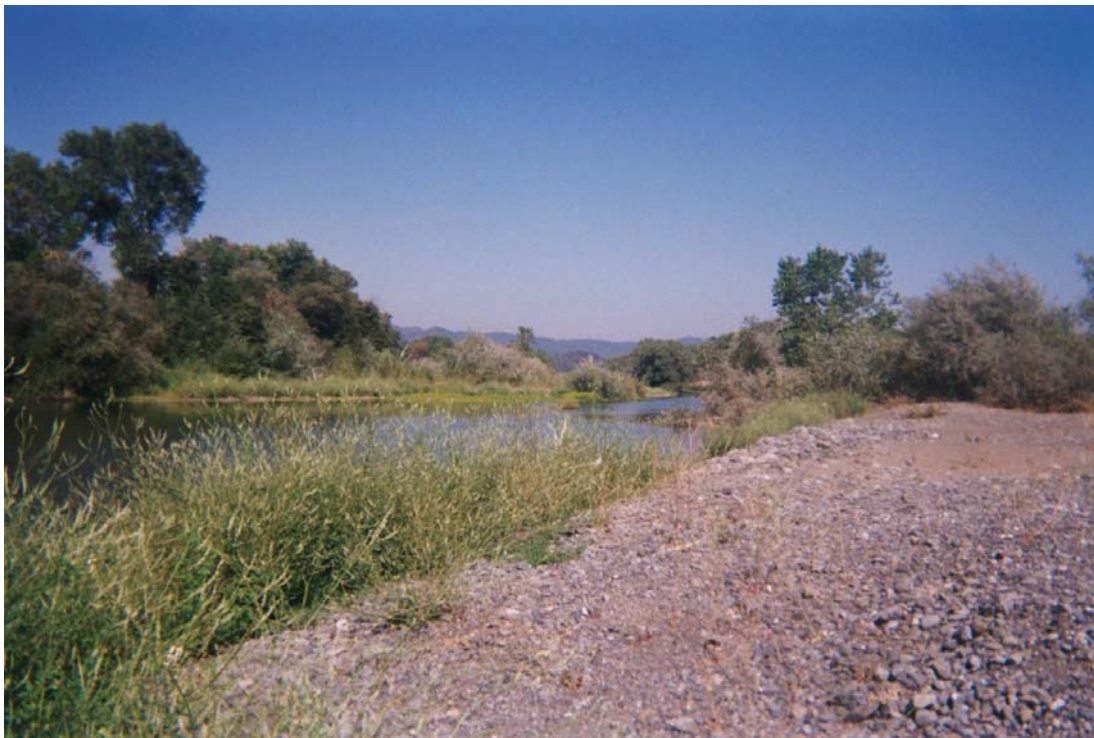
Figure 29: Alexander Valley Reach, Segment A3. This segment contained 1% riffle, 2% deep pool, and 97% flatwater habitats. The top photograph shows a small shallow riffle. Flatwater habitat with adjacent broad gravel bars and sparse riparian cover dominated the segment (bottom). No steelhead were observed.

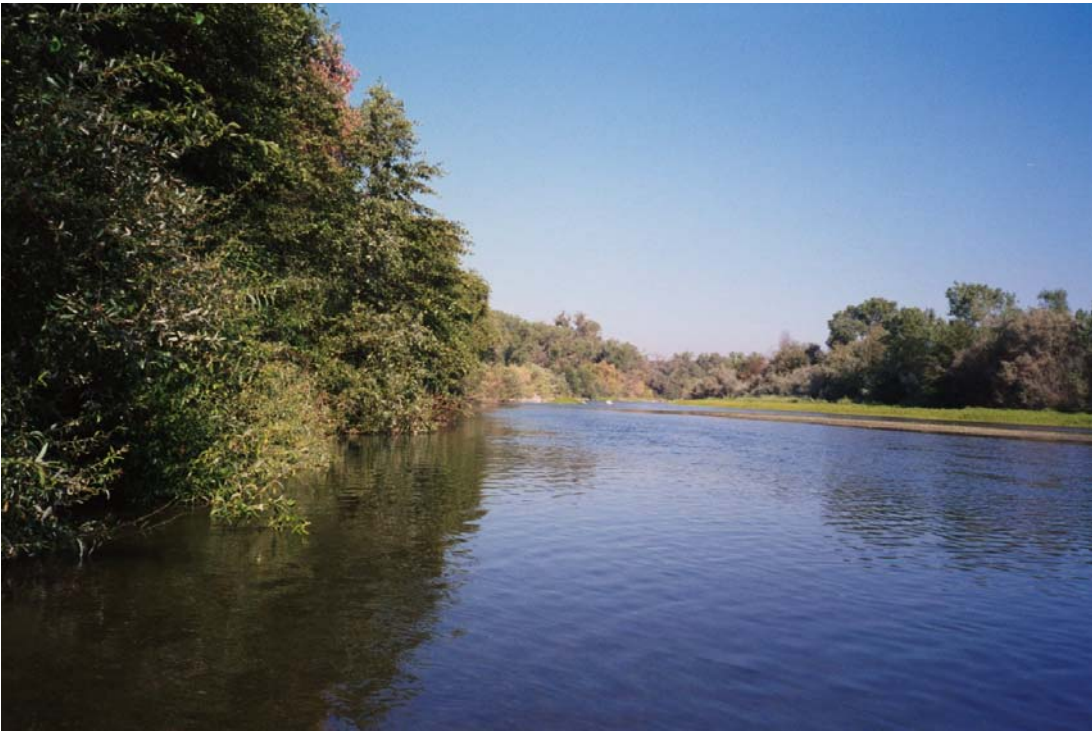
Figure 30: Alexander Valley Reach, Segment A4. This segment consisted of flatwater habitat. No steelhead were observed.

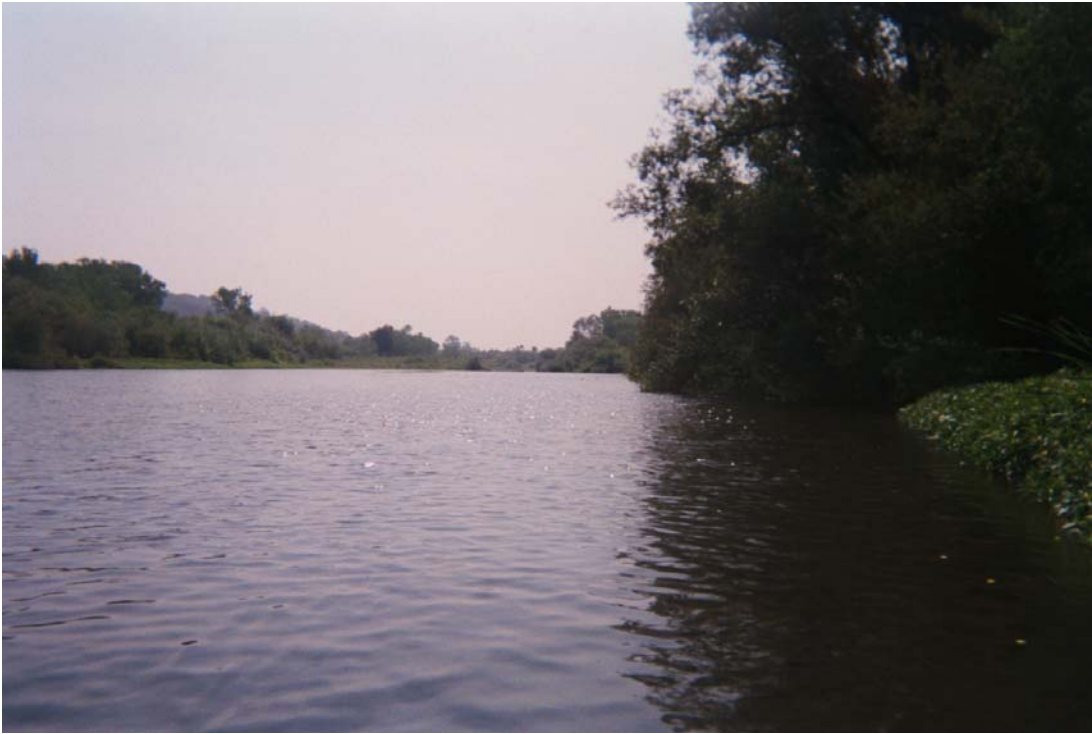
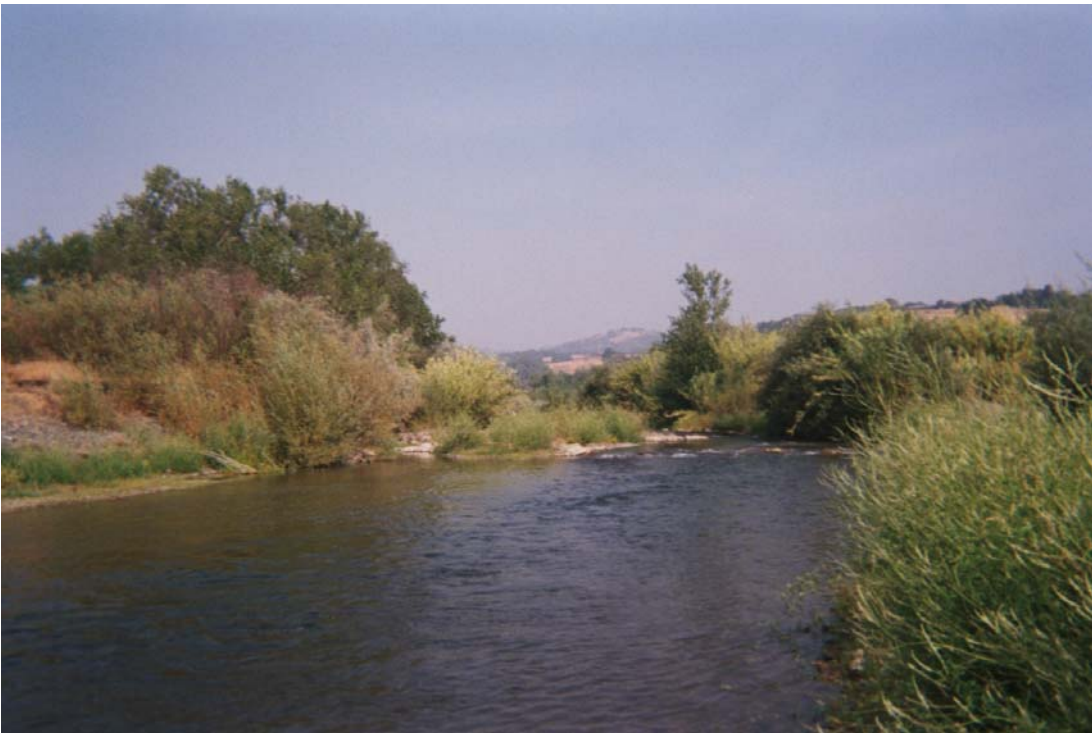
Figure 31: Alexander Valley Reach, Segment A5. This segment contained 99% flatwater, a broad streambed with shallow depths, and sparse riparian cover. No steelhead were observed.

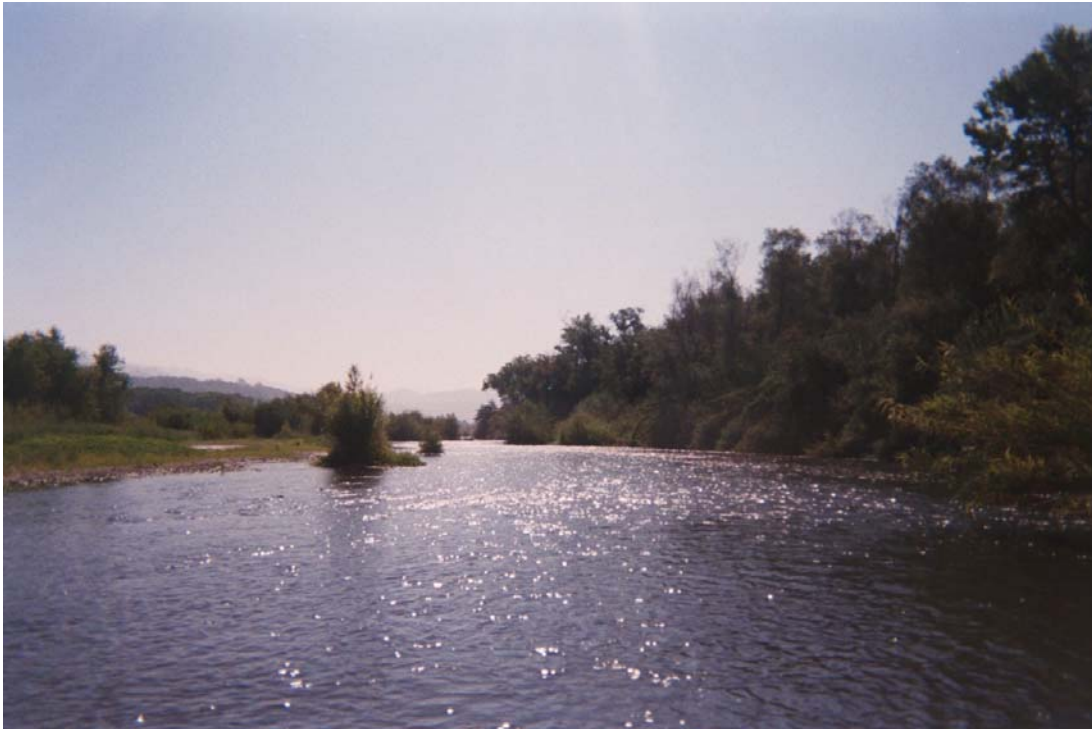
Figure 32: Alexander Valley Reach, Segment A6. This segment contained 98% flatwater, a broad streambed with shallow depths, and sparse riparian cover. No steelhead were observed.

The Alexander Valley reach is located in Alexander Valley and extends from the confluence of Big Sulphur Creek near Cloverdale to the Alexander Valley Road Bridge. The length of the reach was approximately 26 km and included 11 sample segments. Land use along the reach consists of agricultural land (vineyard) outside of the riparian zone and occasional aggregate mining along the gravel bars. Elevation ranges from 59 m to 90 m and has the lowest gradient of all the study reaches (Figure 2). See Appendix Figures 27 through 37 for photographs of the reach.

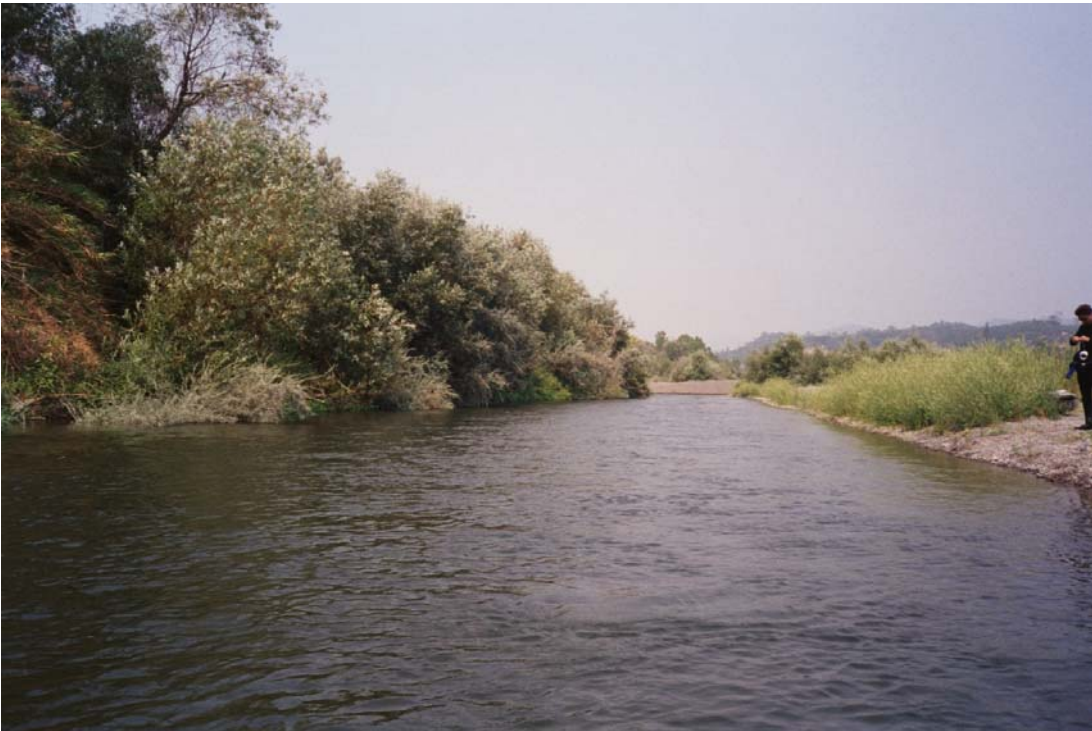
Figure 33: Alexander Valley Reach, Segment A7. This segment contained 40% flatwater and 60% riffle with a gravel substrate. One steelhead was observed in the riffle shown in the top photograph.

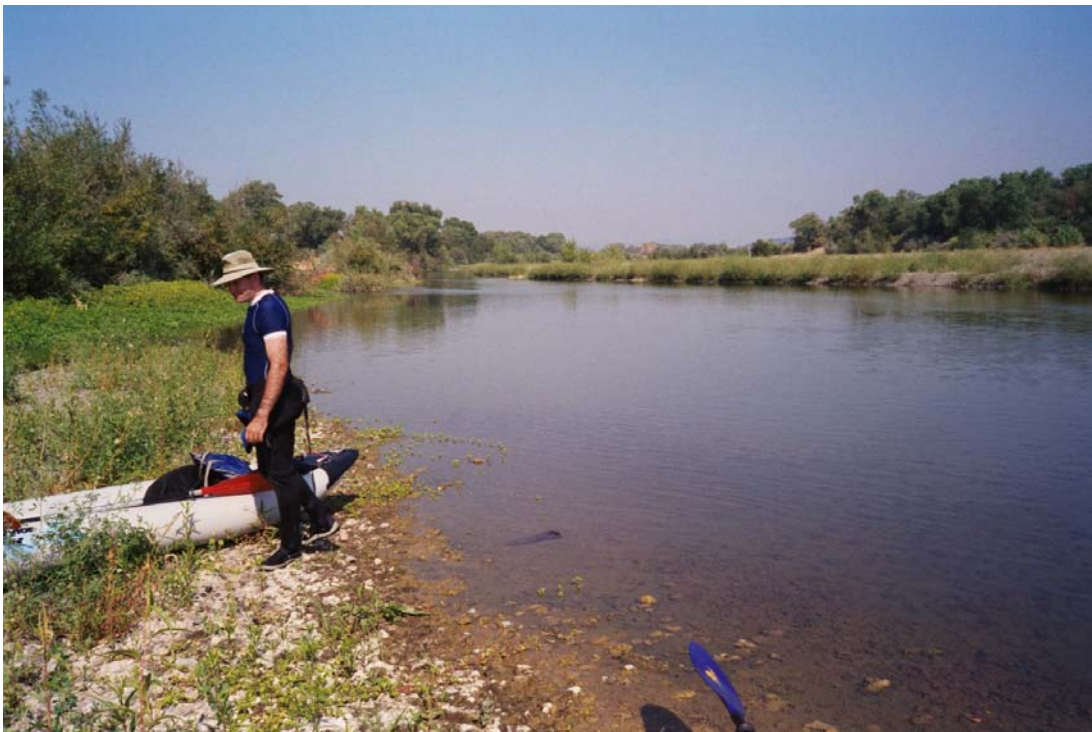
Figure 34: Alexander Valley Reach, Segment A8. This segment contained 83% flatwater, 15% riffle, and 2% deep pool. Flatwater is shown in both photographs. No steelhead were observed.

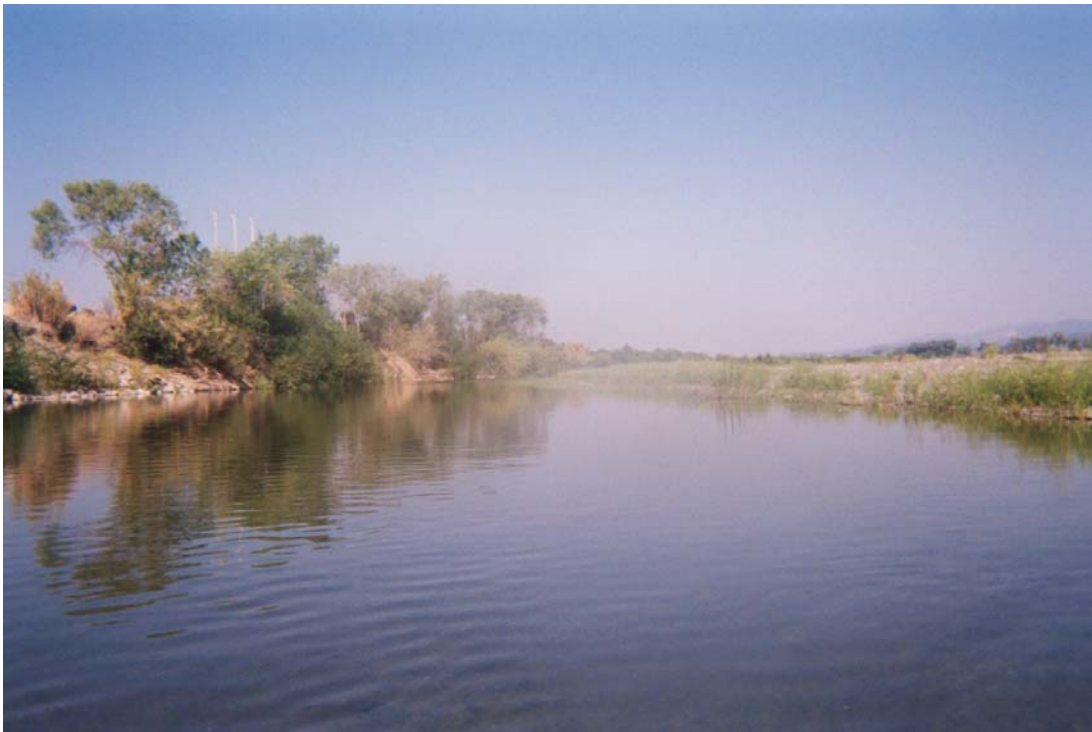
Figure 35: Alexander Valley Reach, Segment A9. This segment contained flatwater, had a broad streambed with shallow depths, and sparse riparian cover. No steelhead were observed.

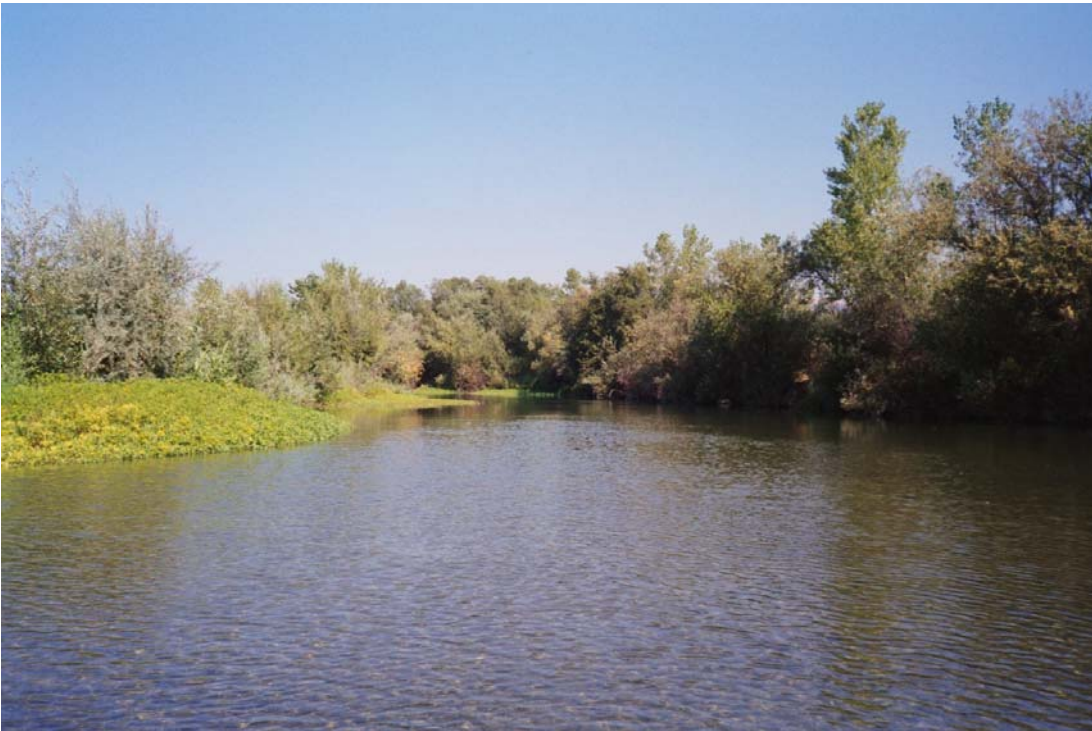
Figure 36: Alexander Valley Reach, Segment A10. This segment was dominated by flatwater (95%) with occasional shallow riffles and deep pools. No steelhead were observed.

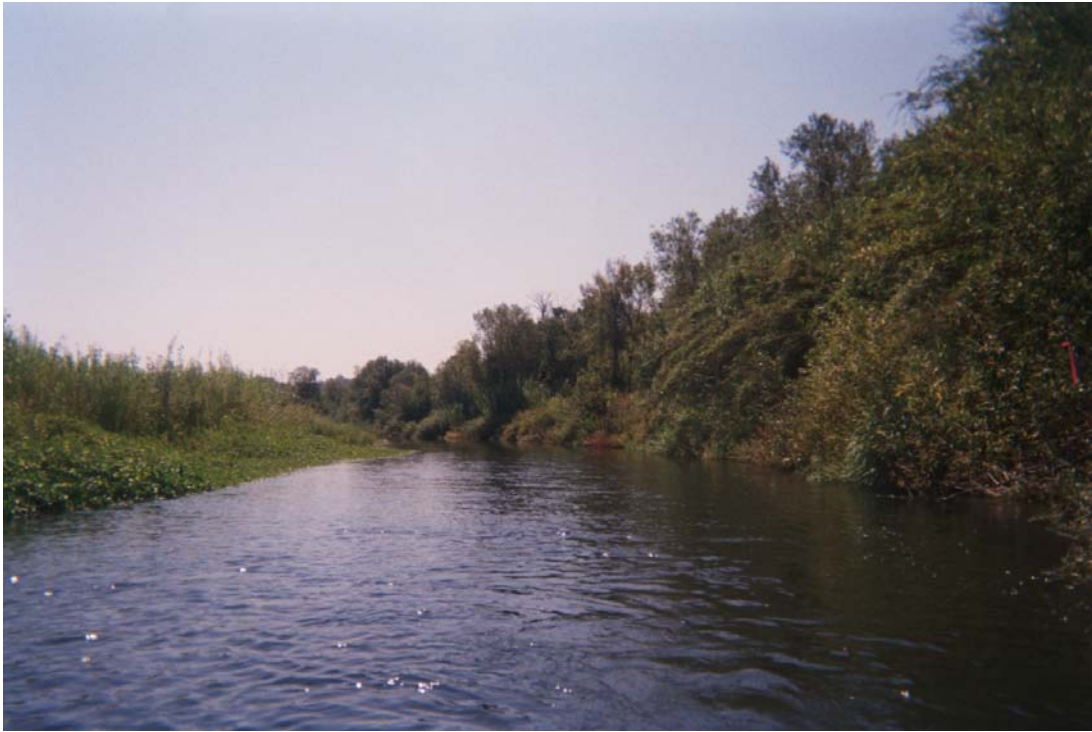
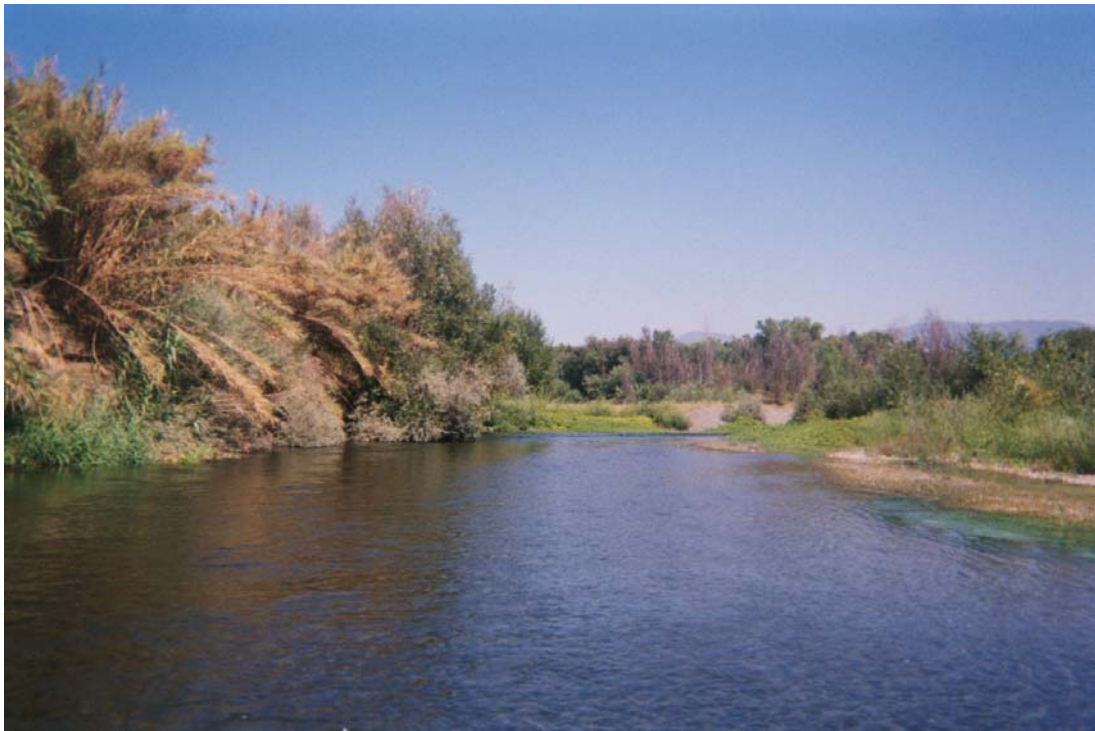
Figure 37: Alexander Valley Reach, Segment A11. This segment was dominated by flatwater (92%) with occasional shallow riffles (5%) and deep pools (3%). No steelhead were observed.

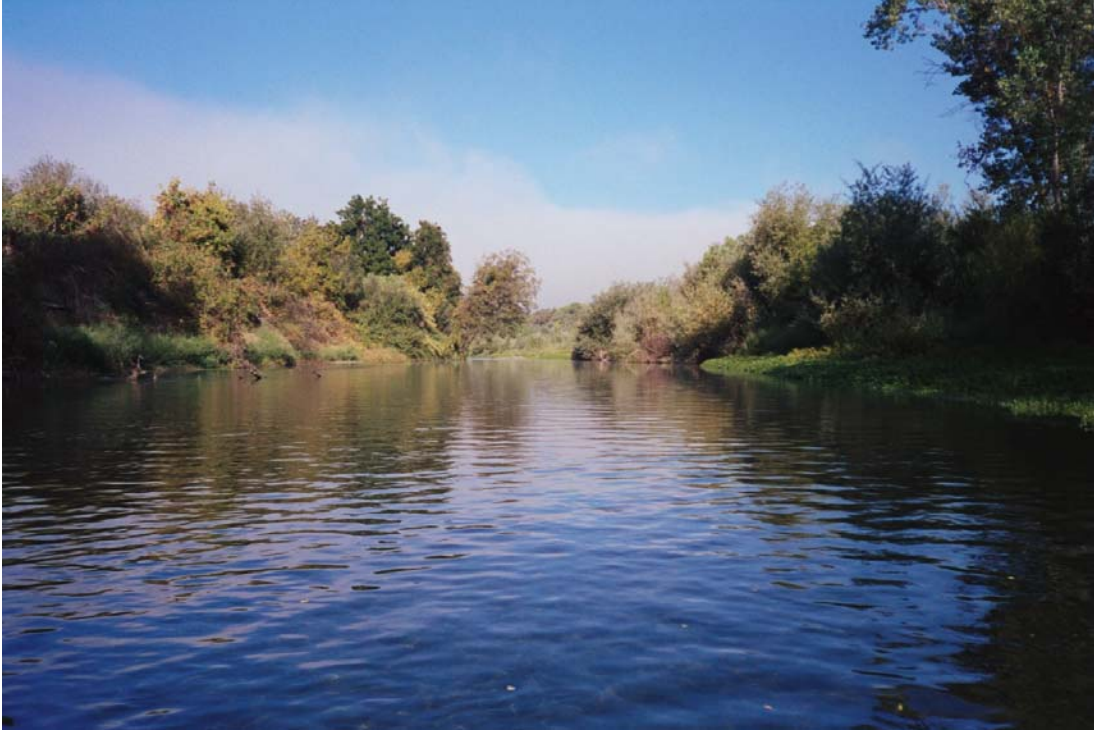
Figure 38: Healdsburg Reach, Segment H1. This segment was not dive surveyed but contained primarily flatwater habitat.

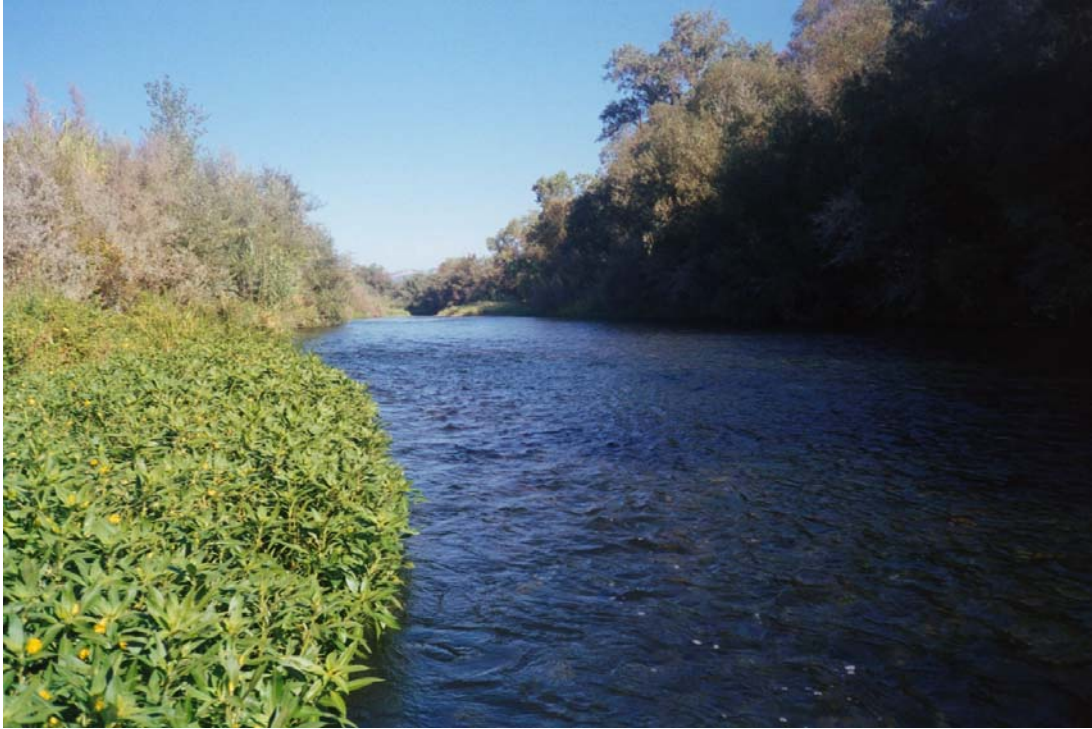
Figure 39: Healdsburg Reach, Segment H2. This segment contained mostly flatwater (94%) habitat with adjacent broad gravel bars, and occasional riffle (4%) and deep pool (2%) habitats. No steelhead were observed.

vineyard and aggregate mining. The hilly central portion of the reach is undeveloped land and rural residences along the banks of the river. Also, Healdsburg Dam is located in the lower portion of the reach. The dam is approximately 5 m high and impounds water above the dam for approximately 2 km upstream. Photographs of the reach are shown in Figures 38 through 47 of the Appendix.

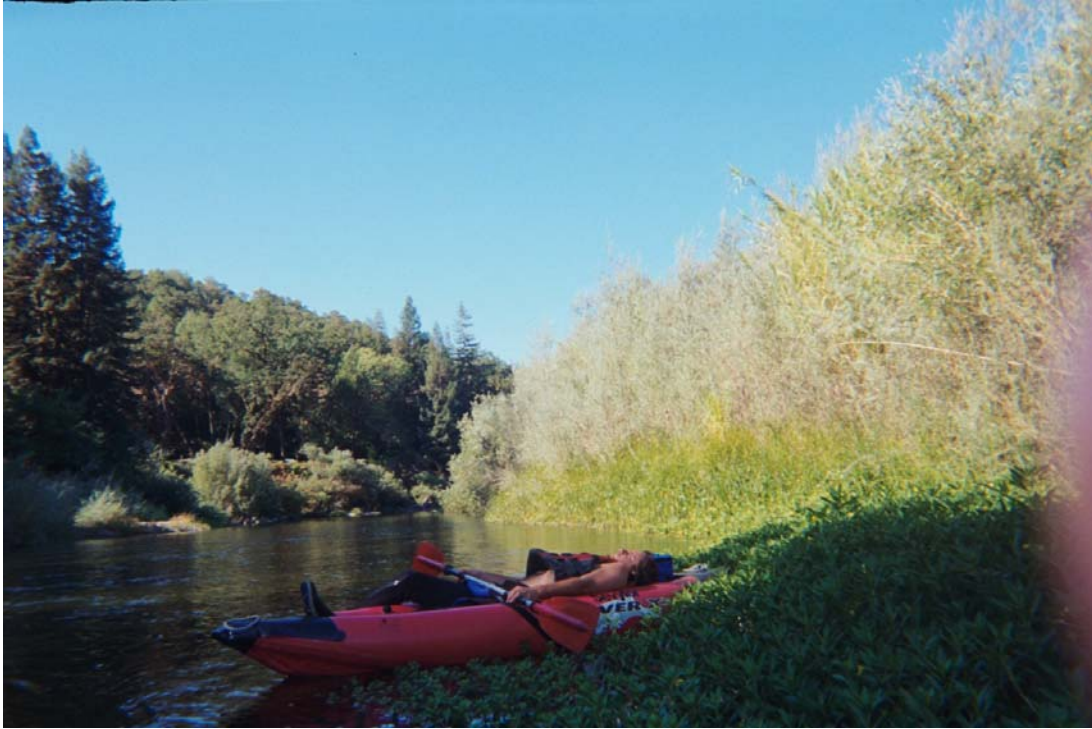
Figure 40: Healdsburg Reach, Segment H3. This segment contained flatwater (97%) and deep pool (3%) habitats. No steelhead were observed.

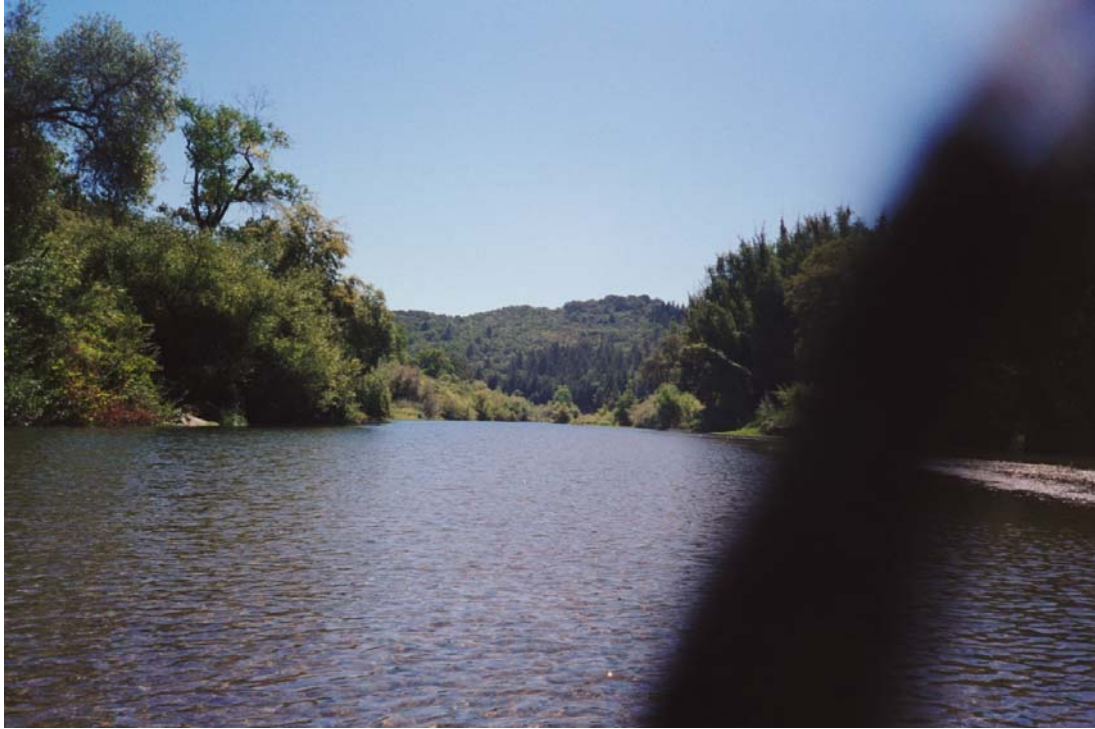
Figure 41: Healdsburg Reach, Segment H4. This segment was not dive surveyed but contained primarily flatwater habitat.

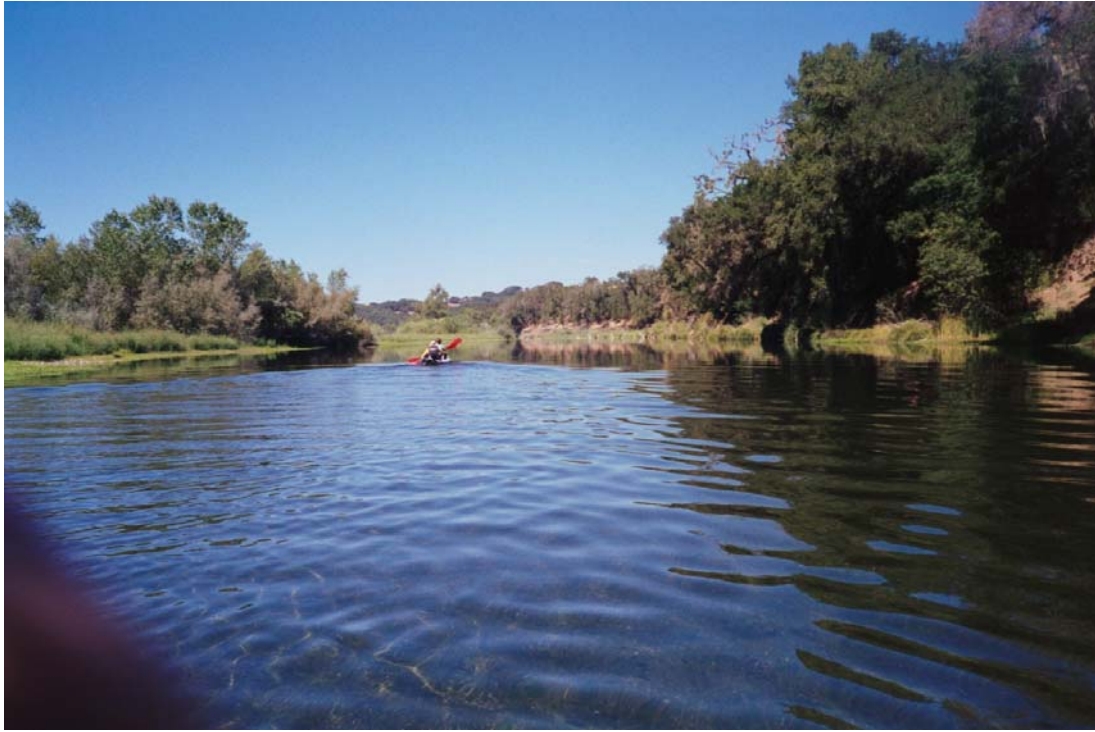
Figure 42: Healdsburg Reach, Segment H5. This segment was not dive surveyed but contained primarily flatwater habitat.

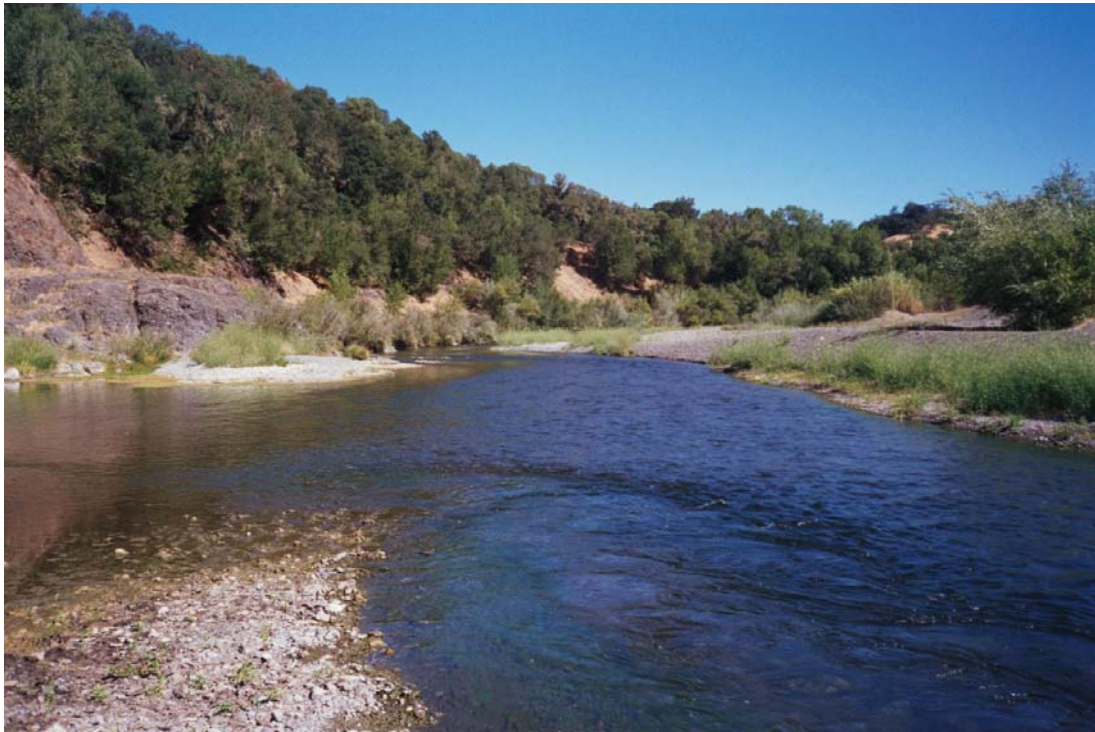
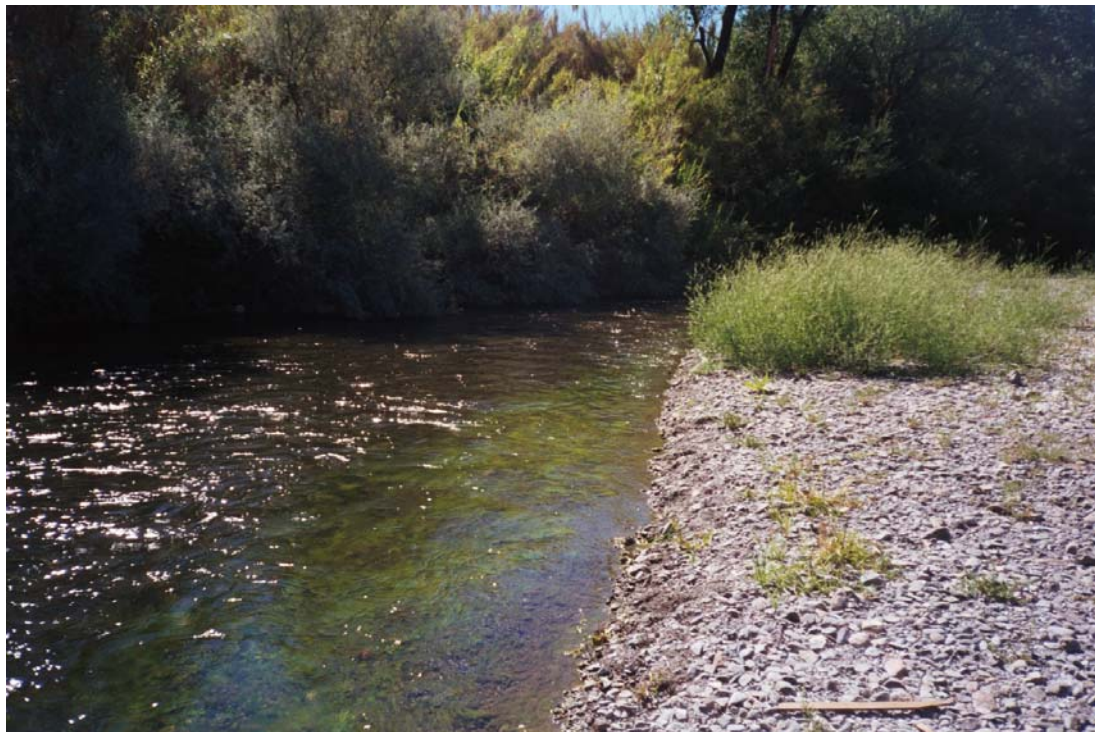
Figure 43: Healdsburg Reach, Segment H6. This segment contained 3% riffle, 94% flatwater, and 3% deep pool habitats. One steelhead was observed in a small riffle (bottom).

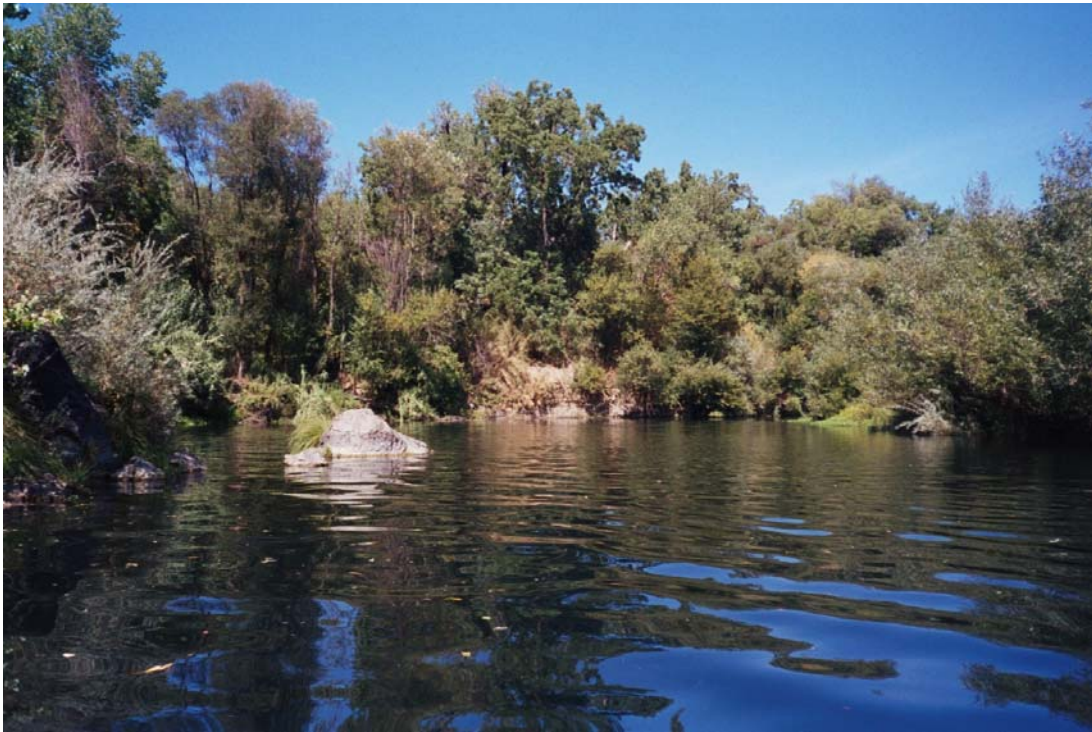
Figure 44: Healdsburg Reach, Segment H7. This segment was not dive surveyed but contained a large deep pool and flatwater habitats.
