# Upper Russian River Steelhead Distribution Study

**Sonoma County Water Agency**  
2150 West College Avenue  
Santa Rosa, California 95401

Prepared by  
David Cook – Senior Environmental Specialist

March 2003

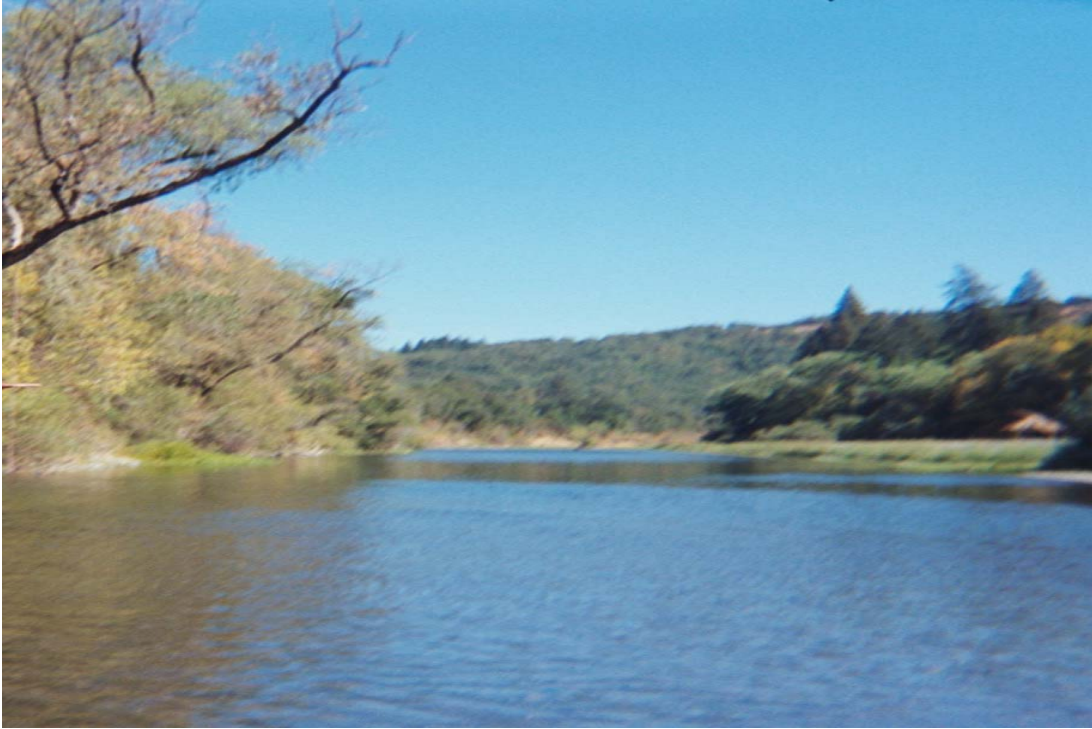
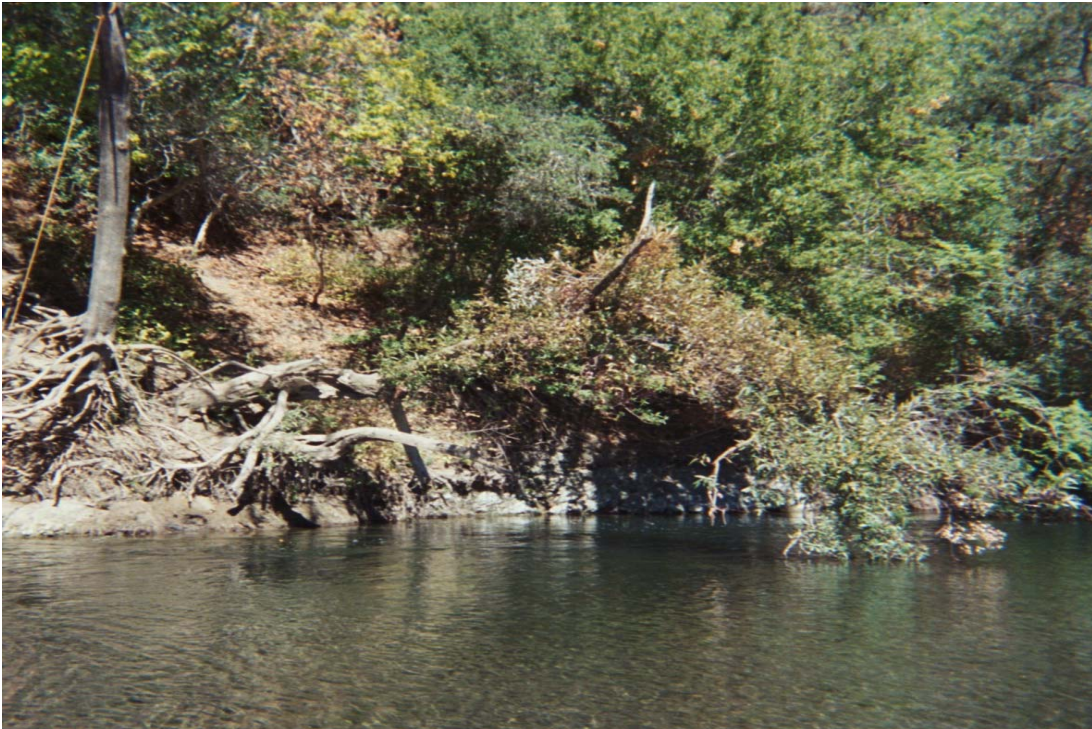
Figure 45: Healdsburg Reach, Segment H8. This segment contained primarily flatwater habitat. No steelhead were observed.

vineyard and aggregate mining. The hilly central portion of the reach is undeveloped land and rural residences along the banks of the river. Also, Healdsburg Dam is located in the lower portion of the reach. The dam is approximately 5 m high and impounds water above the dam for approximately 2 km upstream. Photographs of the reach are shown in Figures 38 through 47 of the Appendix.
