Analysis of the 1998 Garcia River Cross Sections

by
Dennis Jackson

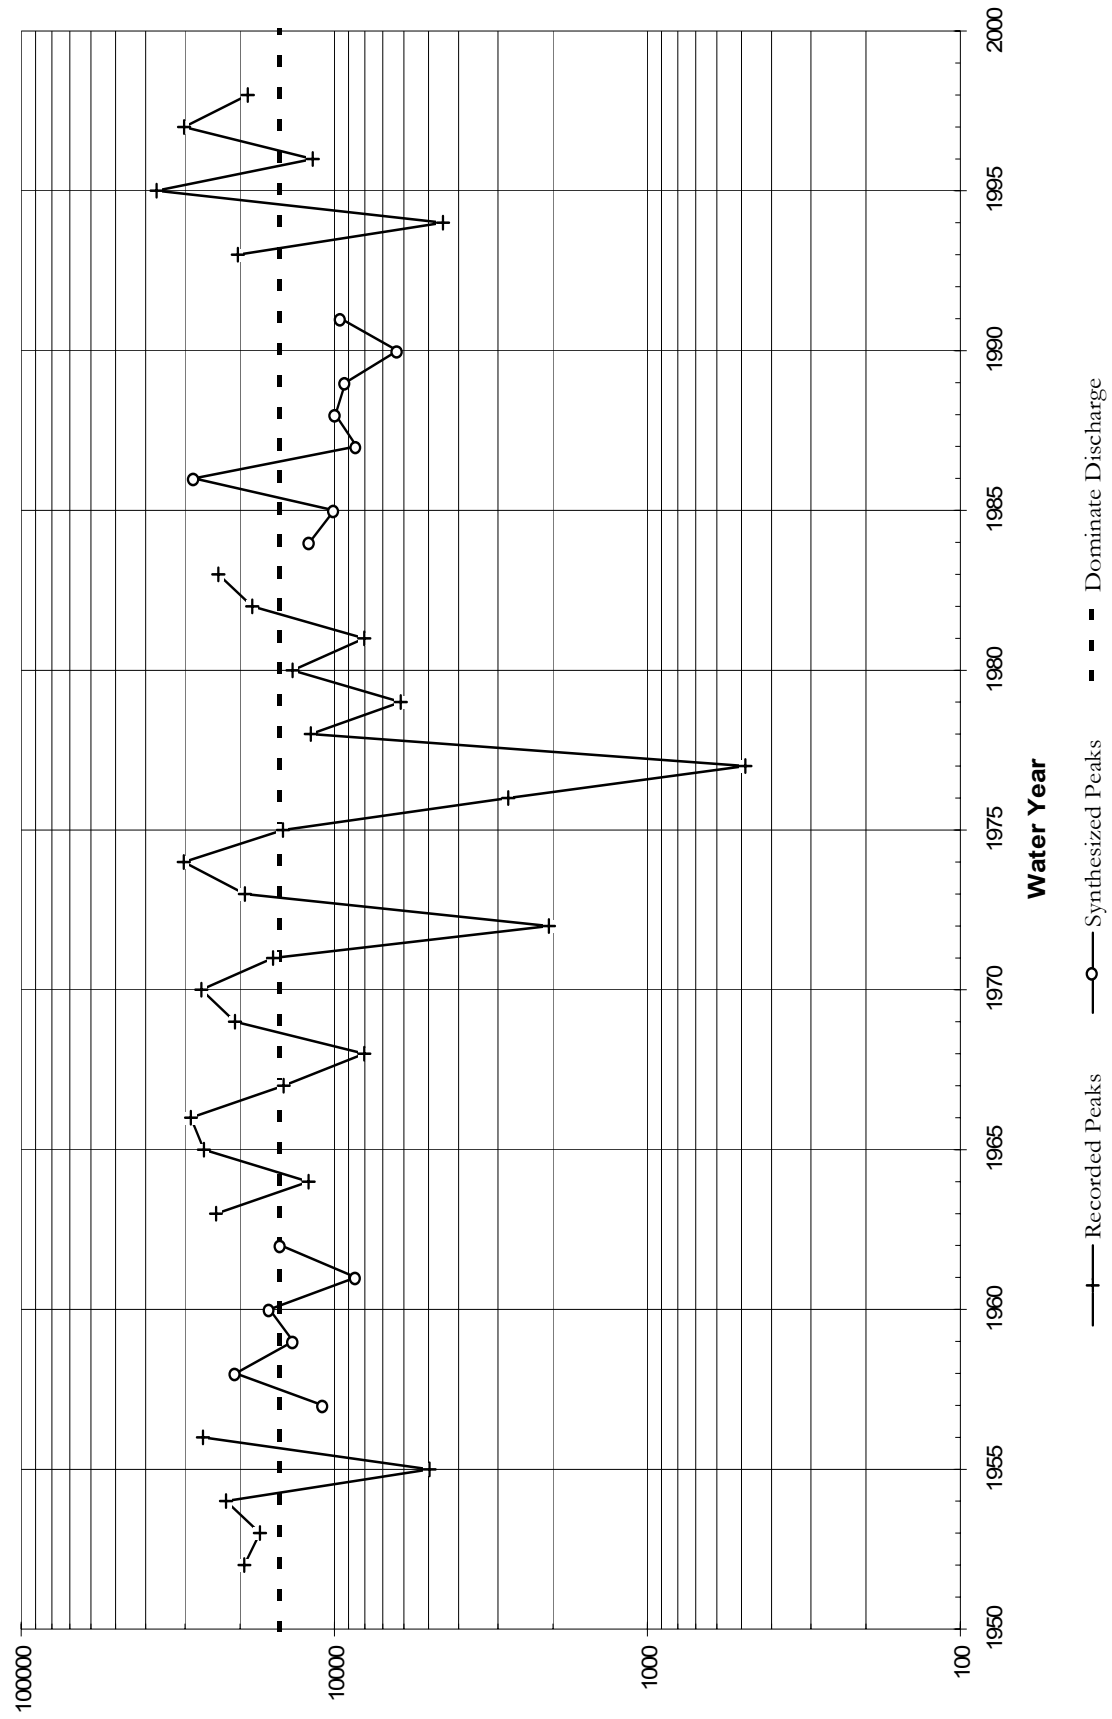
Figure 2. Annual Peak Floods on the Garcia River at the Conner Hole Gaging Station.

Figure 2 shows that the twenty-four year period from 1954 to 1975 had a total of sixteen years with annual peak discharges greater than the dominate discharge (66%), indicating that the period probably had a large input of material into the channel and the power to transport the material. Figure 2 also shows that the twenty-one year period from 1976 to 1996 had a total of five years with annual peak discharges greater than the dominate discharge (25%), indicating that very little new coarse material was delivered to the channel.

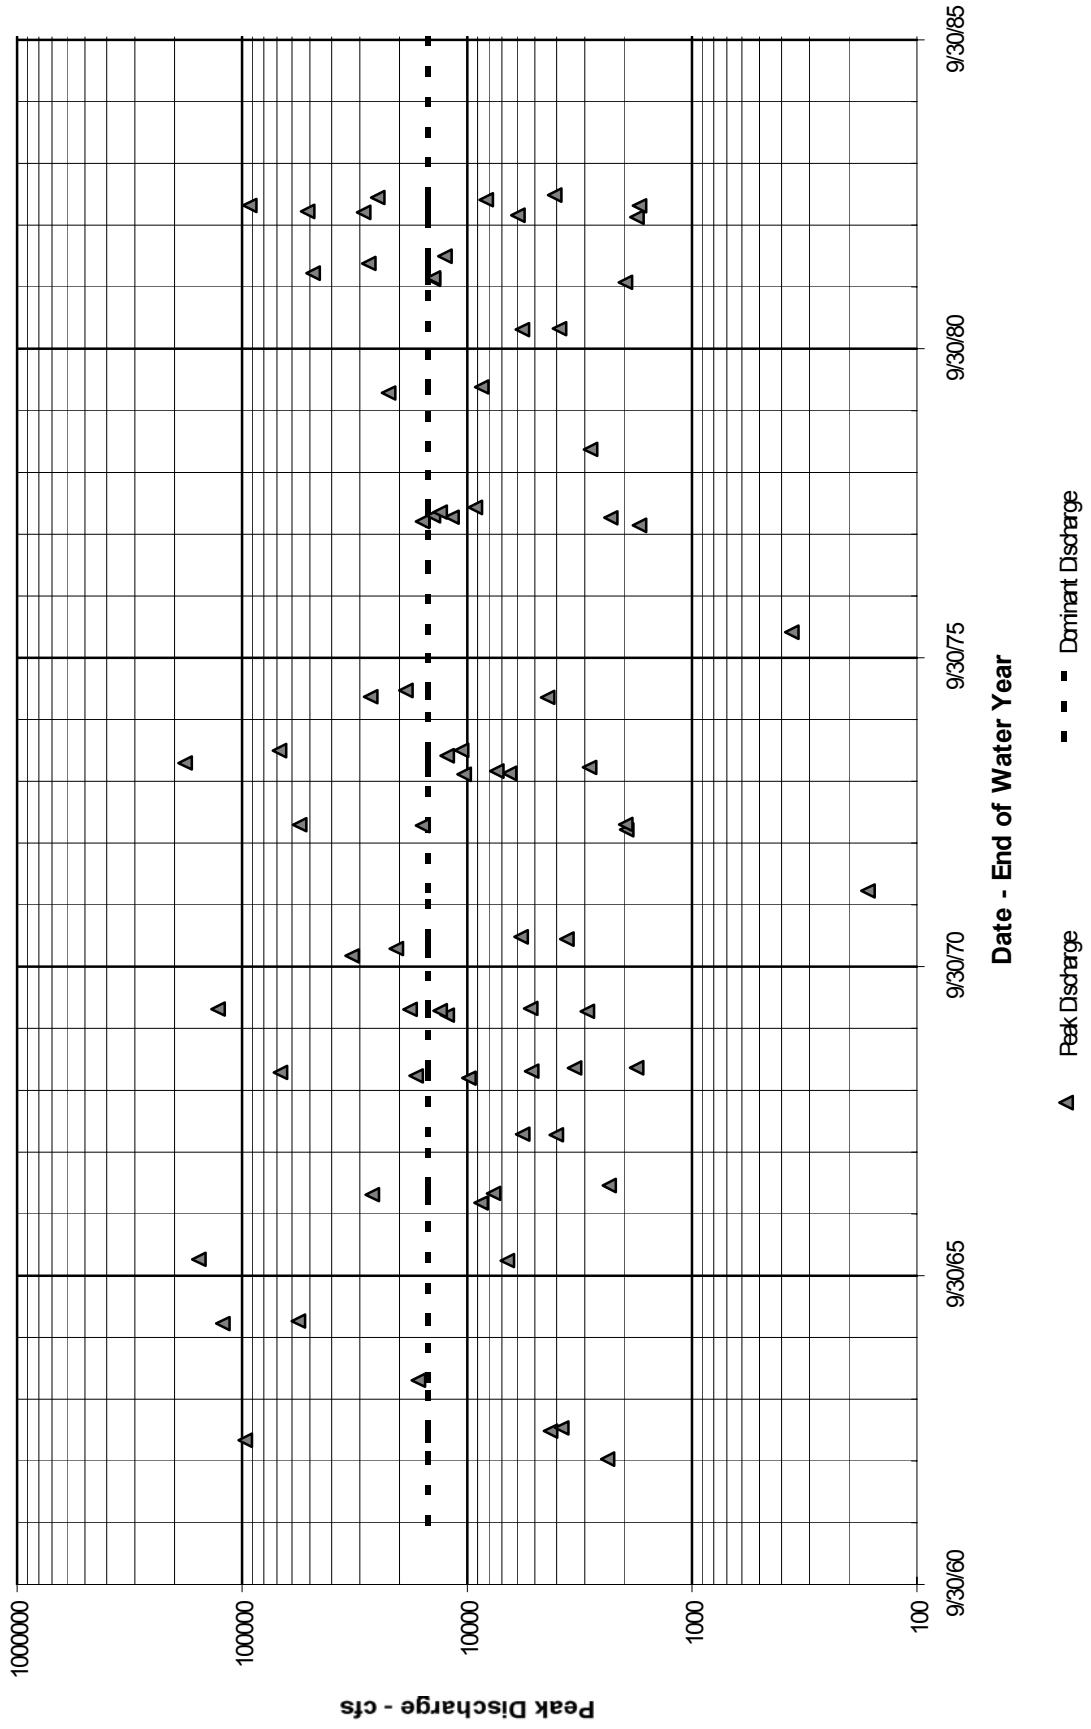
Figure 5. USGS Peak Discharges for Garcia River at Conner Hole for Water Years 1963-1983

The graph of Stage Required for 100 cfs of Flow (Figure 1) suggests a wave of sediment past the Conner Hole Gaging station between 1968 and 1983. Figure 5 is a graph all of the peak discharges recorded at the Conner Hole gaging station. Figure 5 suggests the cause of the sediment wave. The graph of the sediment wave, Figure 1, shows that the rise of the sediment wave started in 1969 and crested in 1975. Figure 5 shows that only two of the eight years between 1968 and 1975 had peak discharges less than the dominant discharge of 15,000 cfs. However, for the next eight years only two years had peak discharges greater than the dominate discharge. (These observations do not imply that there is an eight year weather cycle on the Garcia).

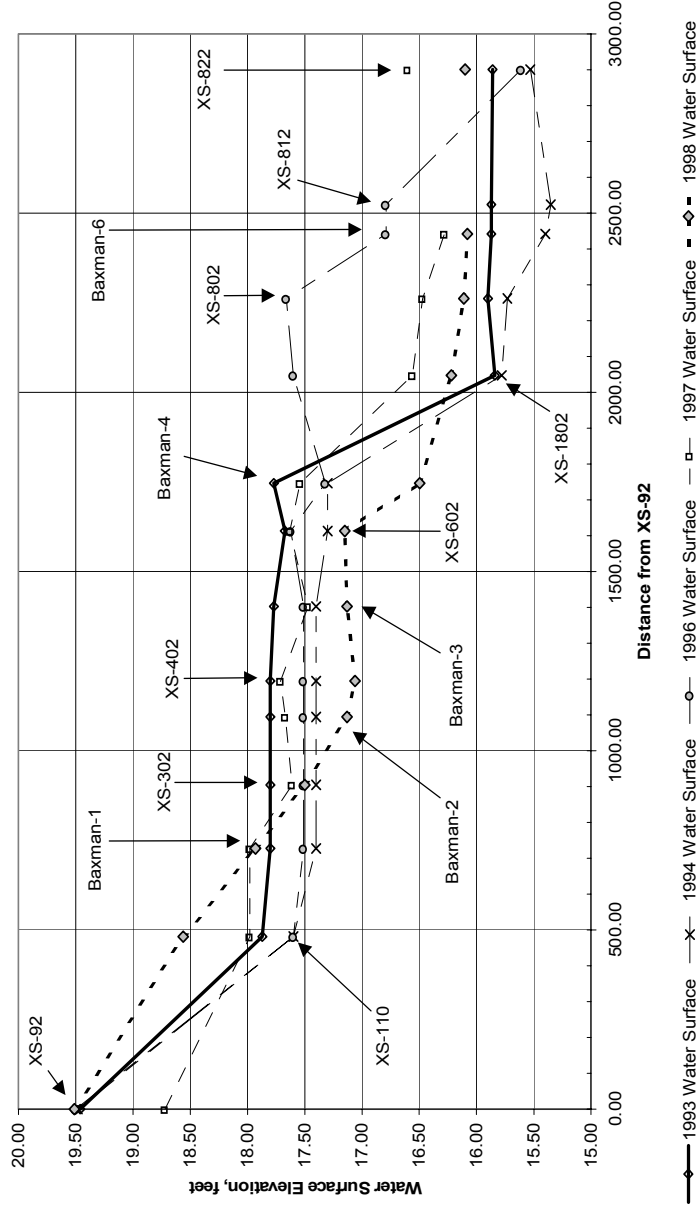
Figure 8. Water surface profiles for the Bentonite Monitoring cross sections.

A review of the changes at each cross sections will be given starting at the upstream end and progressing downstream. At cross section 92, the water surface rose about -0.7 feet and the thalweg rose about 0.4 feet, from 1997 to 1998, (see Table 3 and Figures 8 and 9). Between 1993 to 1996 there was virtually no change in the water surface and thalweg elevations at this cross section. Overall the cross section area decreased by 3% since 1993, see Table 4, showing deposition. Deposition occurred along the left (east) bank burying the reference stake. In 1998, a tree fell over the left bank stake.

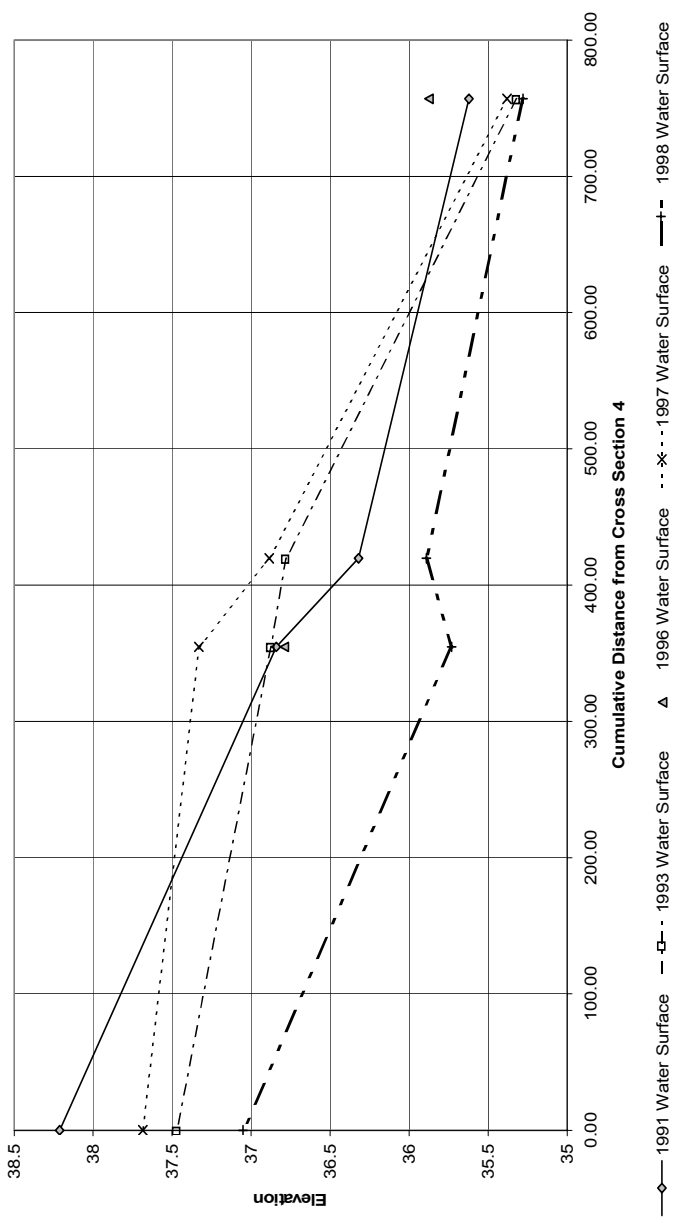
Figure 10. Water surface profiles for the Hooper cross sections.

Figures 10 and 11 show the water surface and thalweg profiles for each year the cross sections were surveyed. The 1998 survey had the lowest water surface and thalweg elevation at all of the Hooper cross sections. This general incision occurred even though the bank collapse at the Hooper - Olsen property boundary has been contributing bedload during the last few years.
