THE RESOURCES AGENCY OF CALIFORNIA  
CALIFORNIA DEPARTMENT OF FISH AND GAME

**STREAM SURVEY**

File form No \_\_\_\_\_ Date: June 15, 1976

Name: First Valley Creek County: Marin

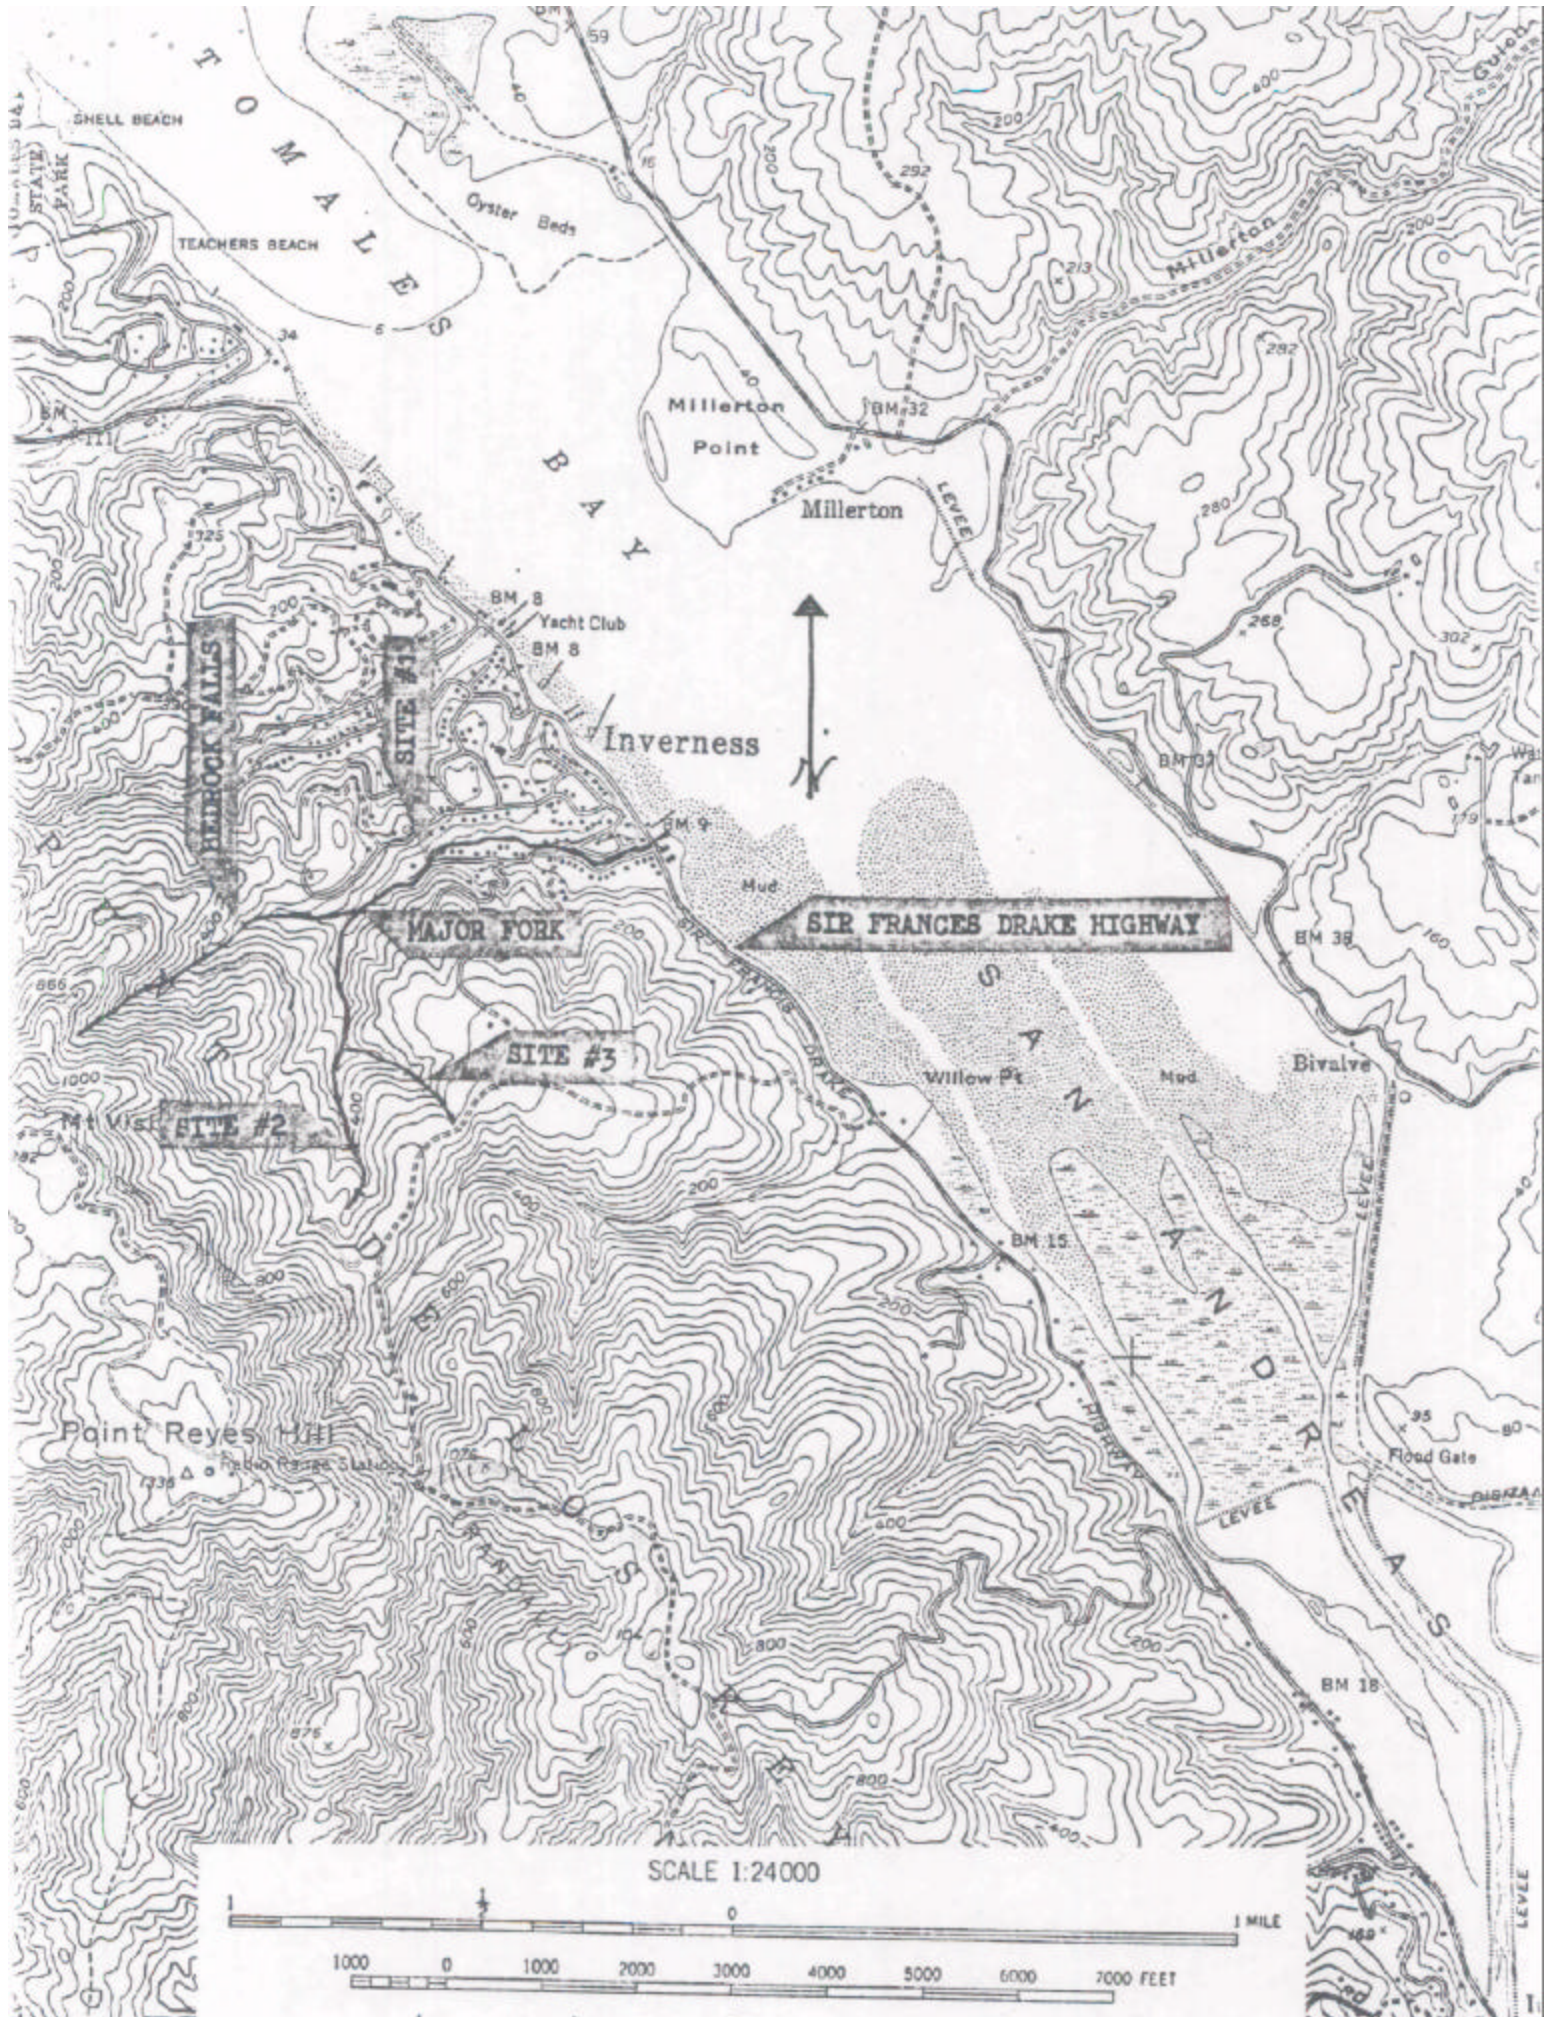
**EXTENT OF OBSERVATION** - On 10 June 1976, First Valley Creek was surveyed on foot by Seasonal Aids Ron Curtis and Gary Scoppettone. The stream was surveyed from the middle reaches of the three principal headwater tributaries to the mouth. (Reference map attached.)

**Altitude** - 8 ft. near the confluence with Tomales Bay at Inverness, and 170 ft. at the major fork of its two headwater tributaries (see reference map). The elevation of the headwater sources averaged approximately 500 ft.

**Barriers** - No significant barriers were observed in the mainstem of First Valley Creek. A series of 5 bedrock falls extending 20 ft. and ranging from 3 to 7 ft. in height, was noted in the stream's northern tributary (see reference map). These falls probably restrict fish passage. An impoundment created by a 5 ft. high concrete dam and enclosed by a shingled roof with wire screen sidings blocks all fish passage at site #2 on the principal southern tributary.
